The Uniform Building Inspection Report

Commercial Office Building:
2228 Kettner Blvd., San Diego

Prepared Exclusively for:
Blokhaus Development

Inspection Date:
9/24/12, 8:30 AM

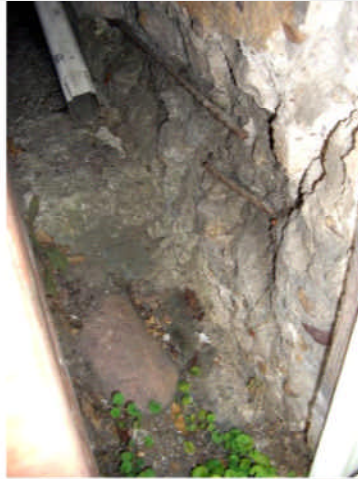
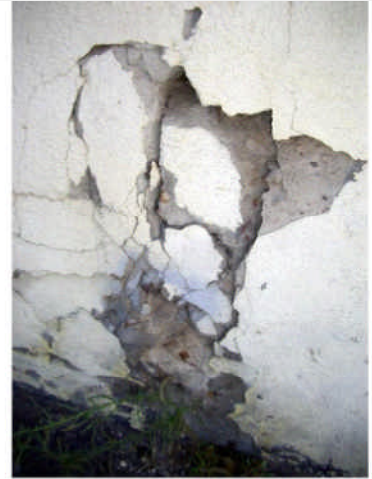
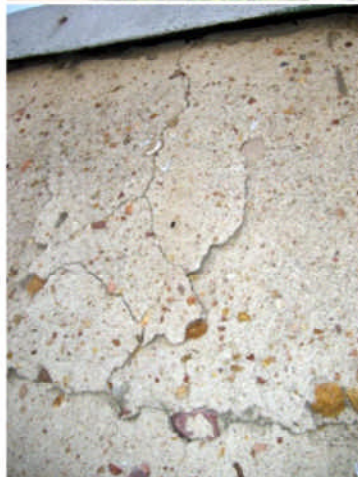
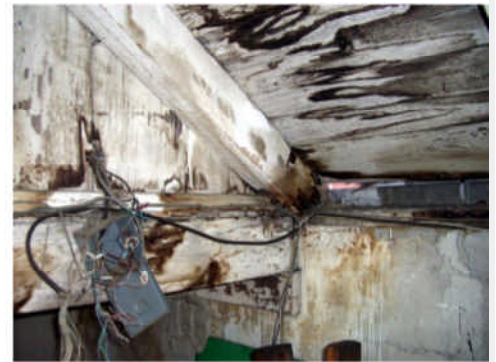
Major water damage and wood wrot are noted, Major structural cracks are noted in the foundation and the exterior walls.

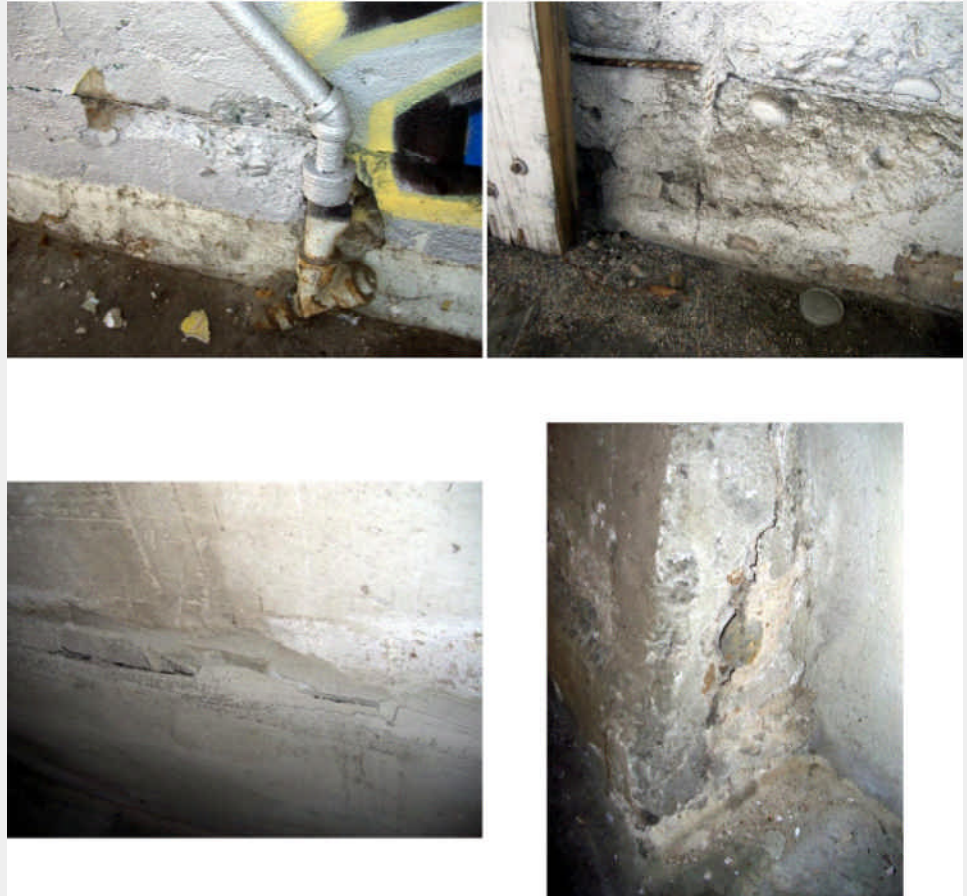
Displacement cracks and damage noted - Recommend further evaluation by a structural engineer.

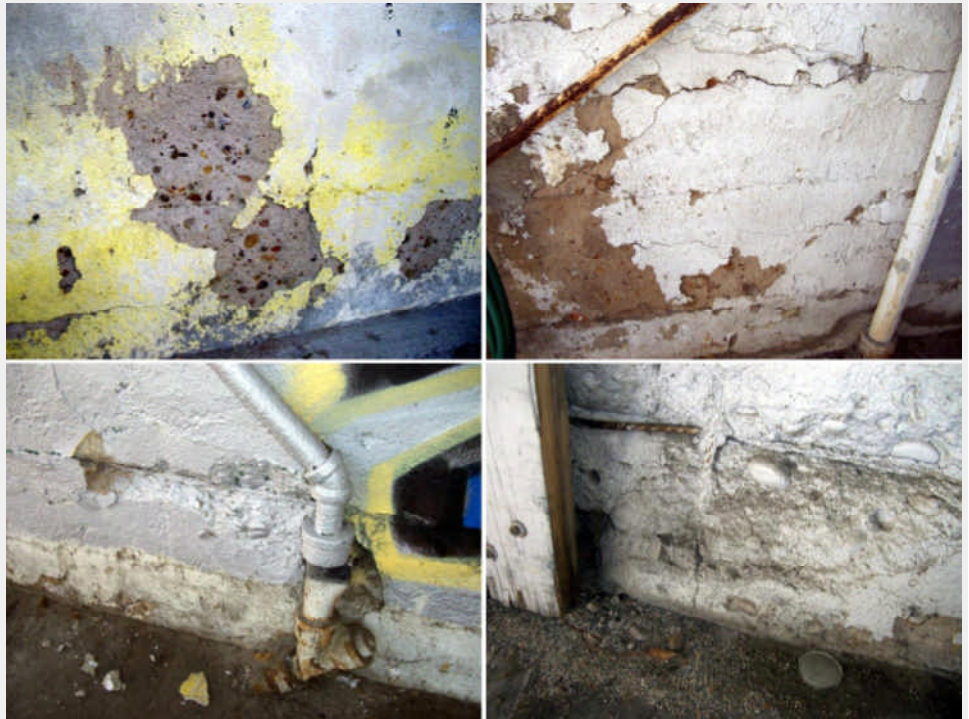
Displacement cracks and damage noted - Recommend further evaluation by a structural engineer.

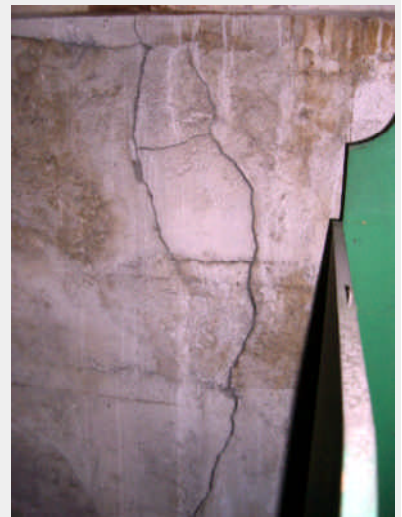
Major cracking is noted - Recommend further evaluation by a structural engineer.

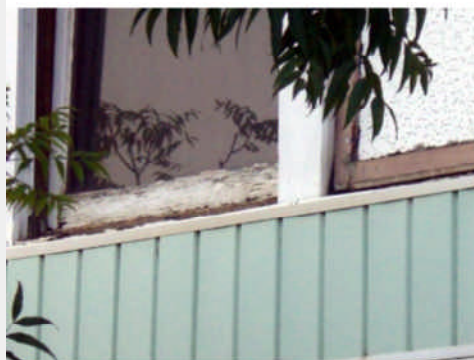
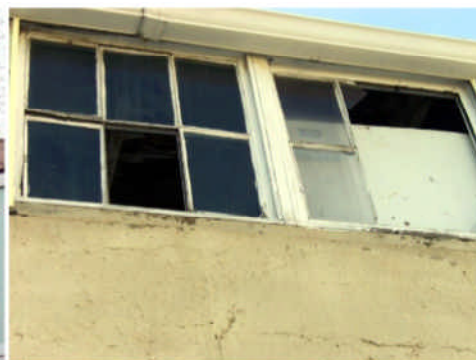
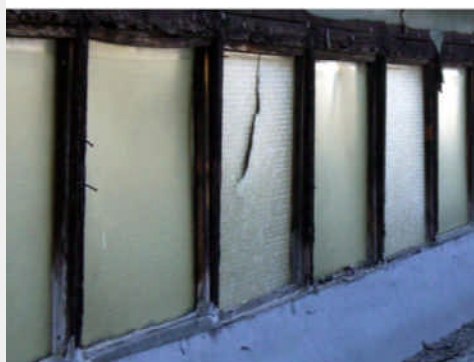
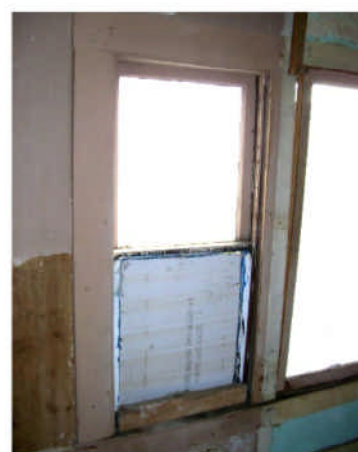
Broken & Missing
Wood Double Hung.

Poor.

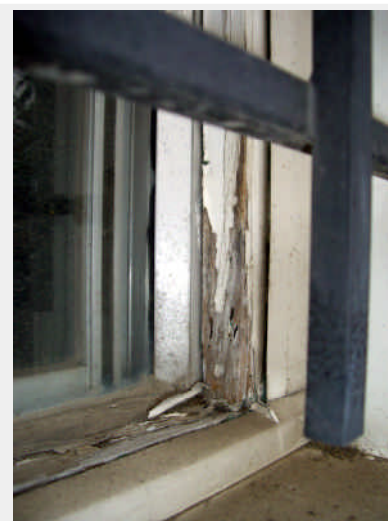
Wood, Poor.

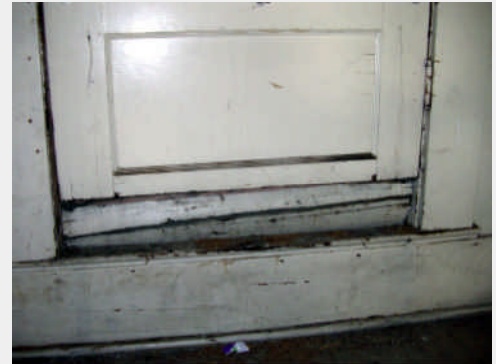
Poor.

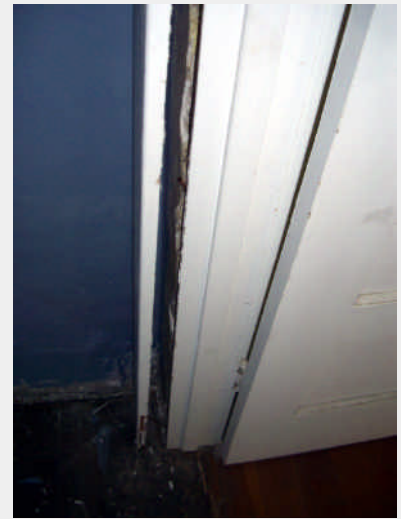
Interior trim is fair. Exterior trim is poor.

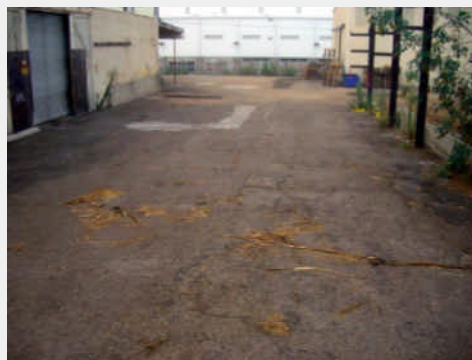
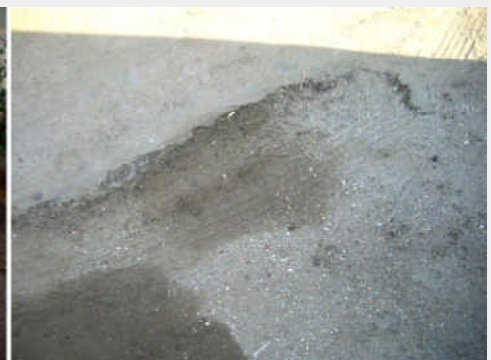
Parking area could stand topcoating with 1 inch of finish asphalt.

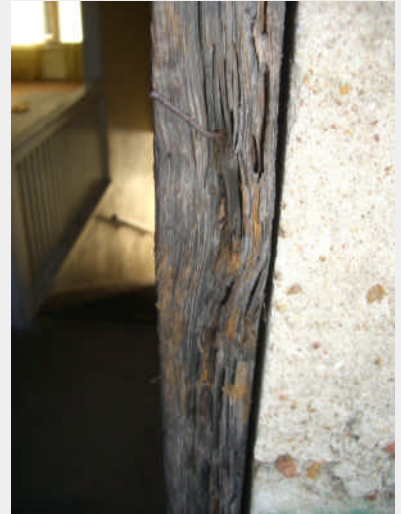
Yes - Further evaluation is needed by a licensed Pest Control Operator.

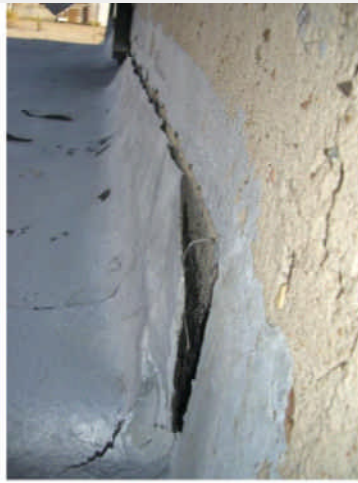
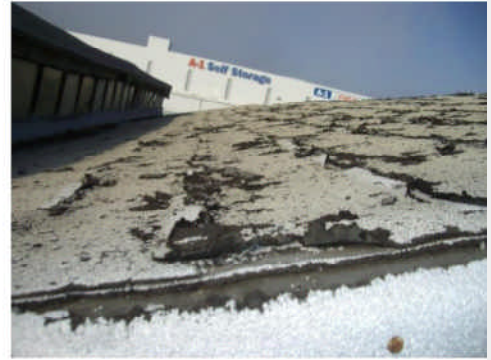
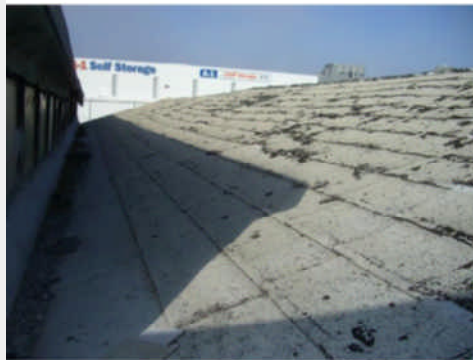
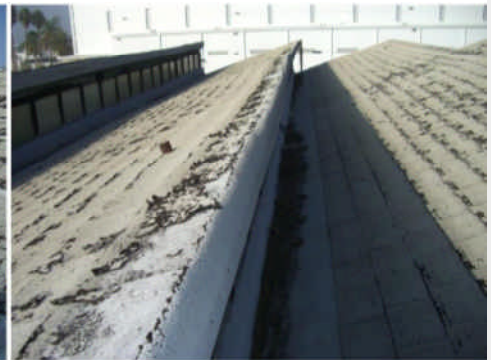
Composition, Roofing material has previously been coated with aluminized roof paint.

Poor, A licensed roofing contractor should be called in to make further evaluation and repairs as needed.

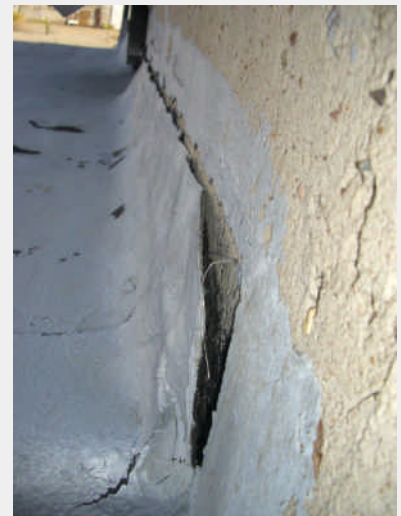
The potential for rainwater entry exists.

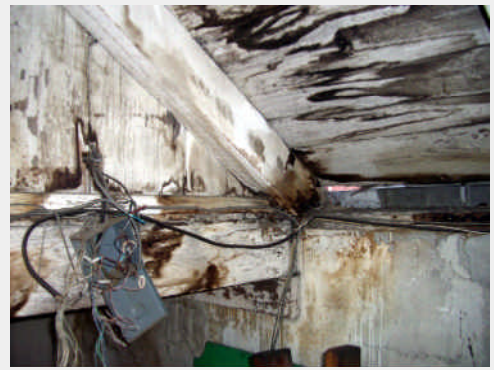
The potential for leakage exists at the following areas: Warehouse and office areas.

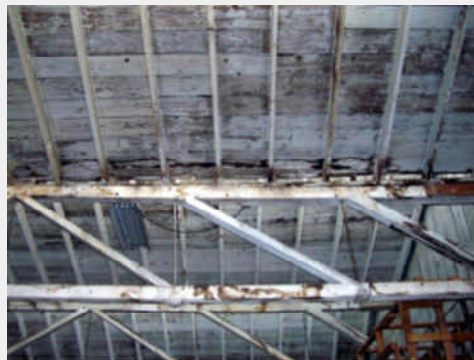
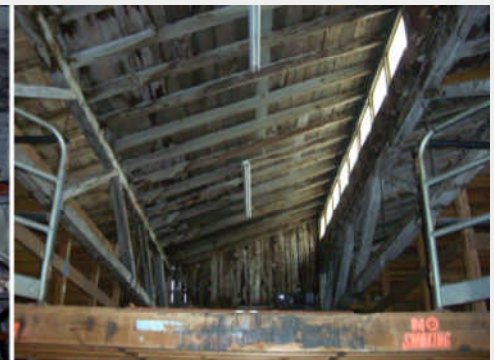
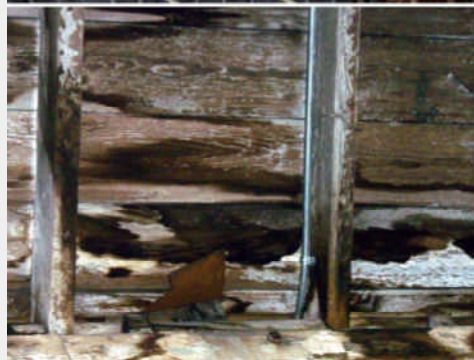
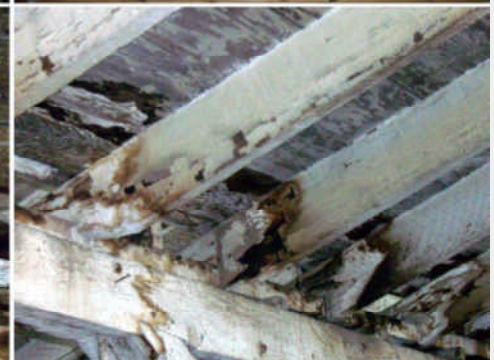
1 inch board, Poor overall condition.

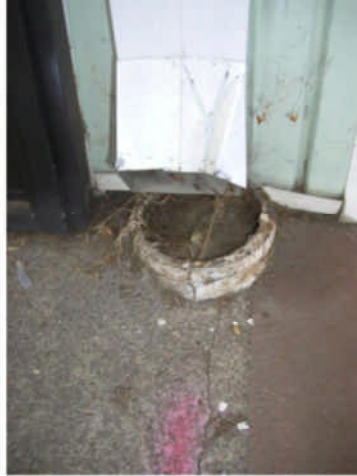
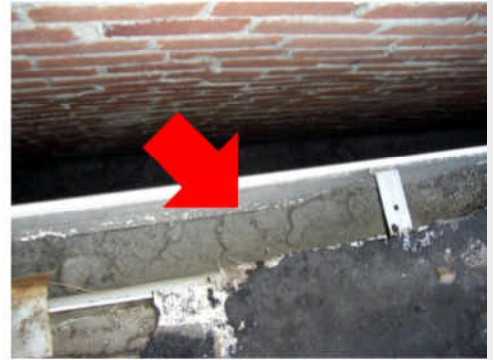
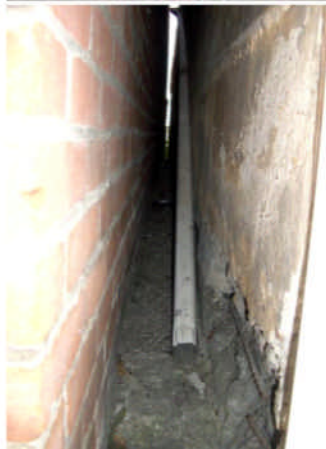
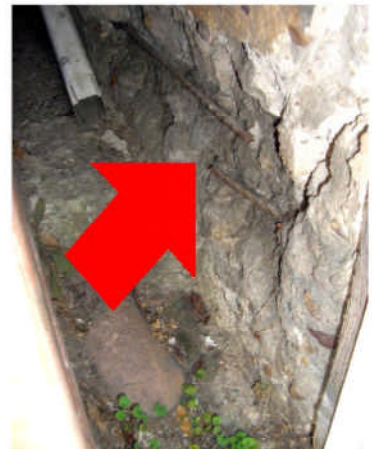
Damage at foundation - rebar exposed

Aluminum, Poor. Clogged drain noted, Missing downspout, debris in the gutters, clean the gutters.

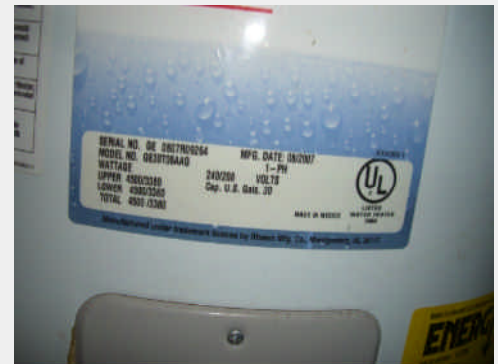
Equipment Condition:	Poor.
Secondary Water Heater:	Fair.

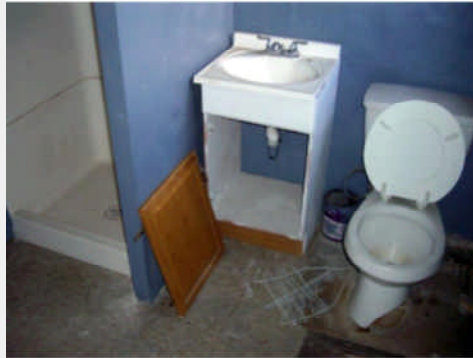
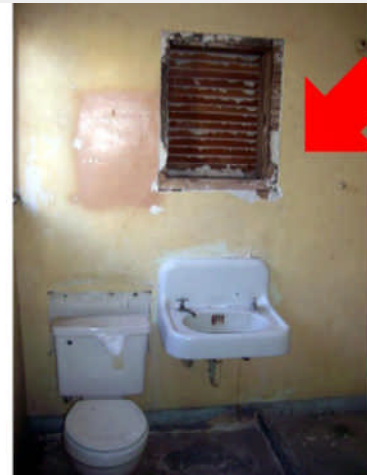
Poor.

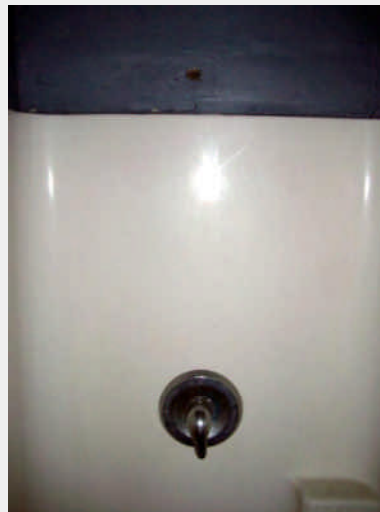
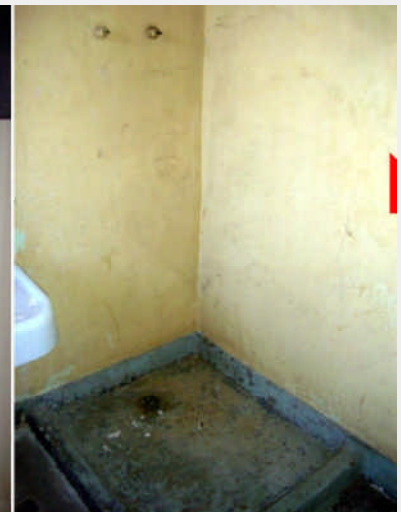
Inoperative.

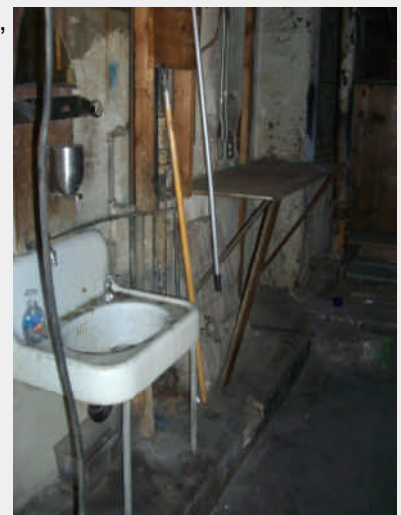
Missing medicine cabinet, missing shower stall, missing showerheads, missing flooring, rusty sink is noted, warehouse sink not plumbed.

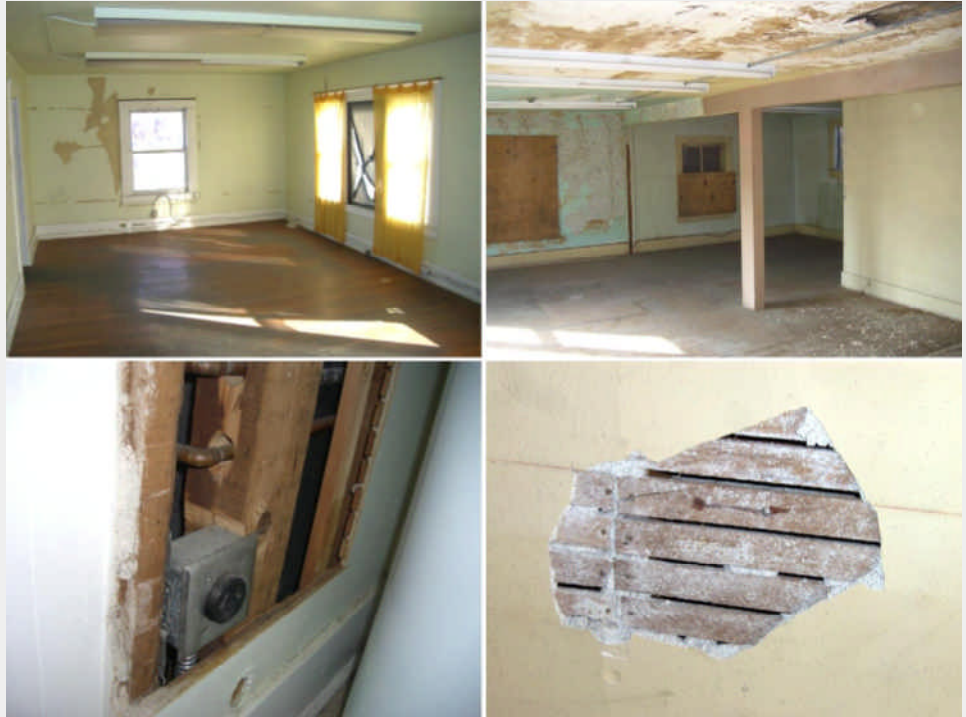
Major water damage to ceilings and walls are noted - Recommend a mold inspection.

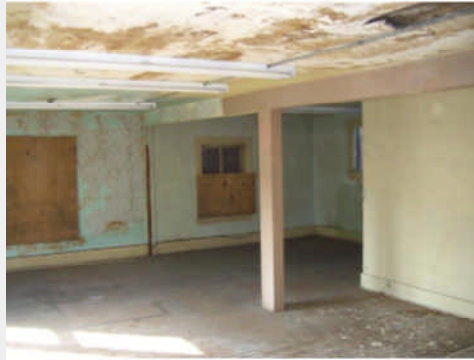
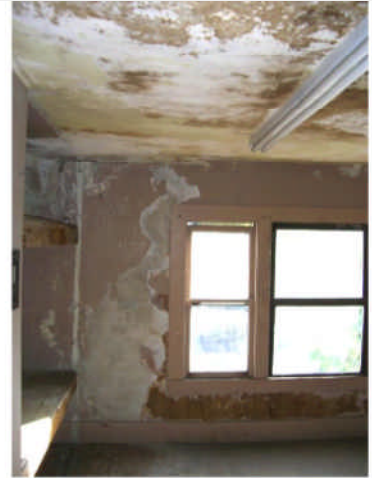
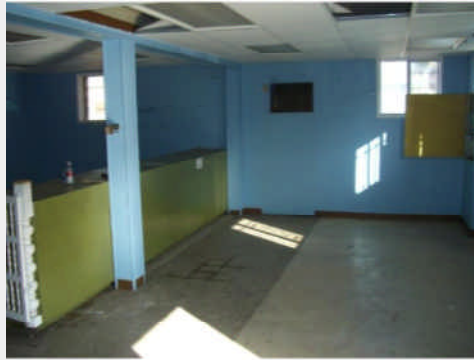
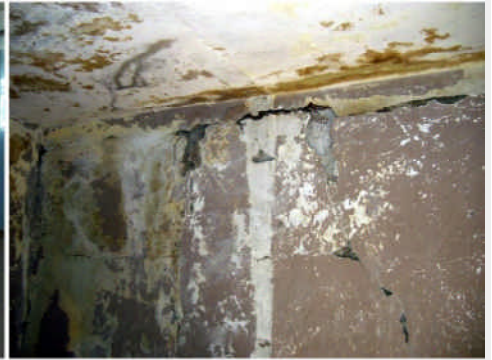
Poor.

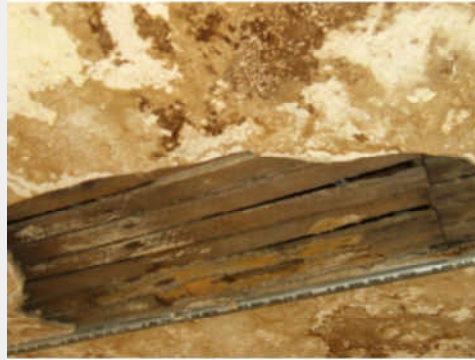
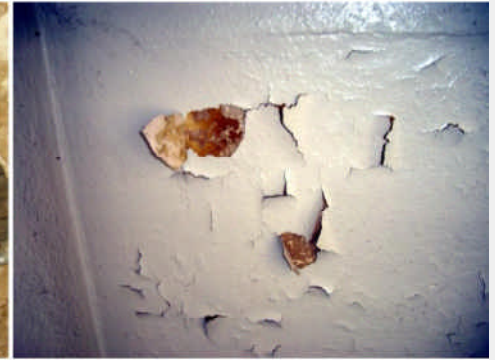
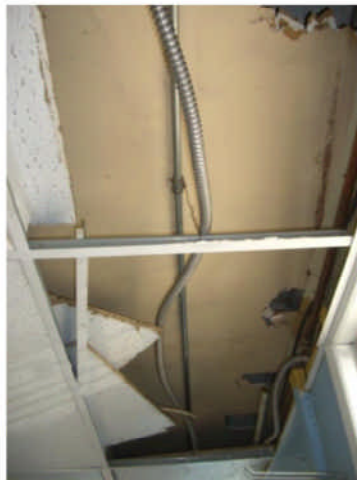
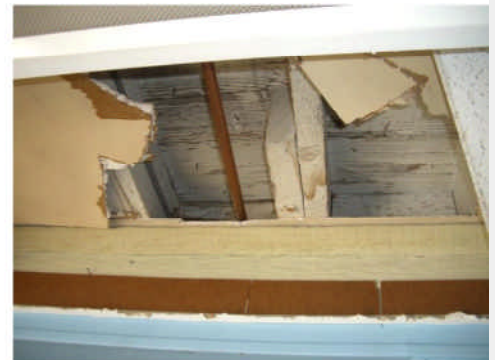
Poor.

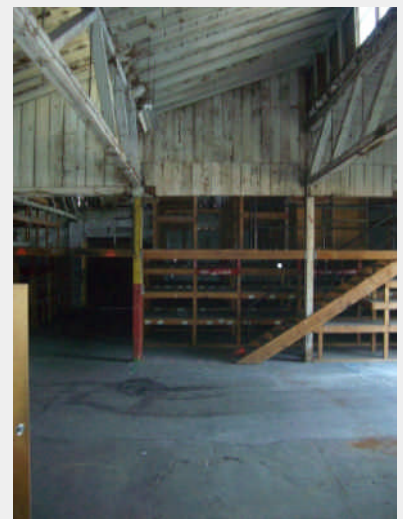
Major water intrusion noted, structural damage noted.

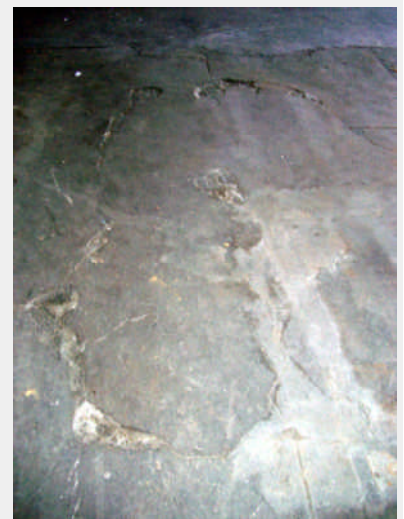
Minor damage is noted.

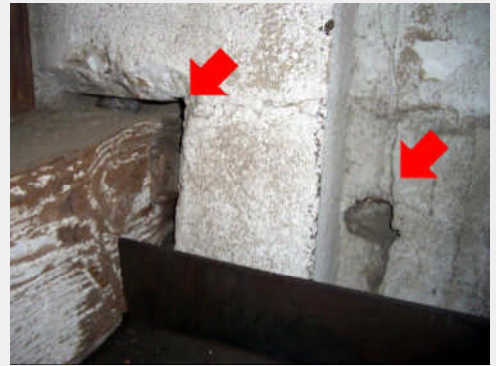
Loose fit, damaged and cracked wall noted - Recommend further evaluation by a structural engineer..

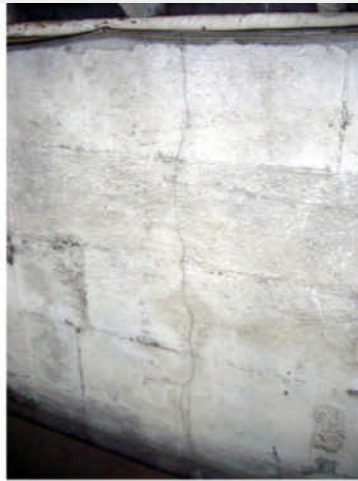
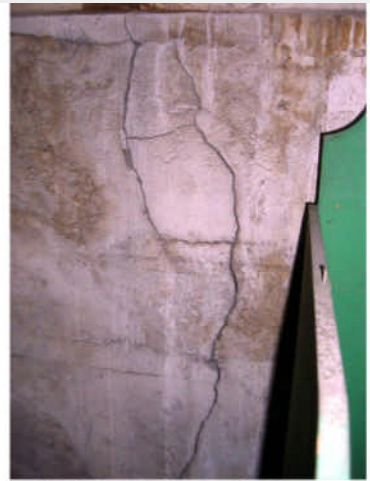
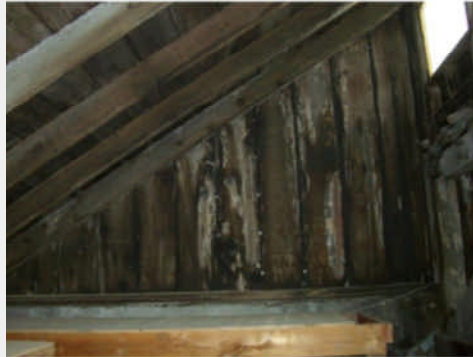
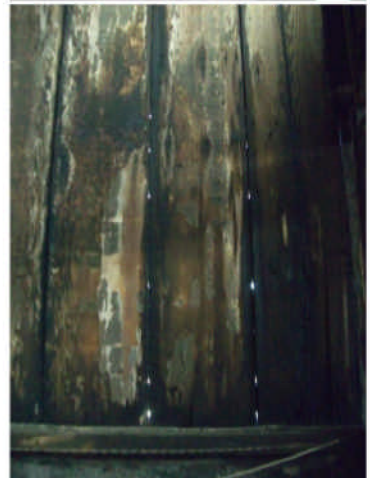
Poured concrete and wood; Cracks, wood wrot and damage noted.

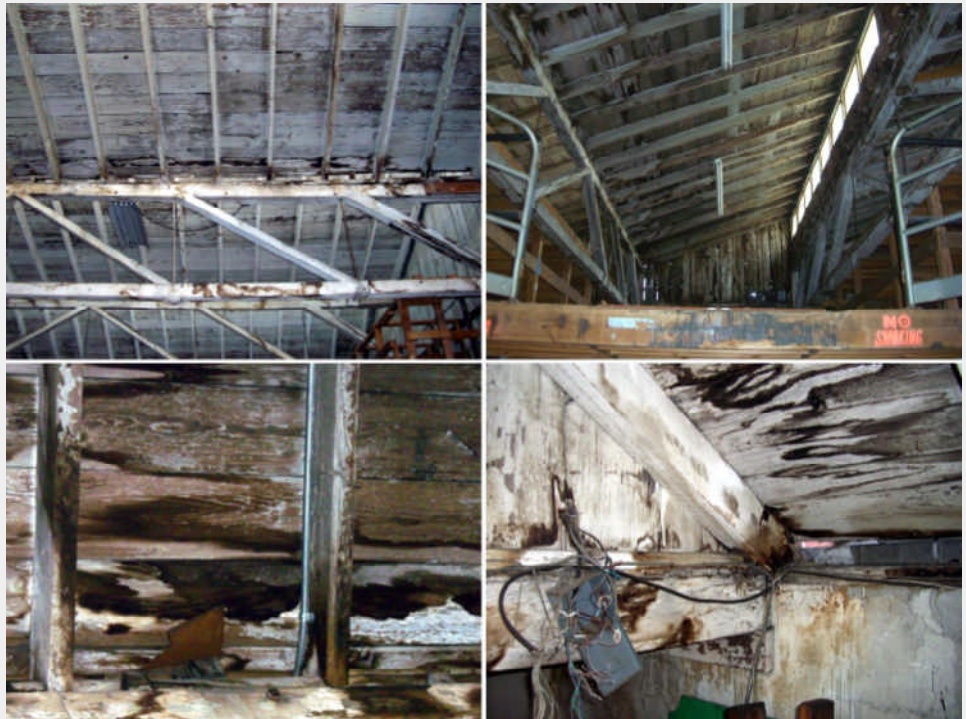
Wood wrot, water stains and leaks noted - Recommend further evaluation and roof replacement by a licensed roofing contractor.
