Uniform Building Inspection Report

409 Ave. Victoria #A, San Clemente, Ca 92672

6/3/2016

Report # 1624

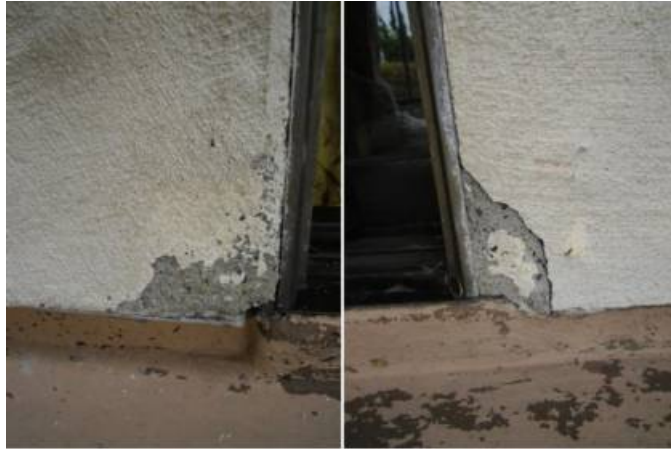
Needs repair at the lower deck area.

Stucco needs repair at the lower deck area.

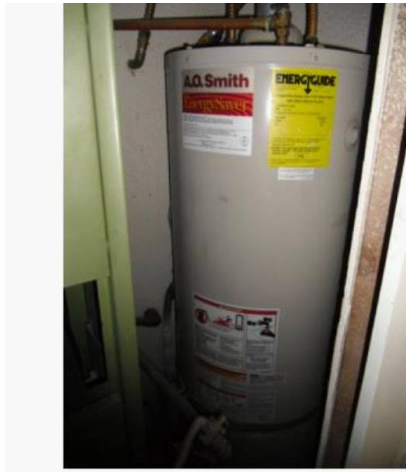
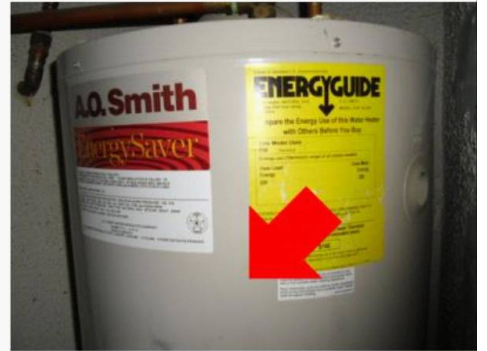
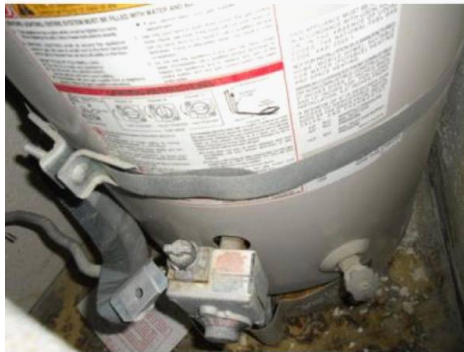
Missing top strap

Flue vent intact, A water shutoff valve is installed. **Unit is not strapped to California Earthquake Guidelines. Recommend two (2) straps, one third from the top and one third from the bottom of unit, 16 gage metal at least 1.5 inches wide and blocked to less than one inch from strapped wall.**

Unit is not strapped to California Earthquake Guidelines. Recommend two (2) straps, one third from the top and one third from the bottom of unit, 16 gage metal at least 1.5 inches wide and blocked to less than one inch from strapped wall.

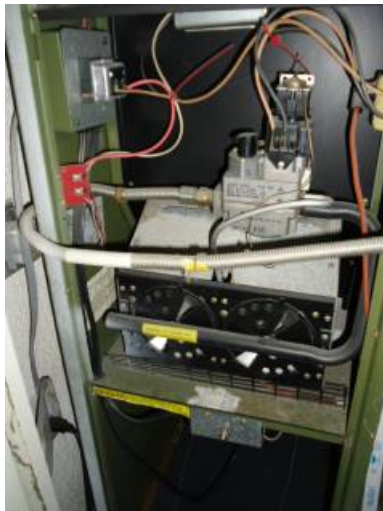
Appears operational.

<i>AIR PLENUM:</i>	Appears serviceable.
<i>AIR FILTERS:</i>	Suggest cleaning/changing filter.
<i>NORMAL CONTROLS:</i>	Appear serviceable.
<i>GENERAL SUGGESTIONS:</i>	Suggest cleaning/servicing blower motor, pilot light, vent system and burners. Recommend consider replacement due to age and lack of efficiency.

Suggest cleaning/servicing blower motor, pilot light, vent system and burners.
Recommend consider replacement due to age and lack of efficiency.

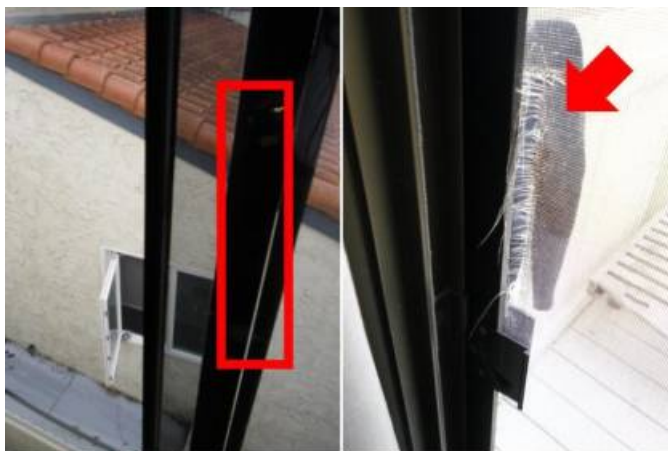
Aluminum, Sliding, Missing window latches in master bedroom and master bath. Damaged screens noted thru out.

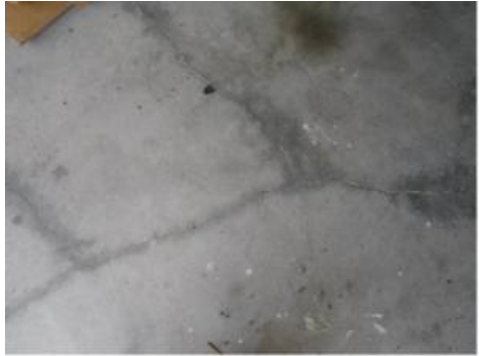
Typical cracks noted.

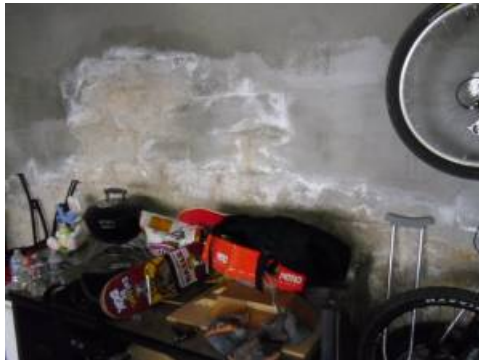
Damage is noted, Repair any openings with approved materials to restore its fire rating, Moisture intrusion noted - Call a specialty contractor for further evaluation and necessary repairs.

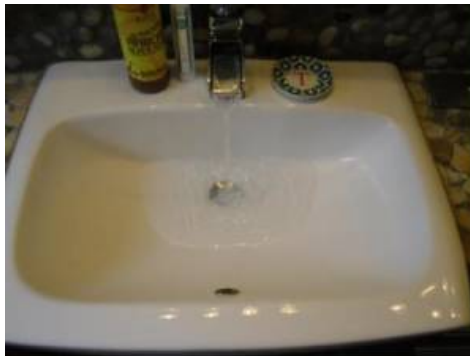
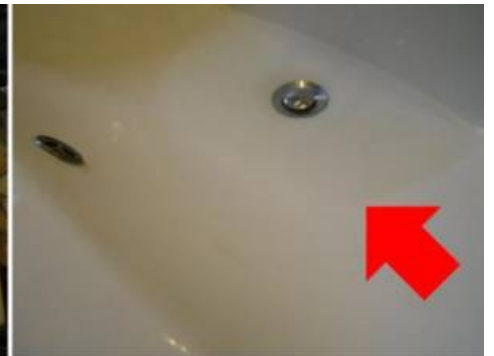
Left sink is slow to drain - Recommend calling a licensed plumber for further evaluation and necessary repair.

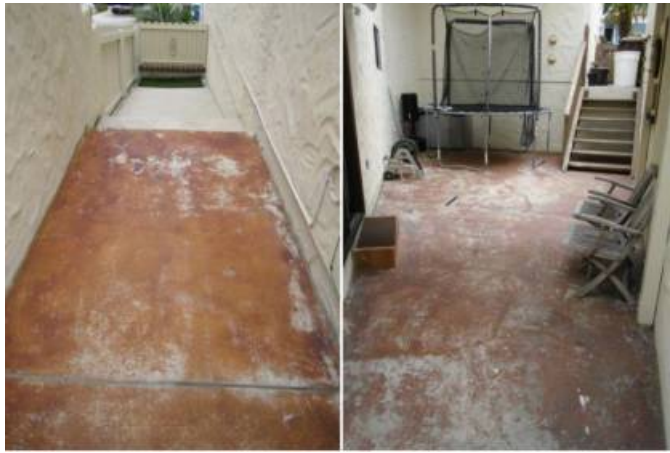
Cracks noted - typical, Color coating would improve the overall appearance. Back stairs and handrails need repair and finish paint.

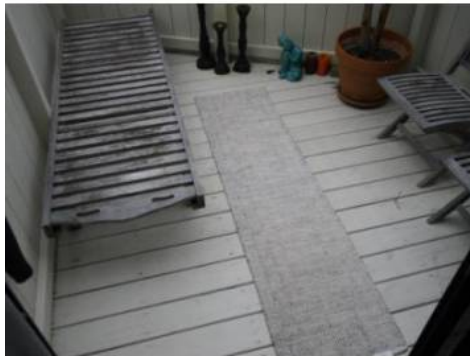
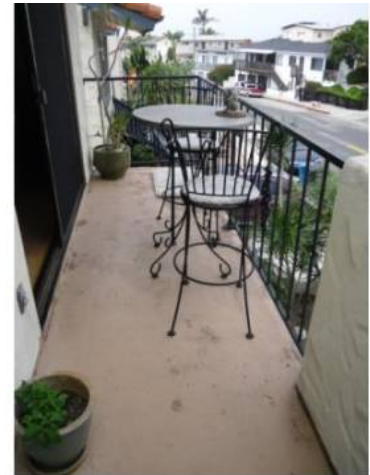
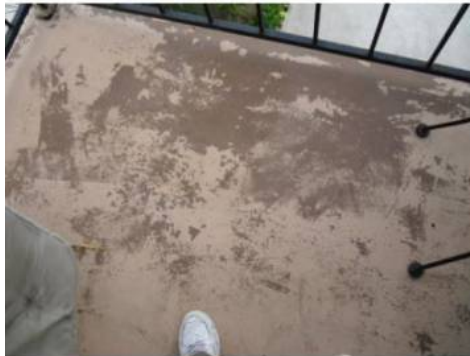
Master bedroom wood deck, Appears serviceable. Deterioration noted to lower deck surface, Wrought iron railing has rust noted, Repairs needed.

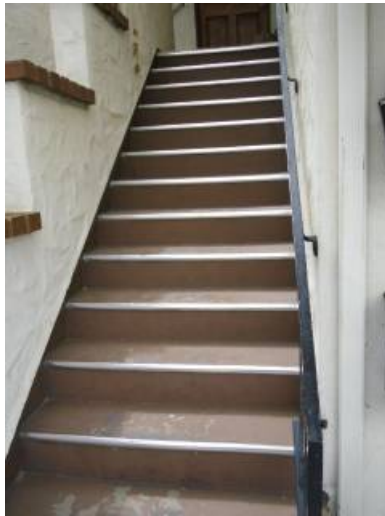
Front entry stairs and handrails are serviceable, but cosmetics would be improved by painting. Exterior back patio stairs and handrails need repairs - cracked and damaged steps noted, prep and paint needed.
