# The Uniform Building Inspection Report

**Historic Bed & Breakfast:**  
406 Maple St., San Diego, Ca.

**Prepared Exclusively for:**  
Blokhaus Development

**Report Number:**  
040512-b000644

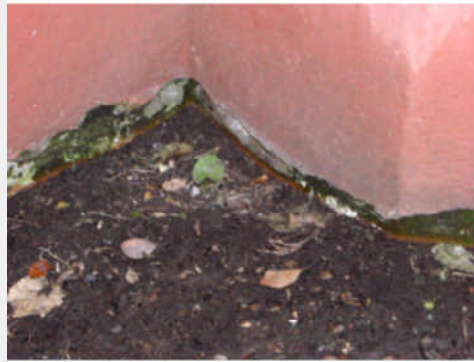
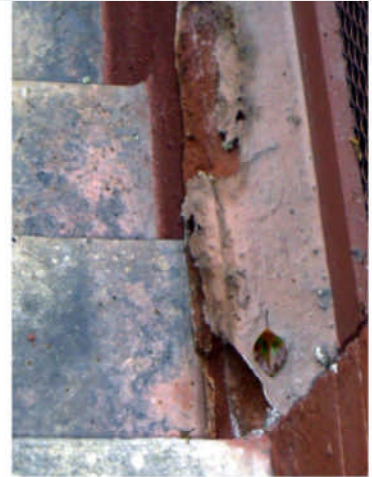
Stucco Color Coat is blistered and/or peeling away, Damaged/rotted from moisture.

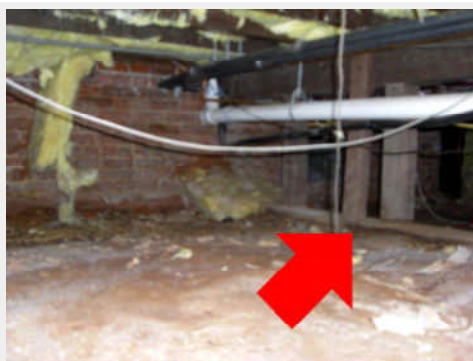
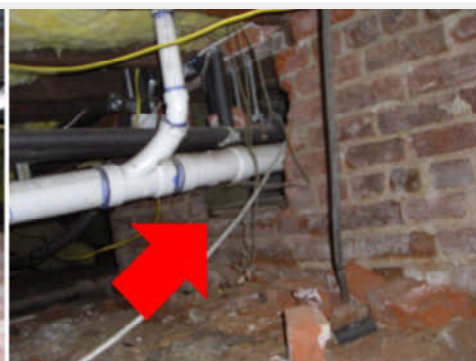
Some piers and posts are, Earth-to-Wood contact is found, Further evaluation by a structural engineer is recommended due to conditions viewed.

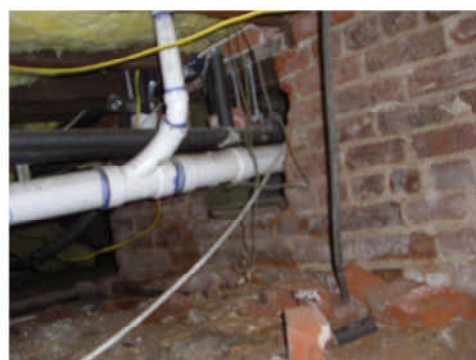
Deterioration noted to foundation walls is major. A Structural Engineer should be called to make further evaluation and recommendations as needed.

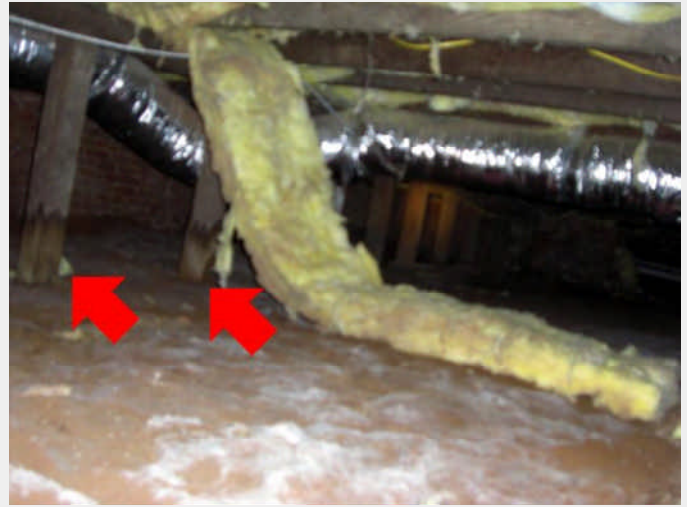
Column/pier is out of plumb or weak, water stains noted.

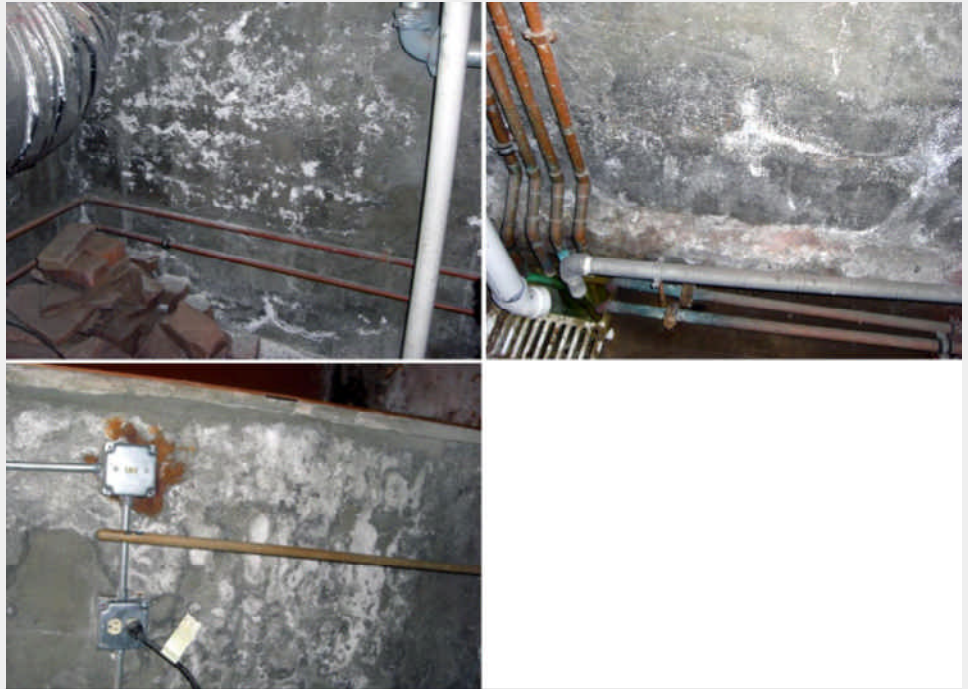
**Efflorescence noted.**

Symptoms of prior water entry exist.

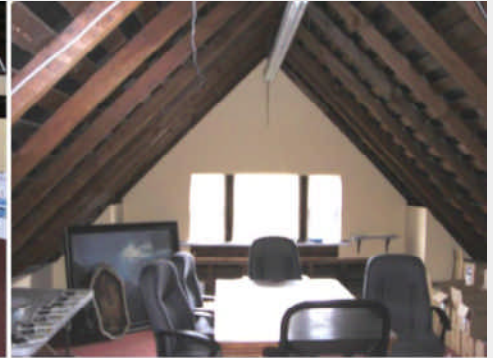
No insulation is provided.

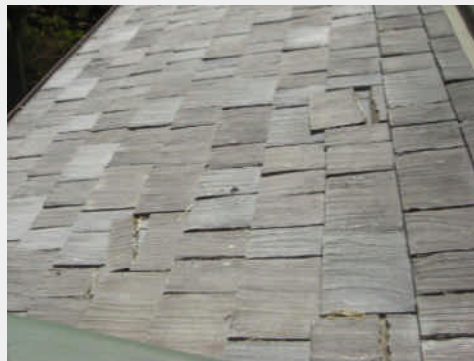
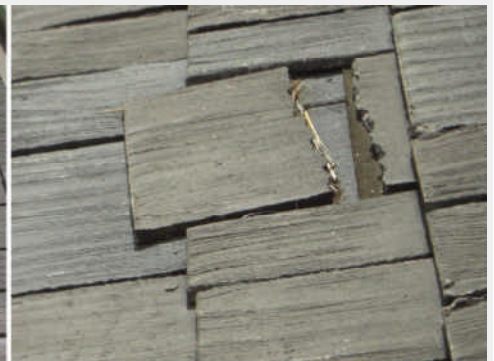
Damage/Deterioration/Defects noted. A licensed roofing contractor should be called to make further evaluation and repairs as needed.

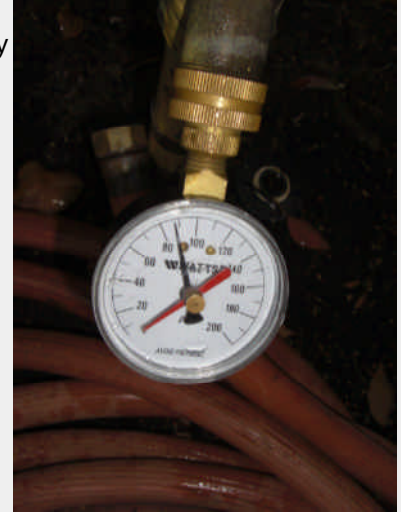
Water pressure to home is too high at 89 psi (Typically 60-80 psi) and a further evaluation by a licensed contractor is recommended.

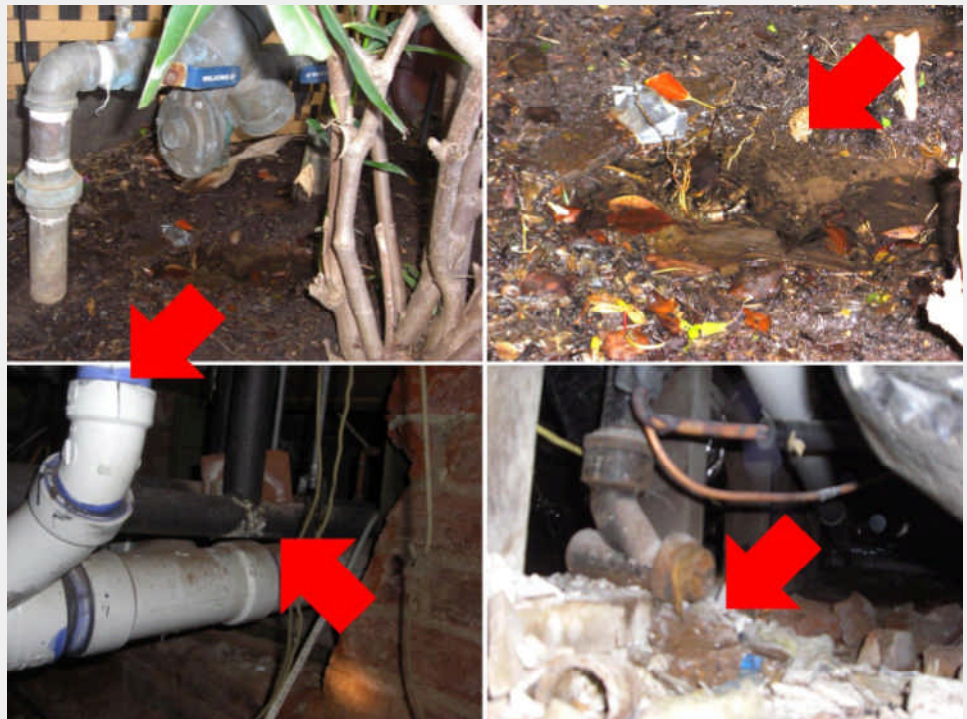
Leaks noted at main supply and in crawl space - Repairs needed.

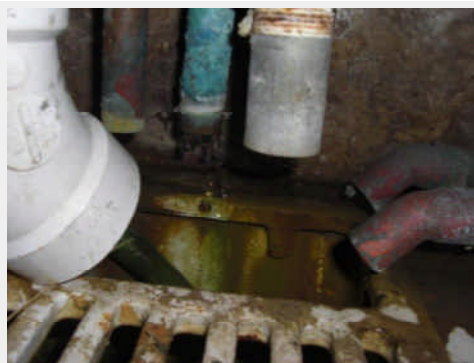
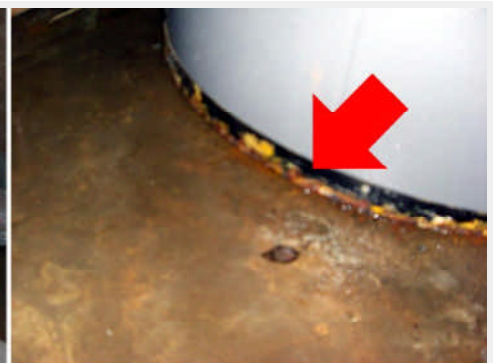
Drain line is not draining properly and flooding the basement floor, causing the water heater to rust - Repairs needed.

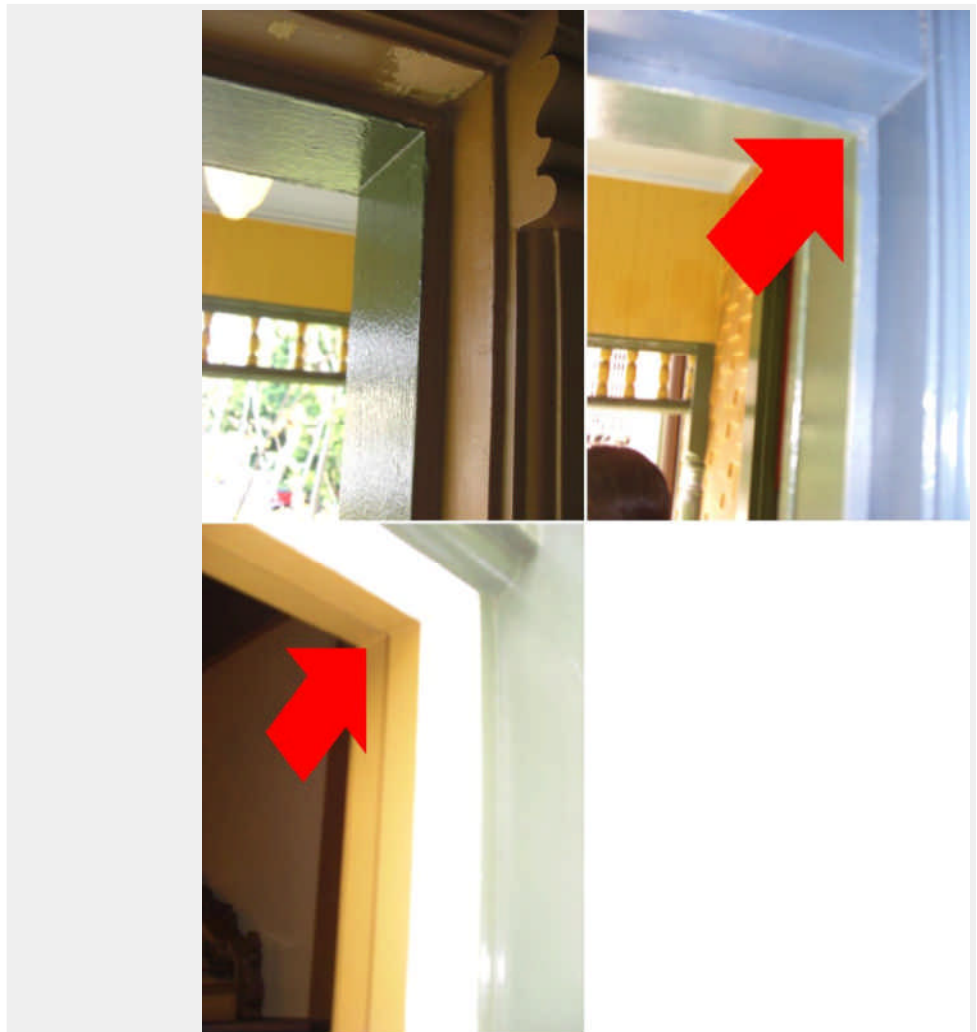
Standard side/rear door, Appears serviceable. Missing weatherstripping is noted at the deck doors of Gothic, Balboa, & Garden Rooms.

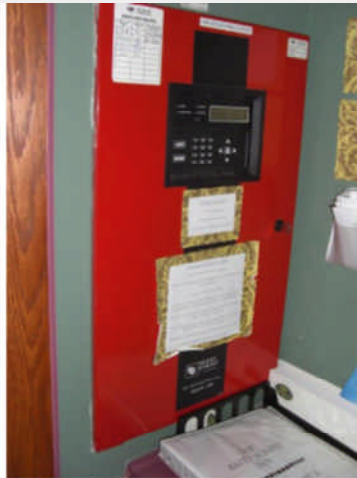
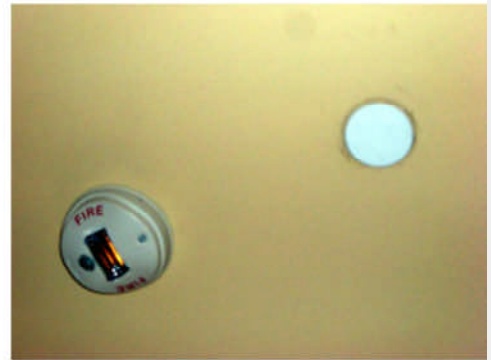
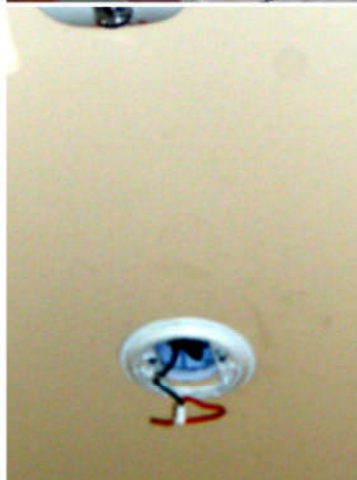
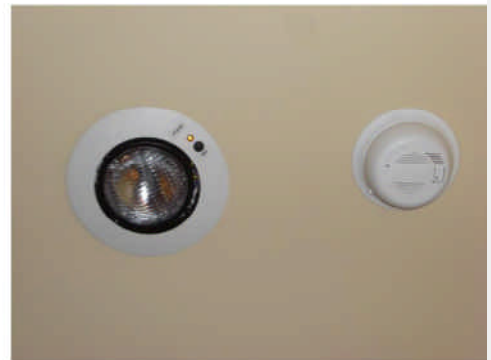
Fire Suppression system & emergency light are noted, but not tested. Missing smoke detectors are noted in Gothic room and in hallway.

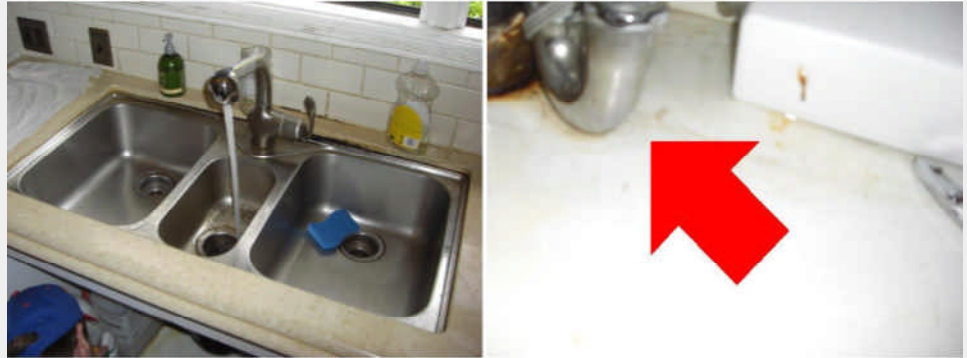
Stainless Steel, **ACTIVE LEAK** noted. Faucet is serviceable, Third faucet is inoperative.

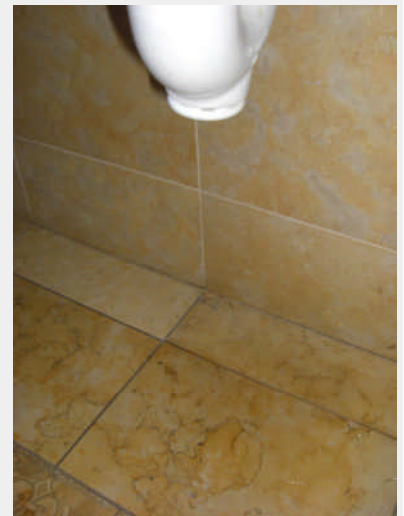
Sink leaks - **ACTIVE LEAK!**

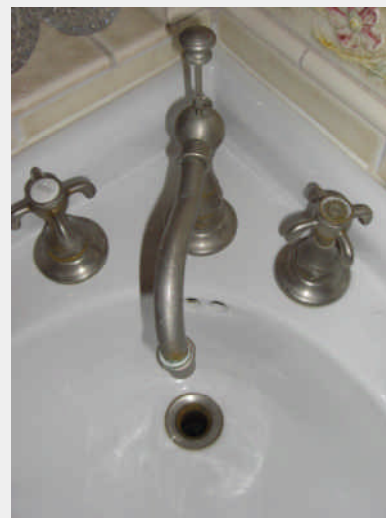
Drain appear serviceable, The following problems were noted at the drain: Missing mechanical stopper.

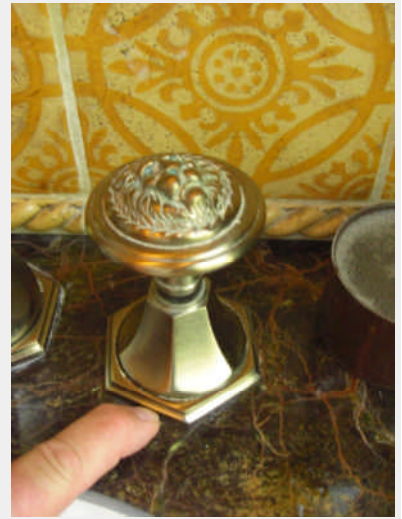
Faucet leaks. Drain appear serviceable, Counters/cabinets appear serviceable.

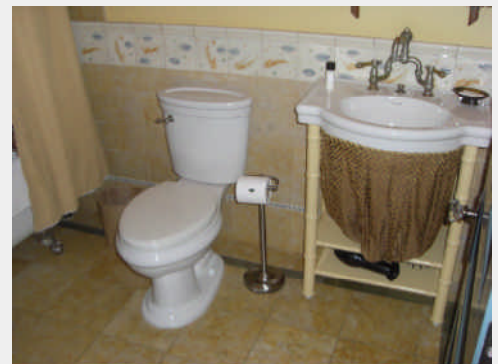
Aesthetic.

Drain appear serviceable. Minor **ACTIVE LEAK** under the sink.

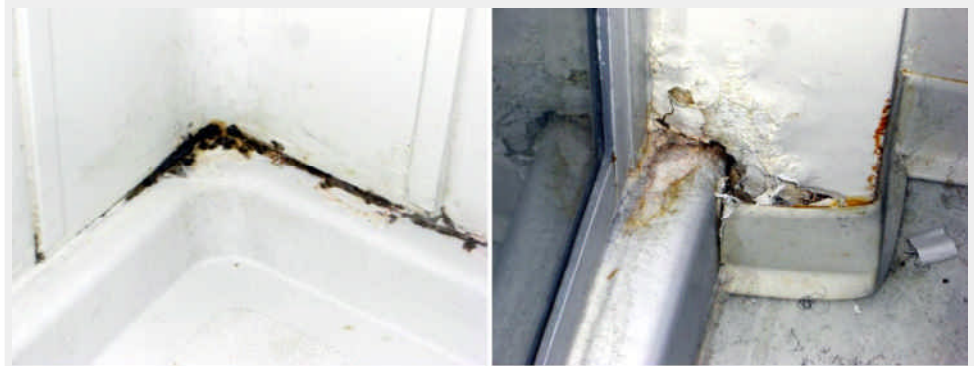
Moisture damage is seen at wall areas.with black mold like substance noted, Enclosure has a leak - Cosmetic moisture damage is noted at the wall or floor outside the tub/shower area.

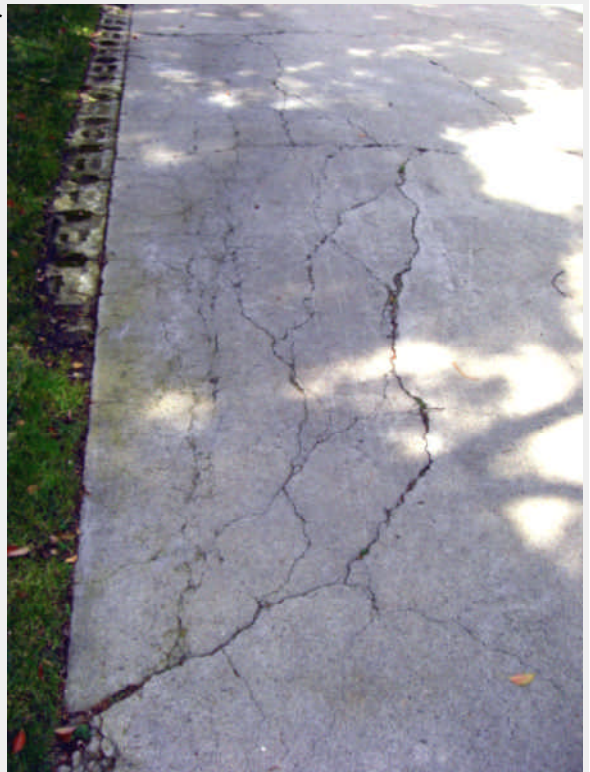
Cracks noted are major, Repair needed.

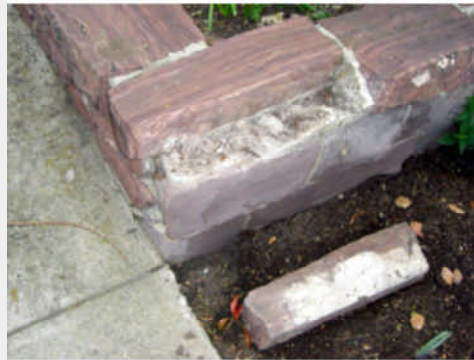
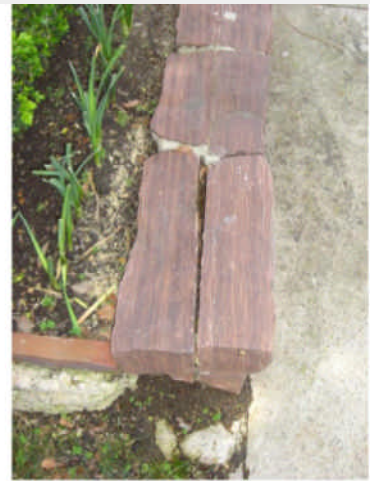
Planter walls in the yard are damaged.

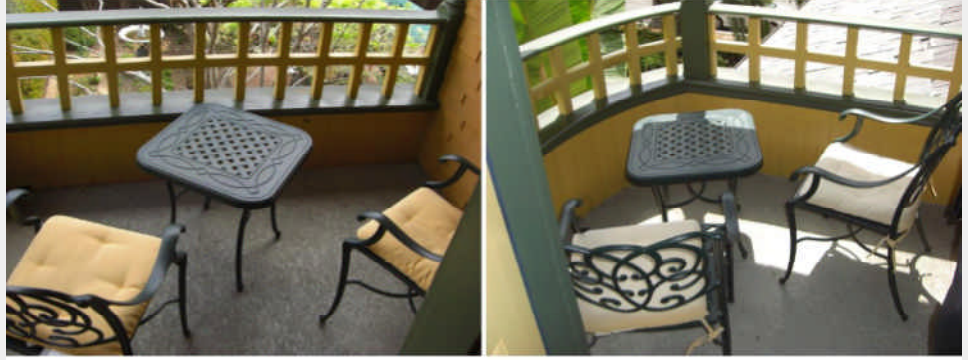
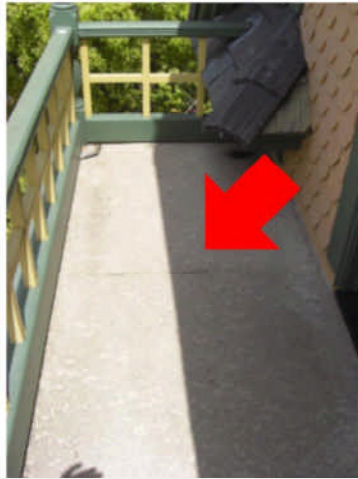
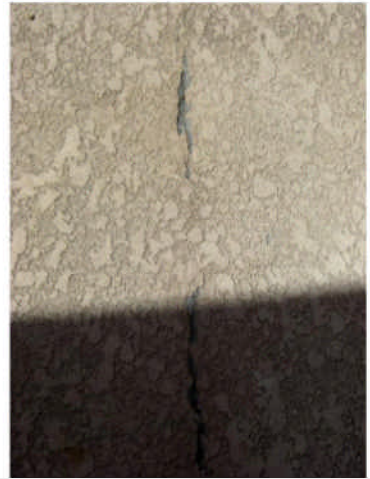
Gothic & Balboa Decks, Appear serviceable; Office, Attic area deck has damage noted - Repairs needed.

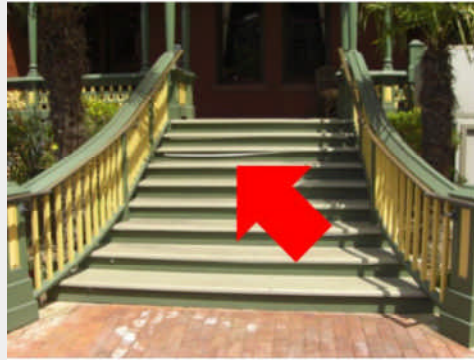
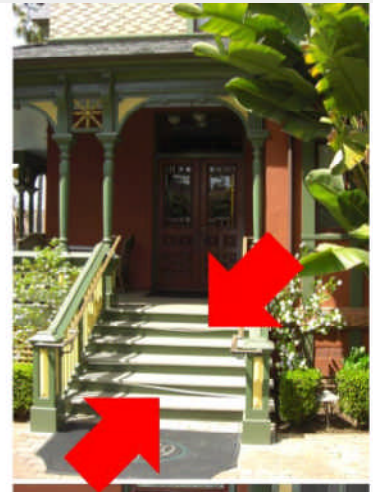
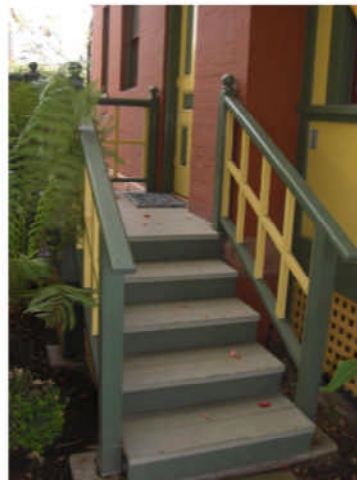
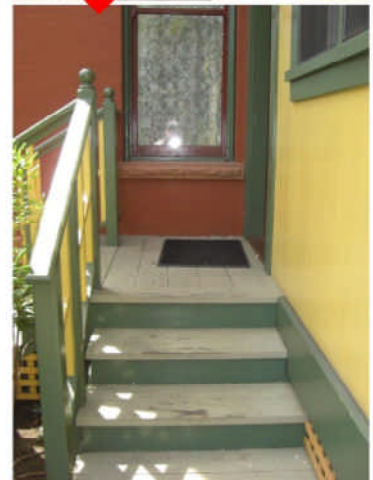
Handrails serviceable. Repairs needed - **TRIP HAZARDS!**

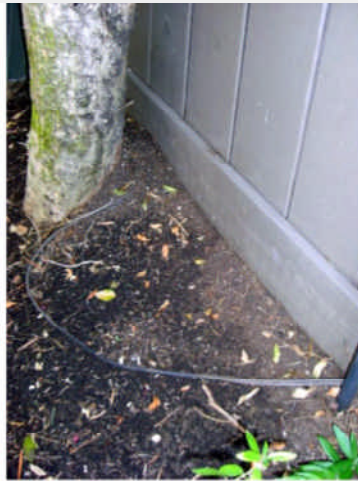
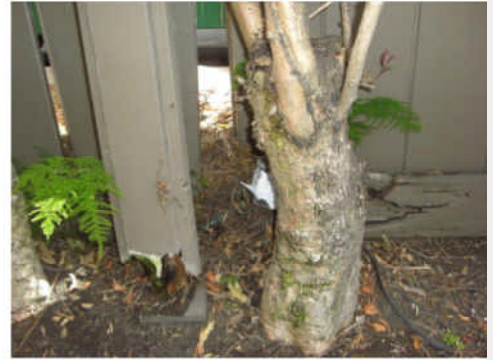
Gate latch does not close- Repairs needed. Earth to wood contact - Lower the dirt 2-3 inches to prevent wood rot. Damage is noted - Repairs needed.
