Uniform Building Inspection Report

2055 Dublin Dr., San Diego, Ca 92154

Prepared for: Corporate Communications
Report #1601

Thursday, January 14, 2016

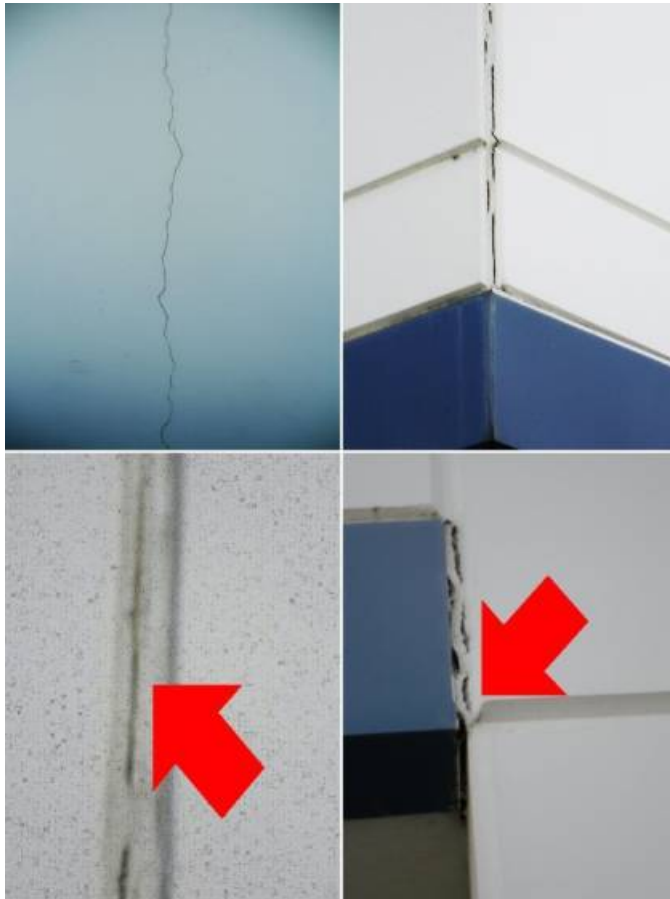
Evidence of Cracking:

Minor hairline cracks are noted at exterior walls, None of the cracks are significant. Seal when repainting occurs.

Some concrete panel seams need sealant to prevent moisture intrusion.

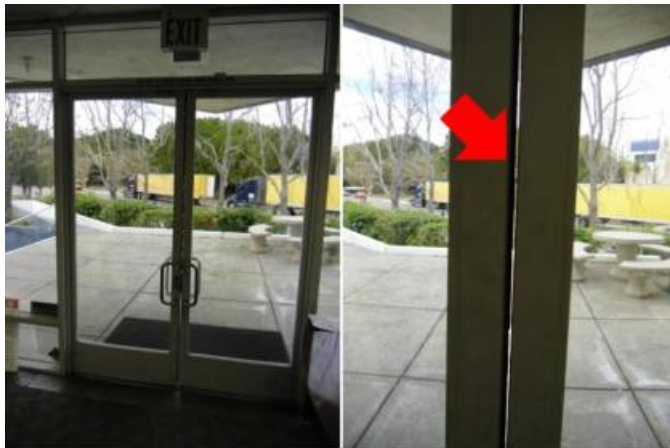
Front Entry Doors:

Fair condition. Door has a loose fit when closed - Weather-stripping is only fair and needs renewal.

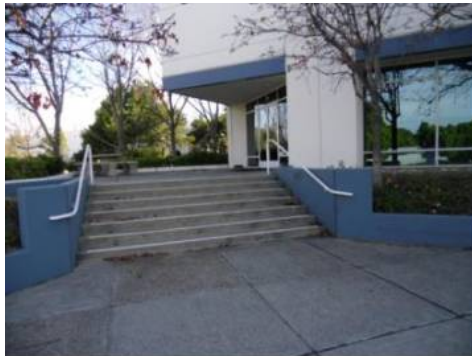
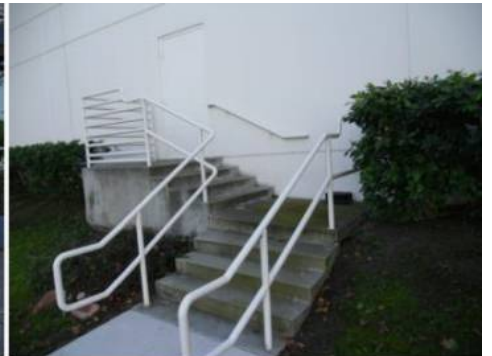
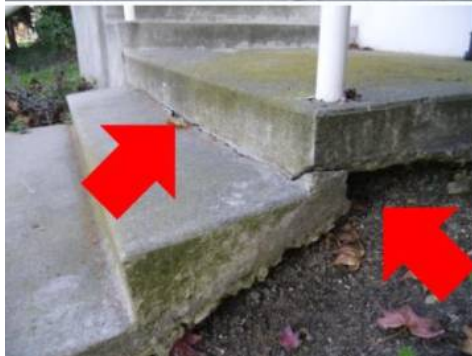
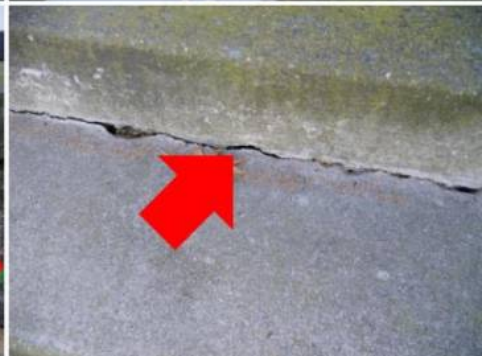
Stairs:

Front entry stairs, Good condition. Side entry stairs have erosion and crack noted - Repair needed.

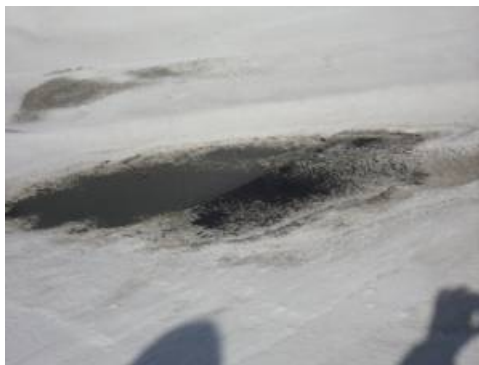
Overall Condition:

Good, with ponding noted.

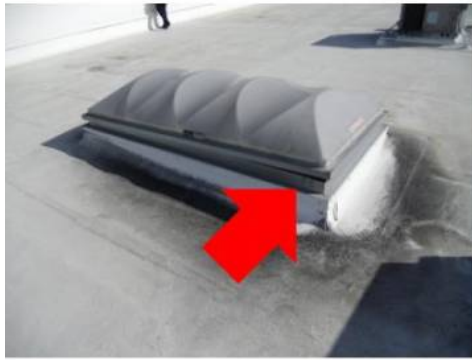
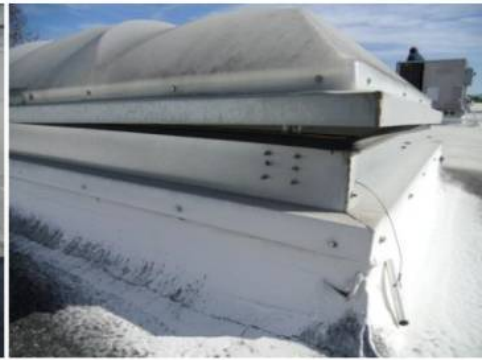
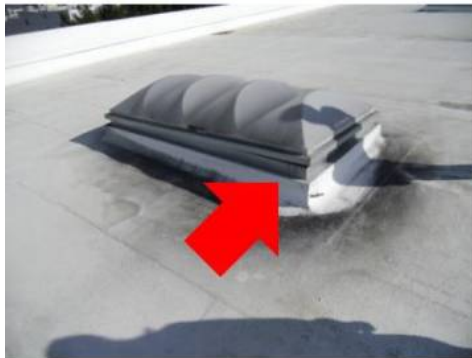
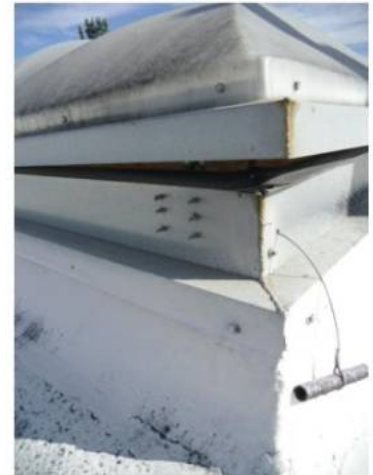
Skylights:

2 different skylights open to weather - Close & seal shut.

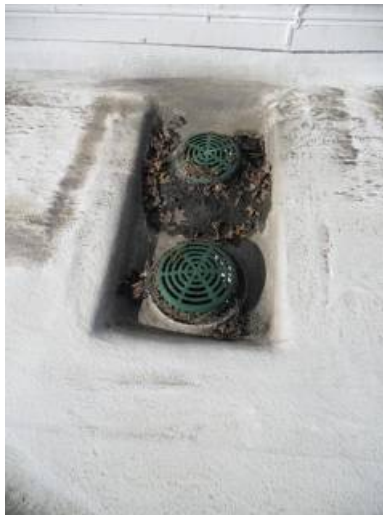
Type and Condition:

Steel. Good overall condition. Debris in the drains - Clean the drains.

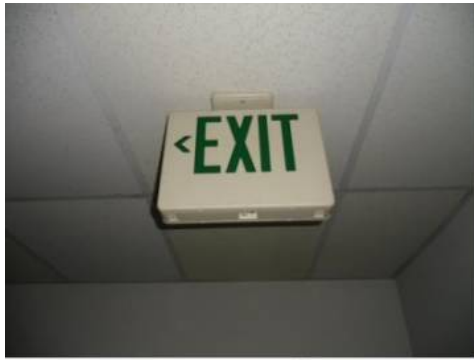
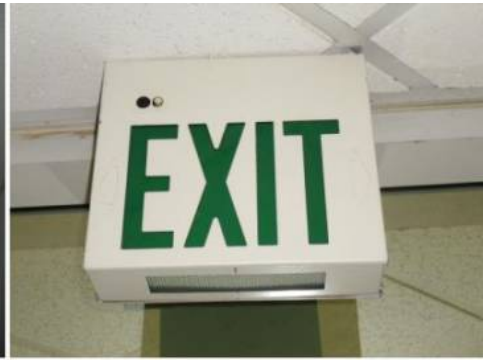
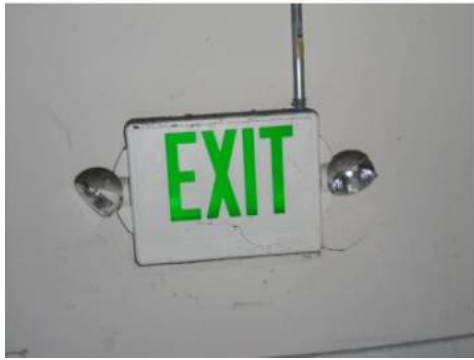
EMERGENCY LIGHTING;

2 inoperative Exit light signs, the rest were operative - Repairs needed.

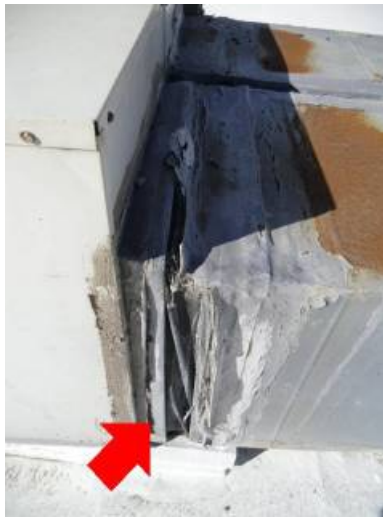
Air Handler:

Upstairs air handlers are not insulated but the ductwork is, thus the galvanized metal air handlers get condensation and drip onto the t- bar ceiling.

Anticipate the need to replace this equipment in the not too distant future. Repairs needed.

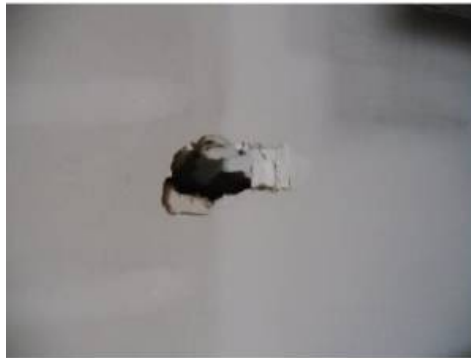
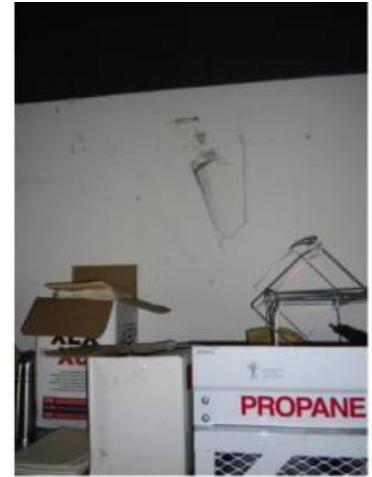
WALLS:

Drywall, Minor blemishes seen at walls of some interior rooms. Make cosmetic as needed.

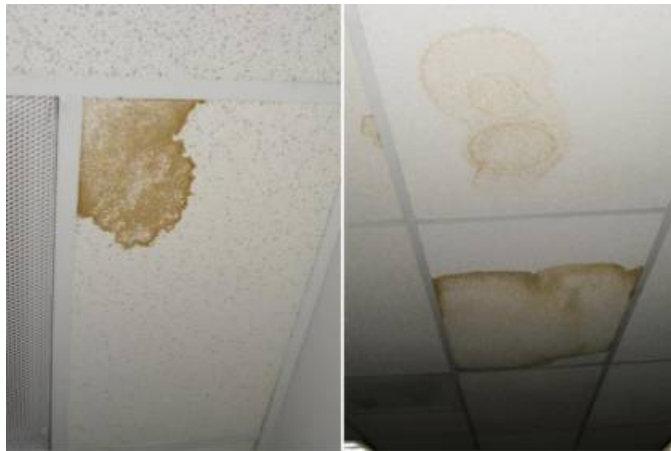
CEILINGS:

Upstairs water stains noted on ceiling tiles. The cause is uninsulated air handlers just above the water stains - Repairs needed. **(See photos under INTERIOR - Ceilings)**

Ceiling areas with dry stains caused by prior leaks are noted in the following areas: Some ceiling tiles are damaged and in need of replacement or cosmetics.

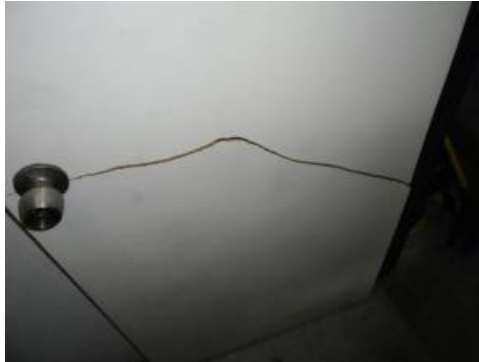
DOORS:

Fair condition. One broken door at warehouse electric room. Numerous missing door stops noted thru out - Replace the door stops.

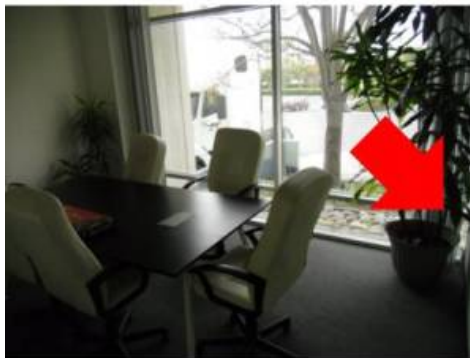
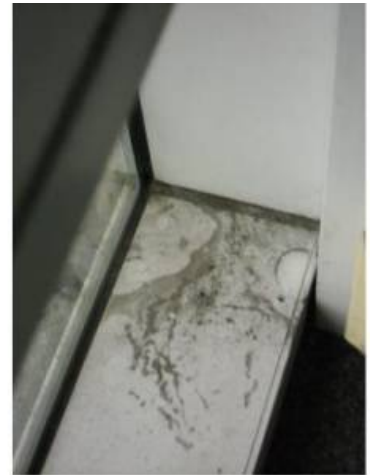
WINDOWS:

Fair condition. Conference room window leaks at right corner - Repair needed.

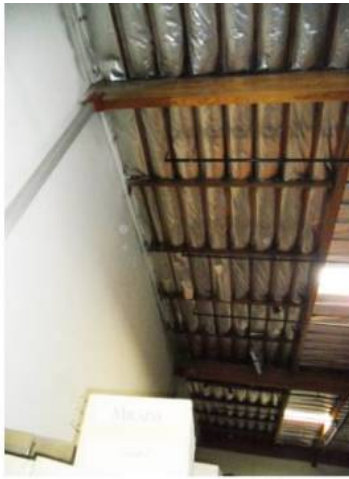
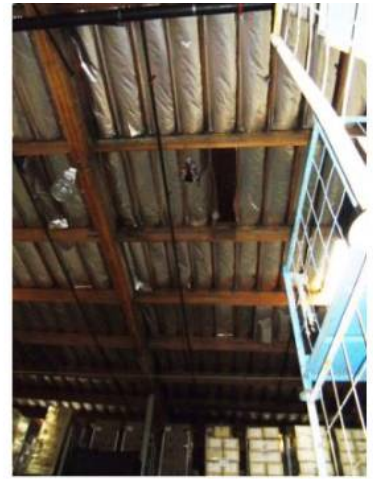
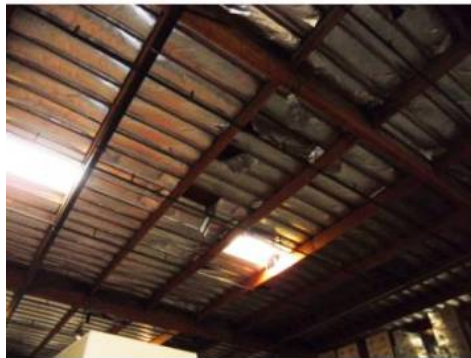
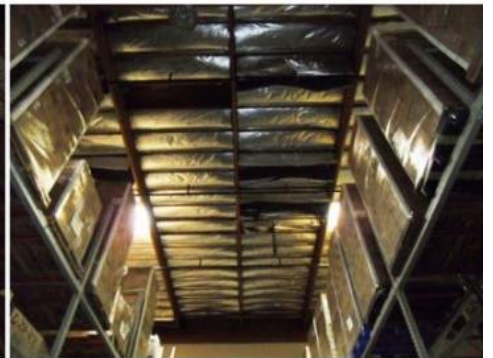
Ceilings:

Insulation coming down - Repairs needed.

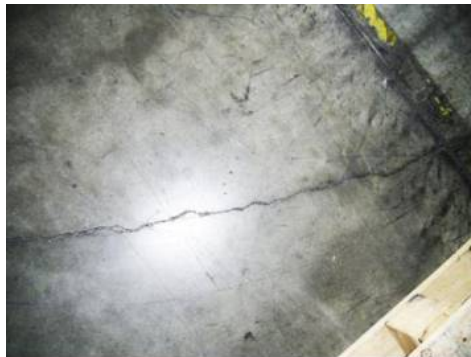
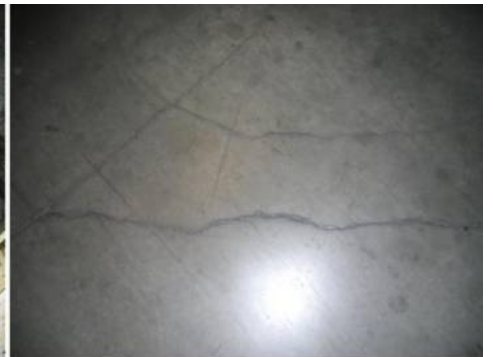
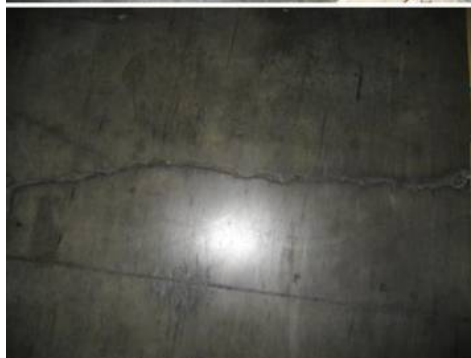
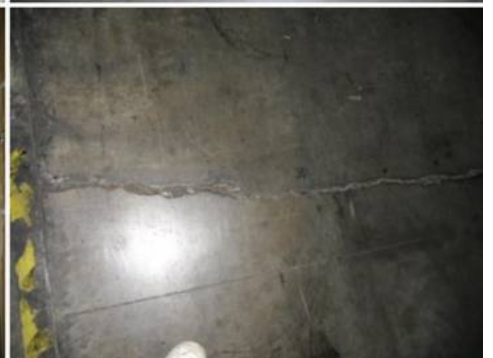
Floors:

Typical cracks noted with some minor damage.

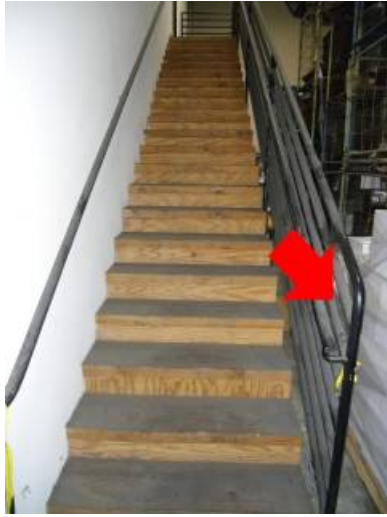
Stairs:

Fair, bur handrail is loose, Secure the handrail.
