Uniform Building Inspection Report

27184 Ortega Hiway, San Juan Capistrano, CA 92675

Report #1710

RE: 27184 Ortega Hiway
San Juan Capistrano CA 92675

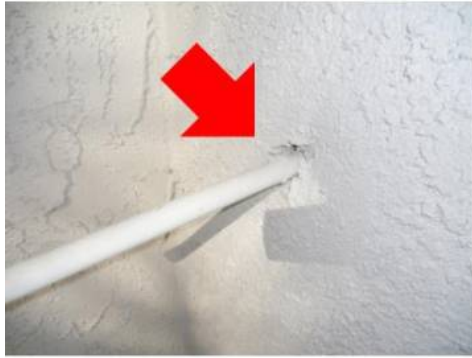
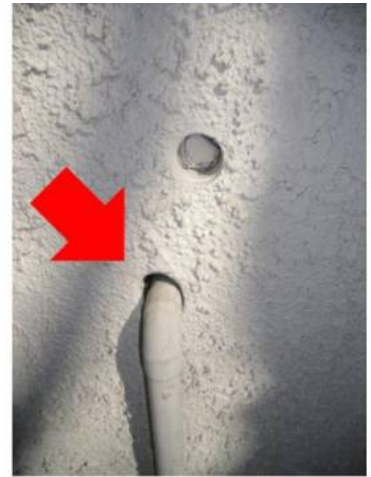
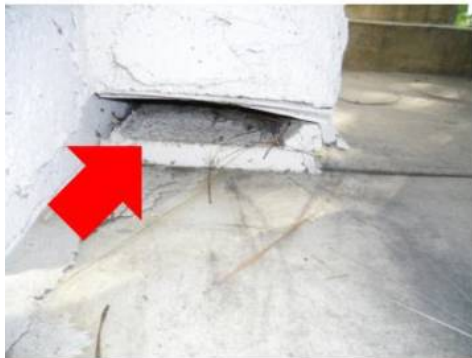
Fair. Two separate pipes coming out of the stucco wall need sealant around them and one spot needs repair.

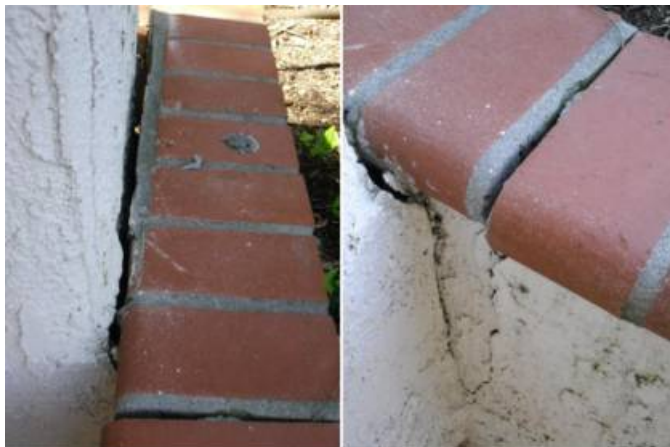
Minor hairline cracks are noted at exterior walls, Structural cracking is found at corner columns and at retaining walls - Movement is noted. Recommend further evaluation and necessary repairs by a soil engineer/structural engineer.

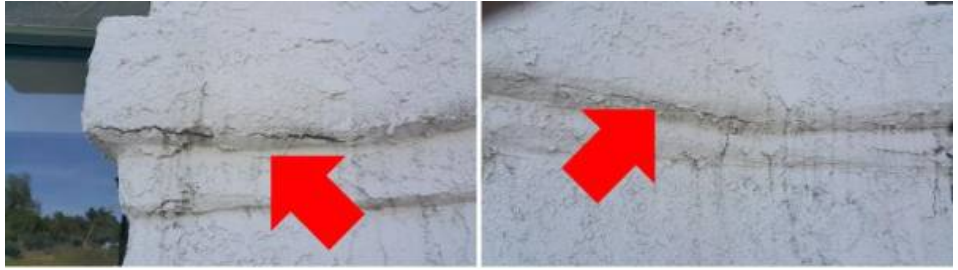
Cracks noted at columns.

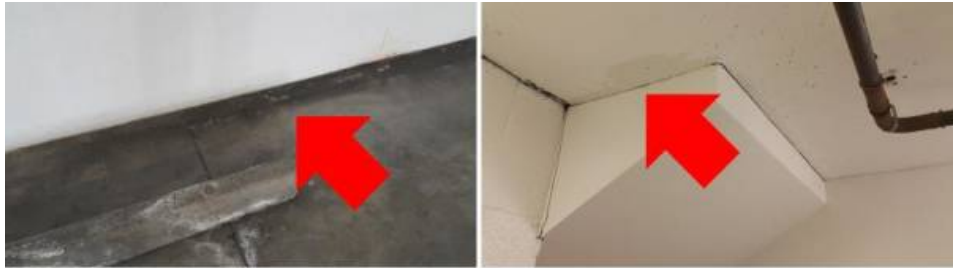
Perimeter walls have active leaks - Repairs needed..

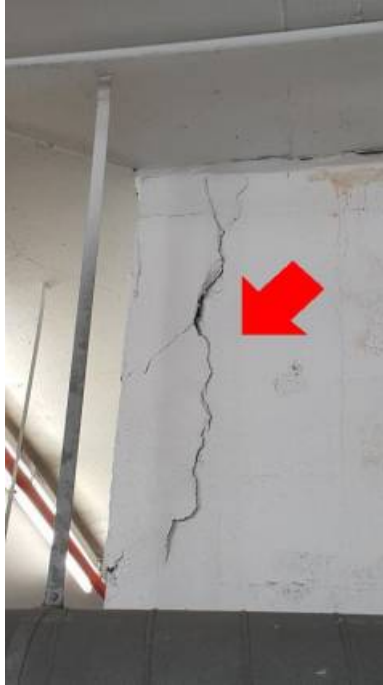
Sub terrain garage has major cracks. efflorescence and ACTIVE water leaks with moldy odors noted. Cinder block walls leak and need water proofing.

Major cracks and efflorescence noted - Repairs needed.

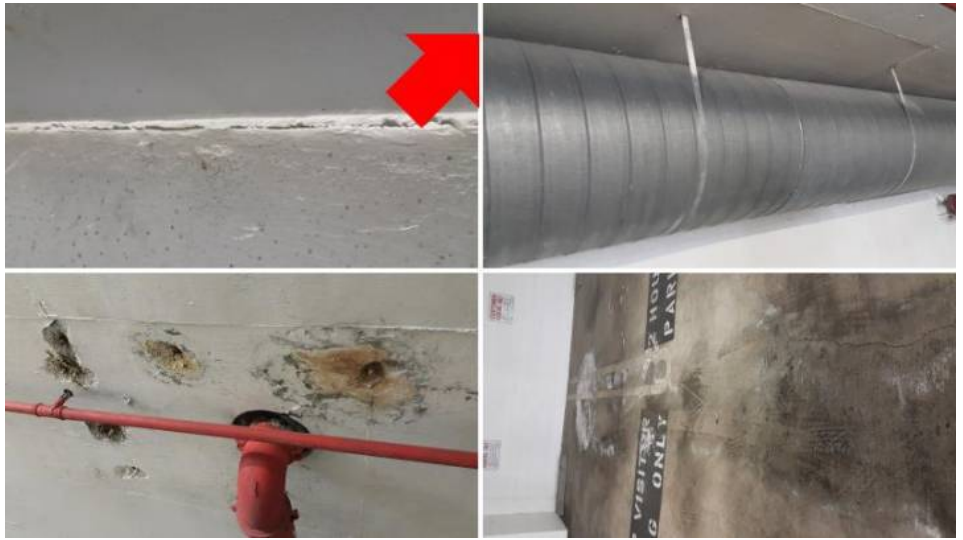
Water damage and ACTIVE LEAKS noted.

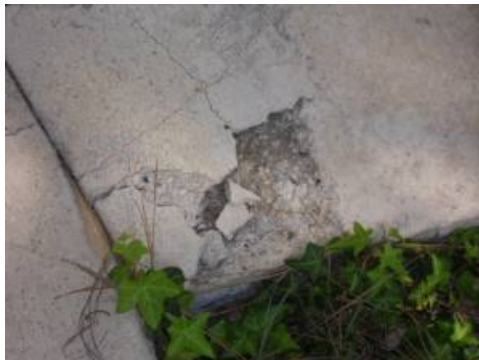
Concrete, one damaged spot noted.

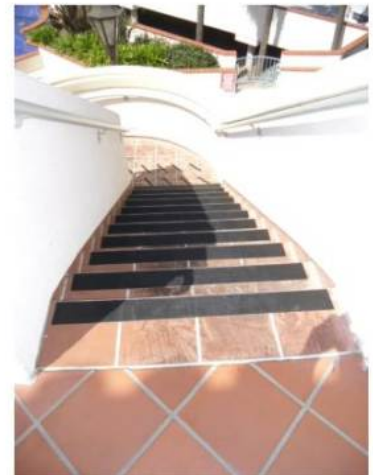
Good condition, except for a loose light grill and damage tile need to be repaired.

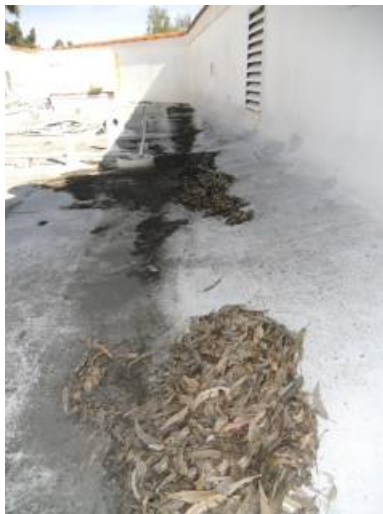
Ponding is noted on the flat roof.

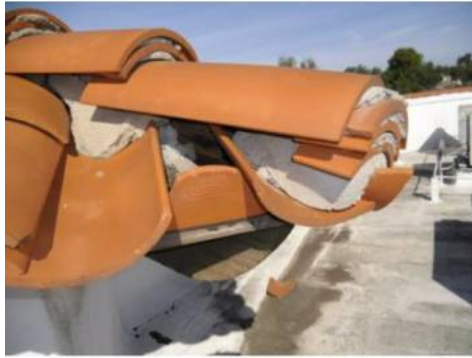
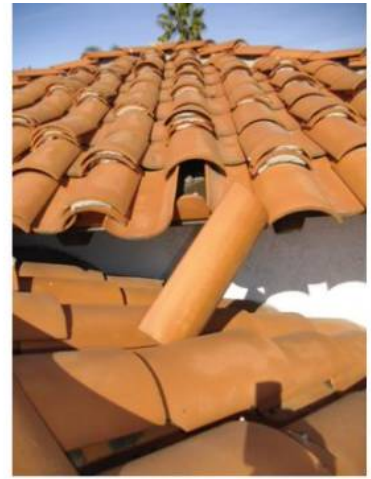
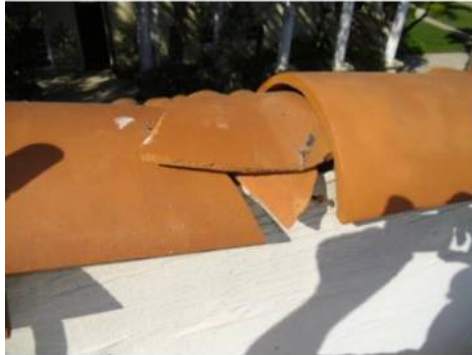
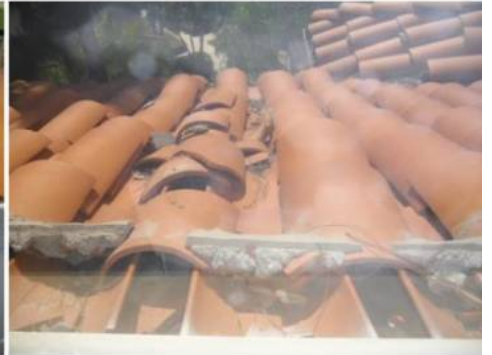
Poor - Recommend further evaluation and necessary repair/replacement by a licensed roofing contractor. The following was observed at the tile roof covering: Cracked and broken roof tiles should be repaired/replaced to protect underlying roofing materials and prevent further water intrusion.

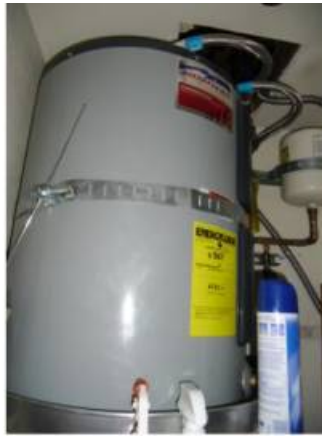
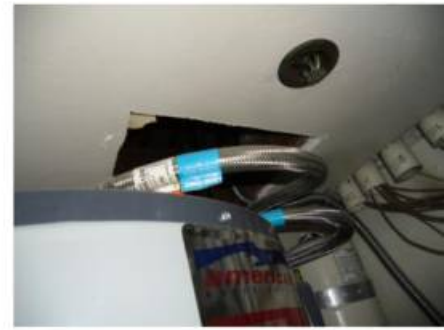
Most units have cold water service only. Public restrooms water heater is electric and operative, but with damage to the fire wall and needs repair - **FIRE HAZARD!**

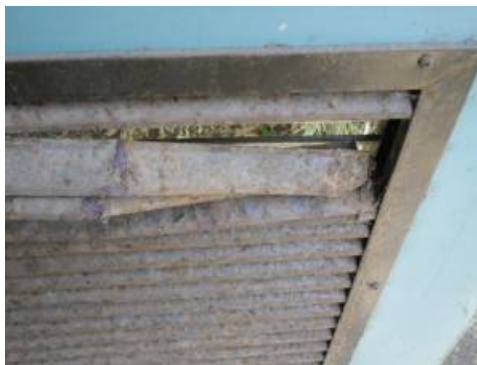
Damage is noted.

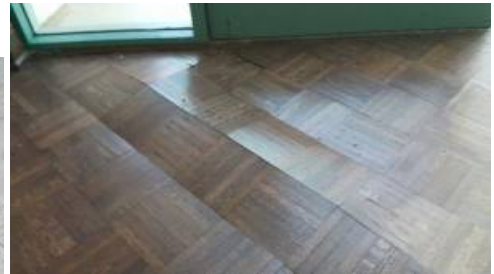
101.

Fair with damaged parquet floor.

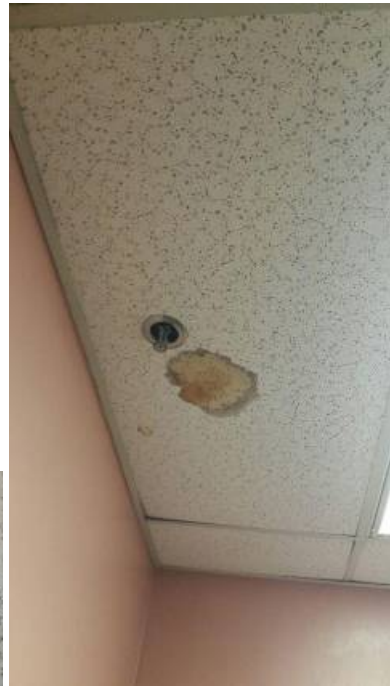
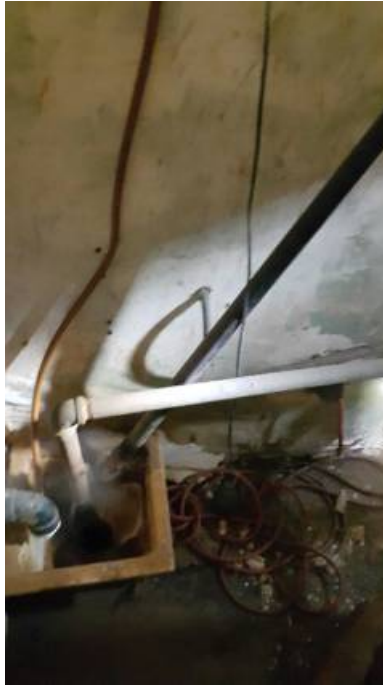
Water leaks at toilet, acoustic tile has water stains.

Water stains on other side of bath wall noted.

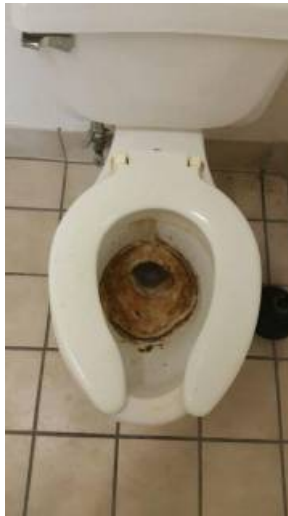
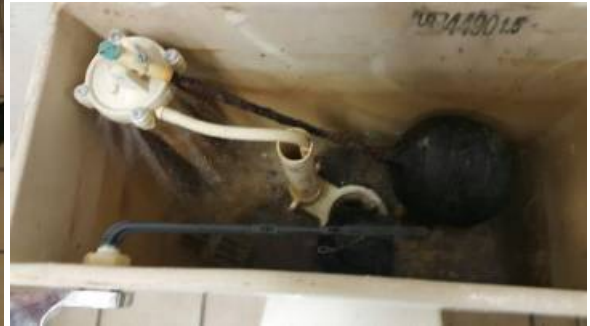
No water.
Bad fluid master and flapper need replacement..

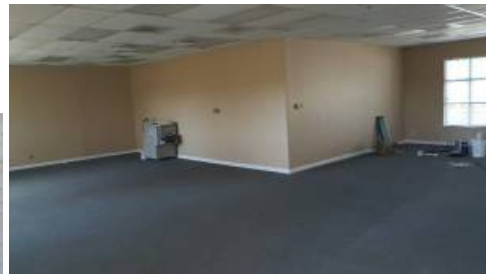
Tenant improvements?

Water stains on ceiling noted.

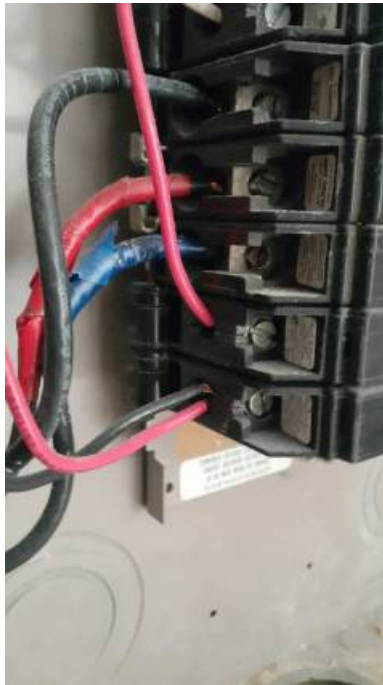
Double lugged breaker noted - Further evaluation by a licensed electrician needed.
