# Uniform Building Inspection Report

4065 Strandberg St., Corona, CA 92881

6/13/2016

Report # 1625

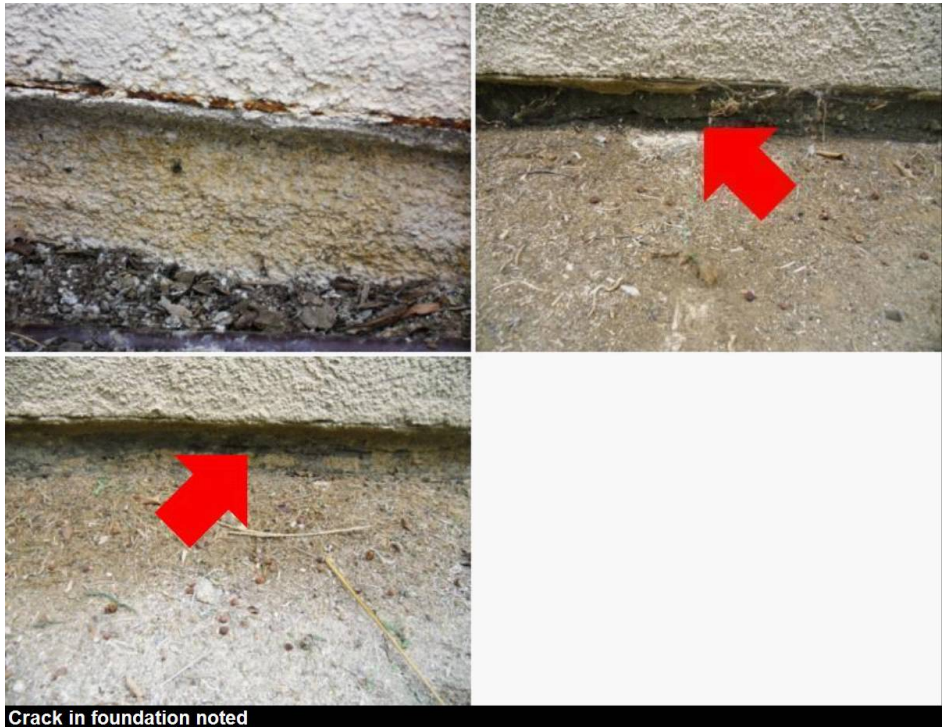
Cracks noted, stucco color coat is blistered and/or peeling away, rusted weep screed noted, cracked foundation noted, damage/rotted from moisture, A qualified contractor should be called to make further evaluation and repairs as needed.

Crack in foundation noted

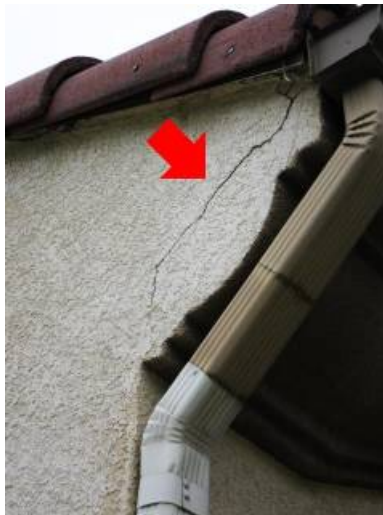
Damage noted, Caulking is needed to prevent water intrusion.

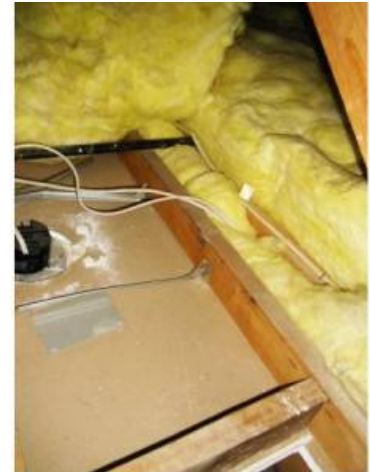
Fiberglass batts, Some insulation is installed unevenly.

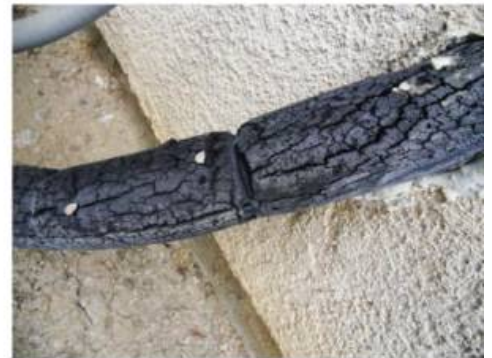
<b>POWER SOURCE:</b>	220 Volt.
<b>COMPRESSOR AGE IN YEARS:</b>	approx 13 years.
<b>SYSTEM CONDITION:</b>	Appears serviceable.
<b>CONDENSATE LINE:</b>	Condensate line installed.
<b>NORMAL CONTROLS:</b>	Appear serviceable.
<b>SECONDARY AIR CONDITIONING SYSTEM CONDITION:</b>	Appears serviceable, except insulation line needs replacement.

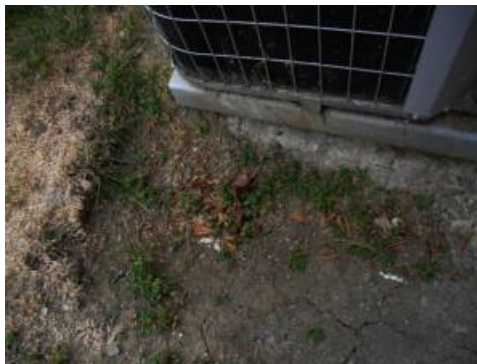
<b>ADDITIONAL INFORMATION:</b>	The hole next to the second air conditioning unit is undermining the platform, Repairs needed.
--------------------------------	------------------------------------------------------------------------------------------------

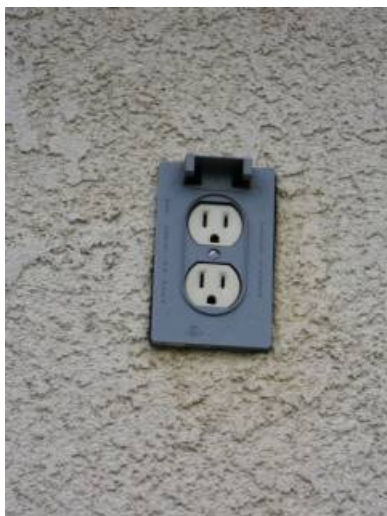
A representative sampling of switches and outlets was tested. As a whole, outlets and switches throughout the house are in serviceable condition. One exterior outlet is missing the cover and is no longer weather tight.

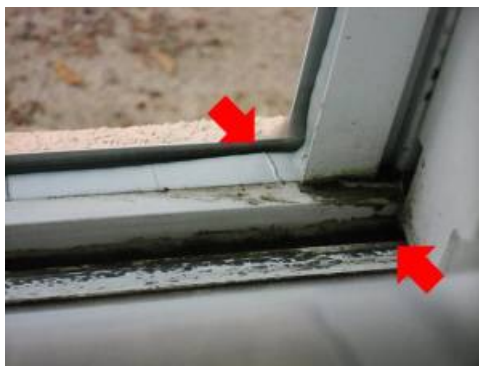
Aluminum, Vinyl windows, Sliding, A representative sampling was taken. Windows as a grouping are generally operational. Two (2) bedroom windows had previous leaks and broken seal noted.

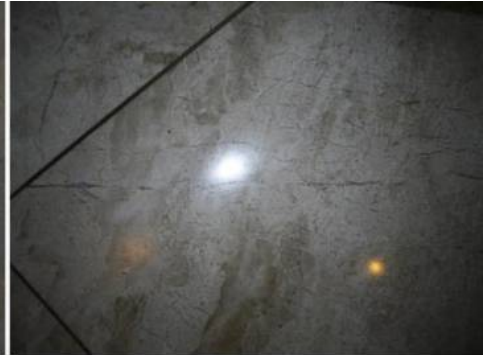
Carpet, Tile, General condition appears serviceable. Minor cracks noted in entry tiles.

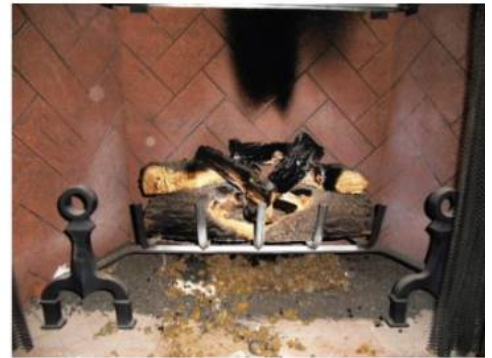
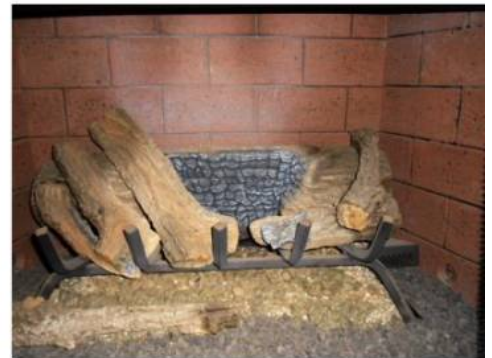
*LOCATION - TYPE - CONDITION:* Location #1: Living room. Location #2: Master bedroom. Prefabricated metal, Dampers are operational. Soot is noted, Recommend further evaluation by a licensed chimney sweep.

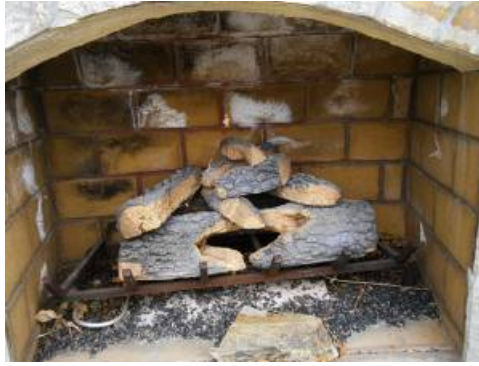
Location #4 : Exterior patio area of the backyard, Efflorescence noted.

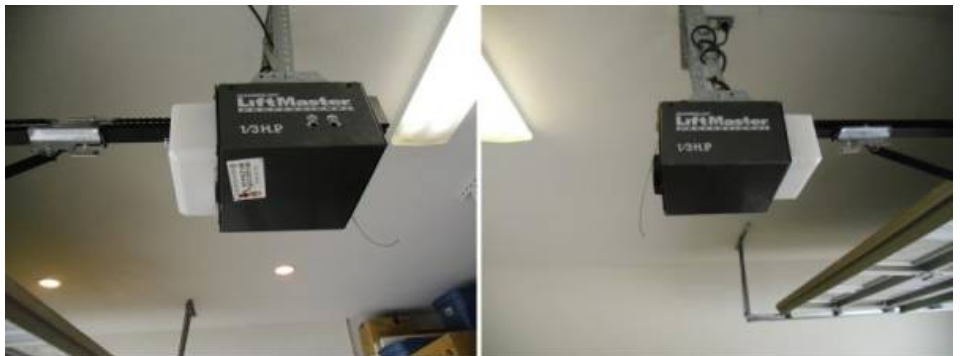
Appears serviceable, Automatic door opener(s)- operational, Automatic reverse feature is, operational. Recommend greasing the chains to lessen the noise.

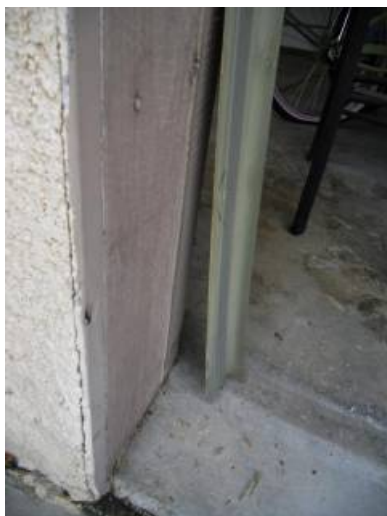
Damage garage door trim needs replacement.

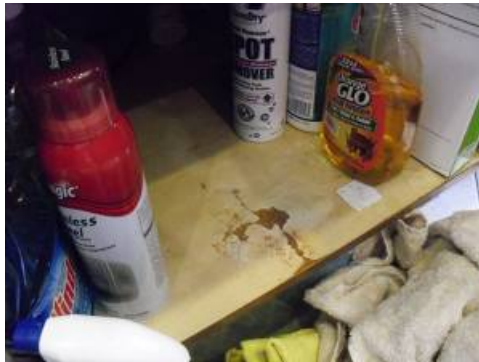
Water damage noted under sink.

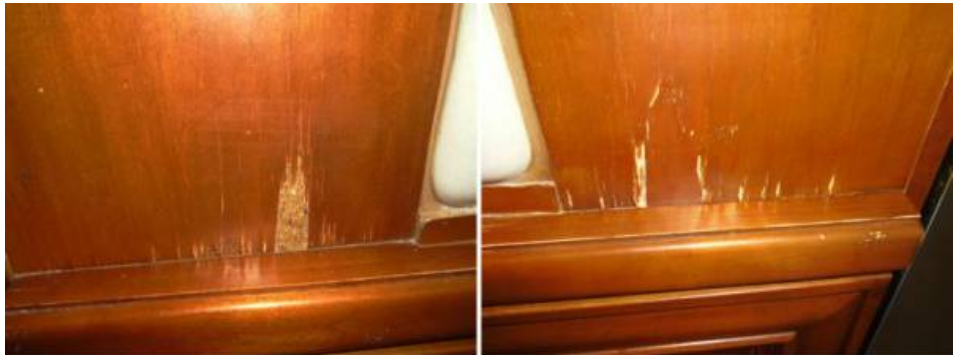
Counters are Granite, Cabinets are Wood with water damage noted.

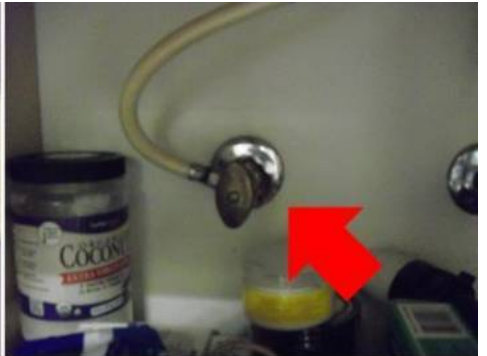
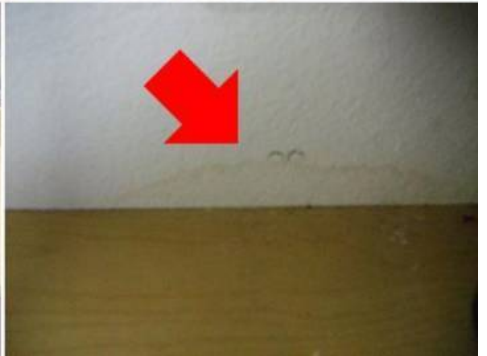
Previous leak noted under left side sink and broken mechanical stopper. Right side sink hot water side valve corrosion noted. Recommend further evaluation and necessary repair by a licensed plumber.

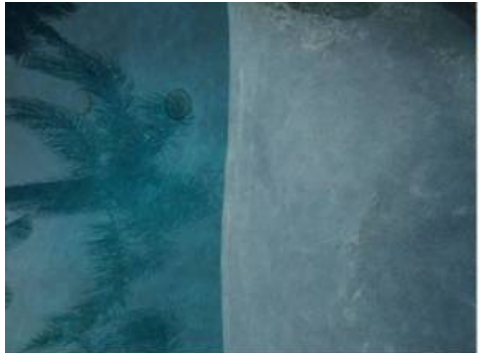
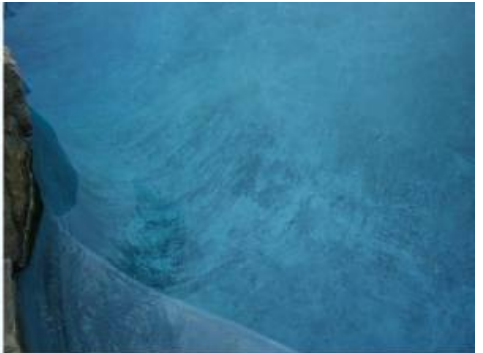
Appearance is marginal, The following was seen: Stains noted - A qualified pool contractor should be called to make further evaluation and recommendations for repair or replacement.

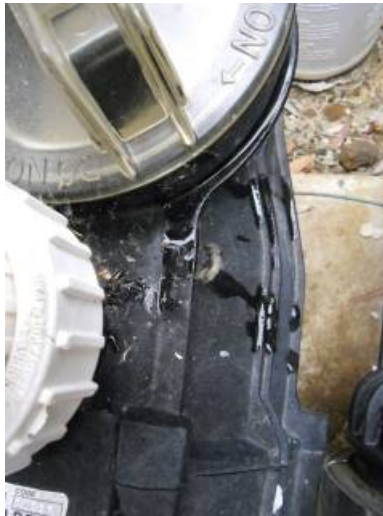
Minor leakage is noted:

A minor leak exists at piping attached to the top of the pump and one diatomaceous earth filter (**See photos above**).

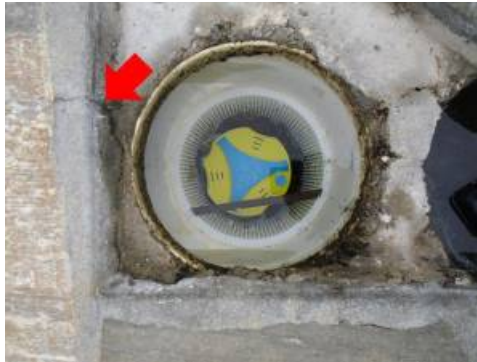
Crack noted.

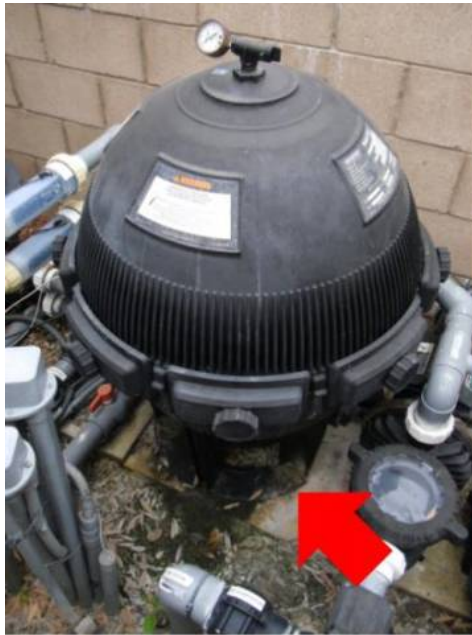
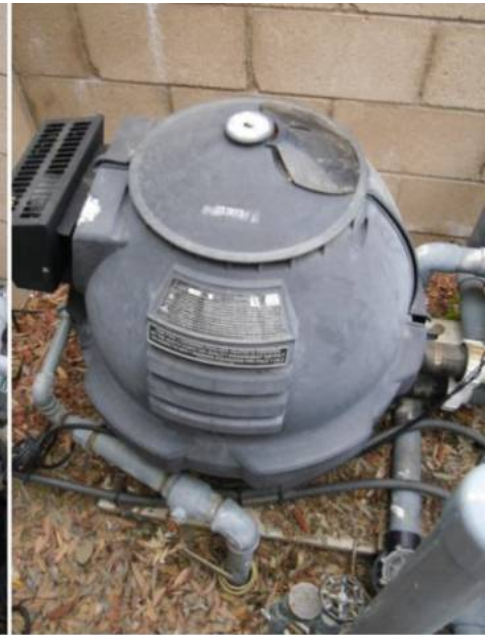
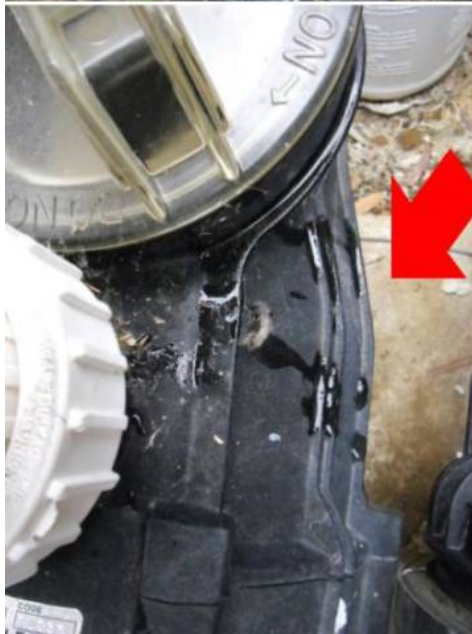
Diatomaceous earth, Filter is operable but filter is an older type for which replacement parts are hard to find. Expect the need to replace the filter sometime in the future. Marginal condition, due to advanced age of the unit.

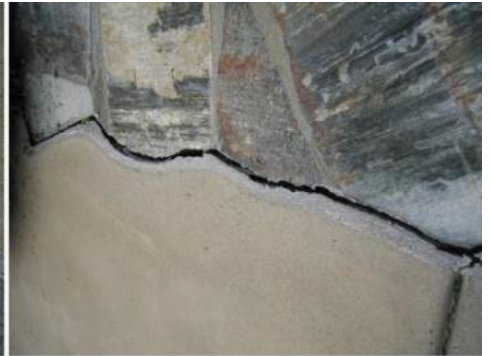
Scored concrete/Keystone, A few minor settlement cracks are noted. Repairs needed to prevent further damage - Recommend further evaluation and necessary repairs by a licensed pool contractor.

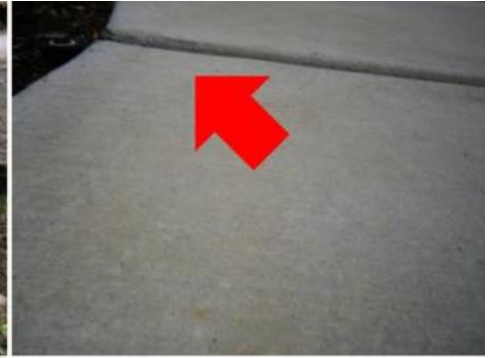
Left side of house sidewalk is undermined, Repair needed. Surface raised/settled, **TRIP HAZARD!**

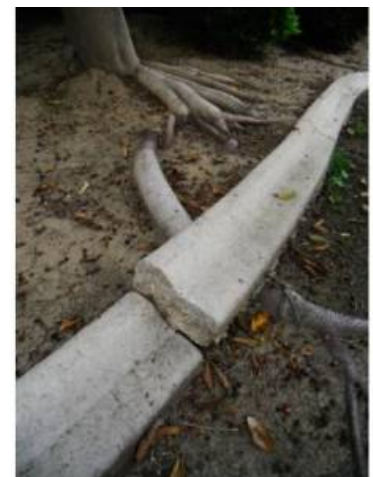
Maintained, Trees planted close to structure. Removal may be needed.

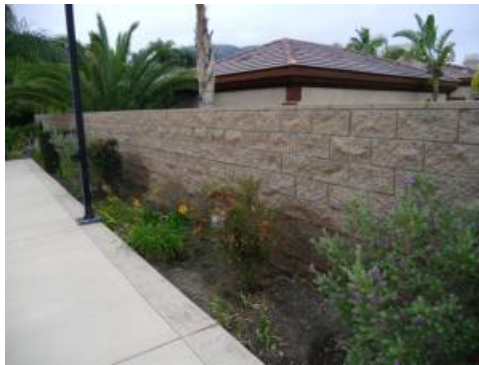
Appears serviceable, Displacement/Cracks typical. Re-direct the sprinklers away from the foundation and walls.

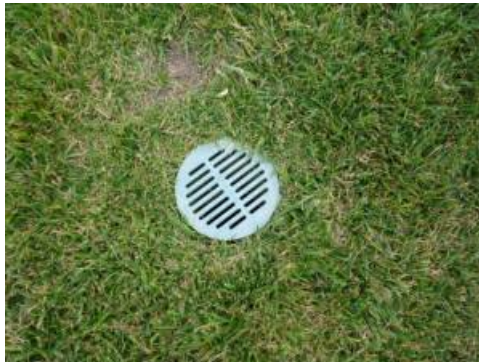
Drains are present in the yard, Grade at foundation needs correction, Pitch slope of soils away from foundation. Slope should fall away from the foundation at a minimum of 1/2 inch per foot and extend at least 10 feet away from the foundation. Recommend calling a grading and drainage contractor for further evaluation and necessary repairs.

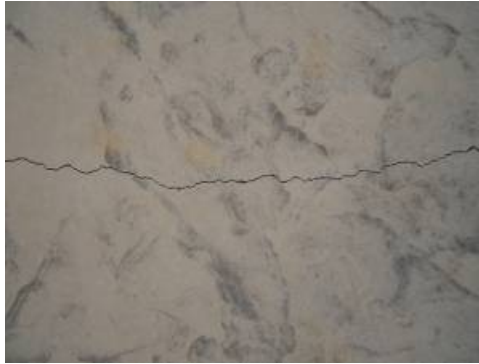
Cracks noted - typical.

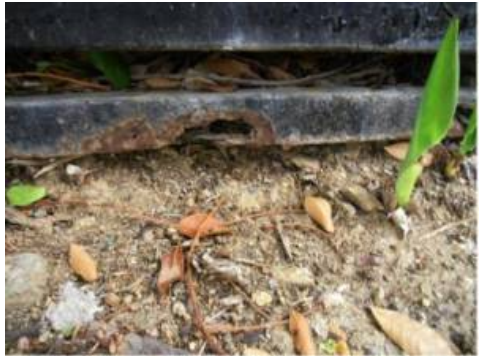
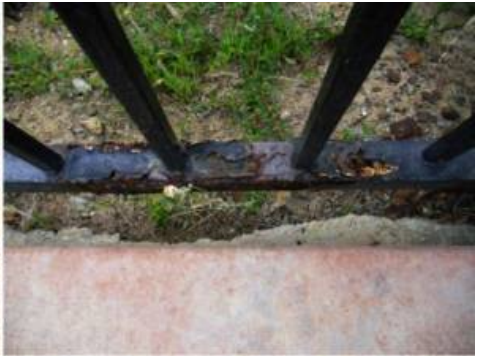
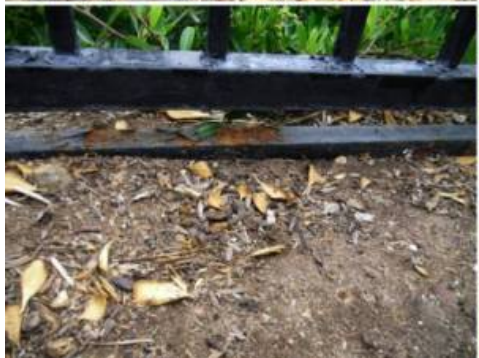
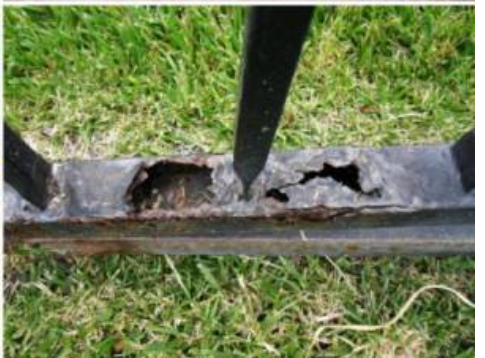
Wrot iron fences are rusted.
