# Thermal Infrared Imaging Report

4065 Standberg St.  
Corona, Ca. 92881

Date:6-12-2016  
Time of Day:11:00 am  
Ambient Temperature:72 F  
Wind Speed:None  
Relative Humidity:71%

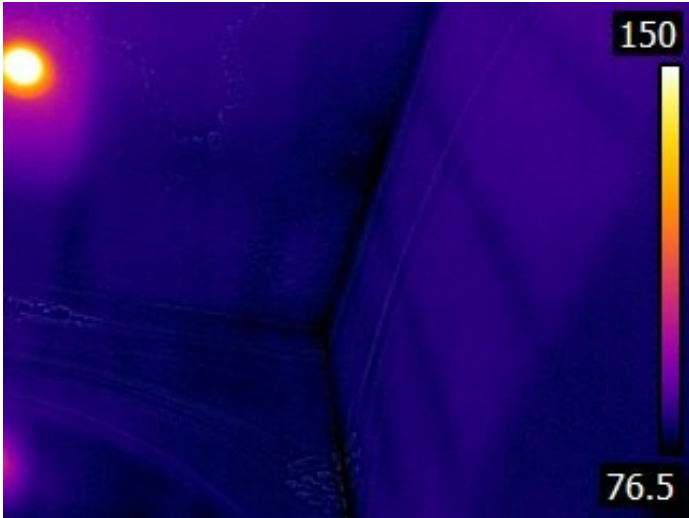
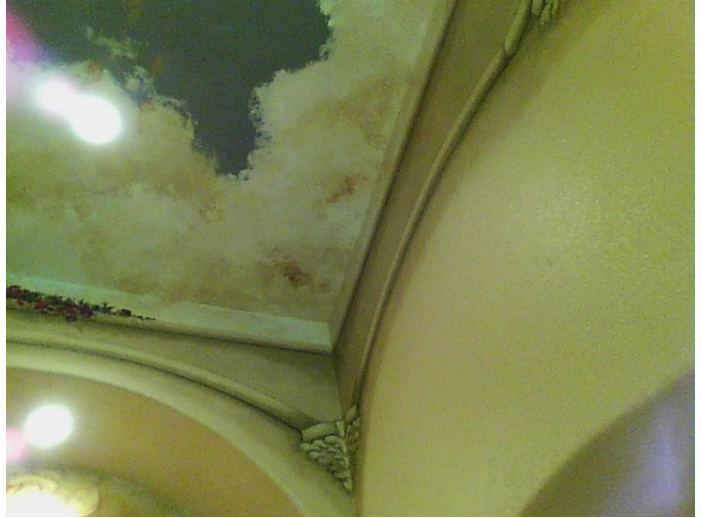
Location: Entry ceiling

No anomalies.

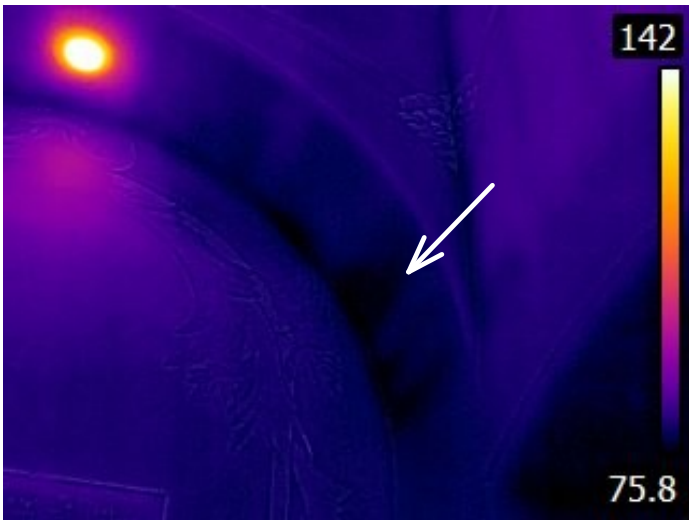
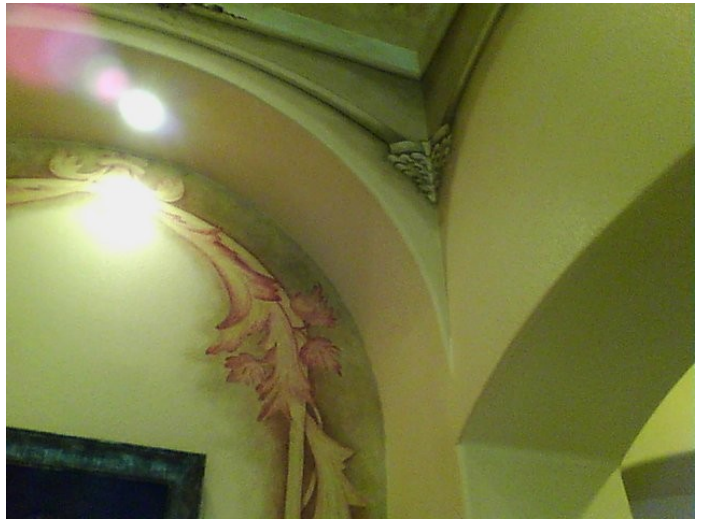
Location: Entry ceiling

Crushed insulation noted.

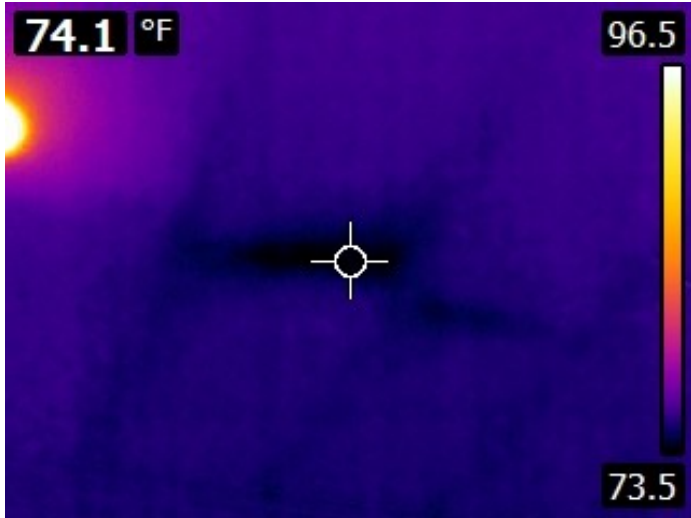
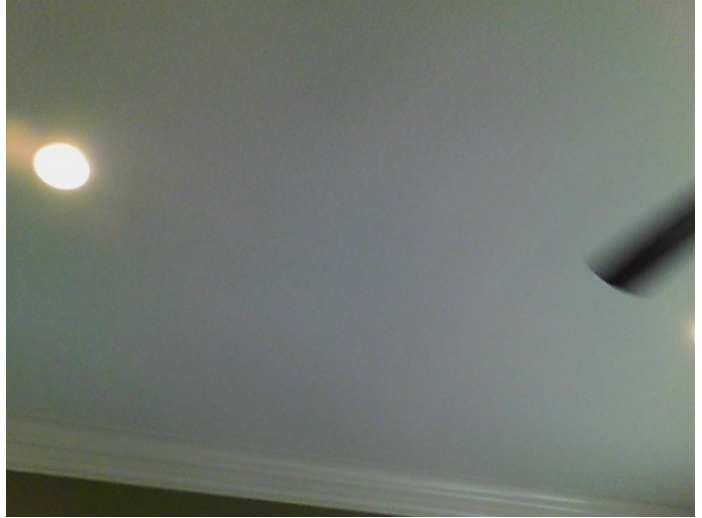
Location: Hallway ceiling

Crushed insulation noted.

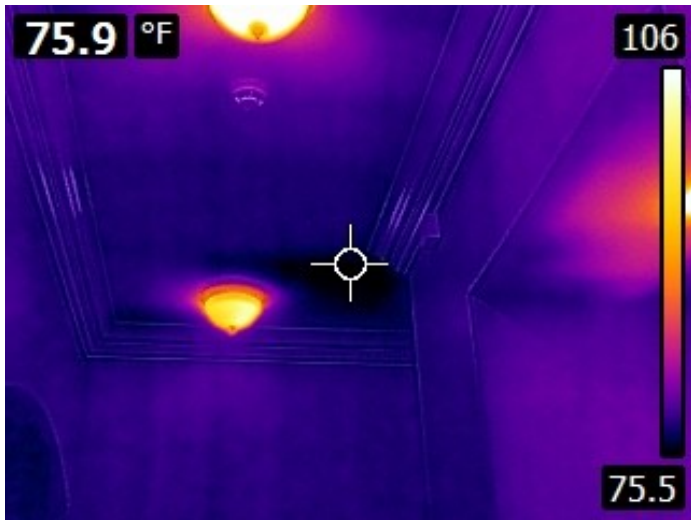
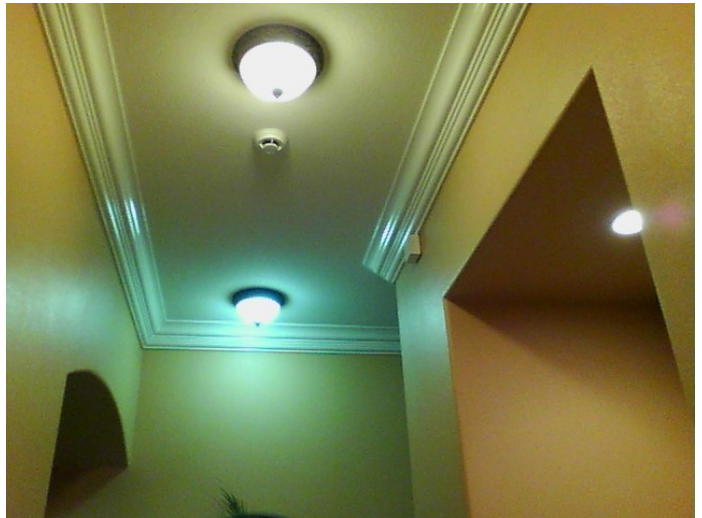
Location: Hallway ceiling

Crushed insulation noted.

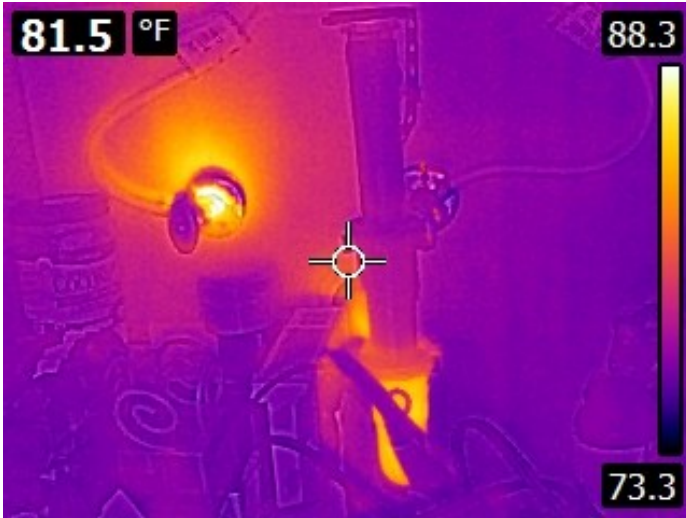
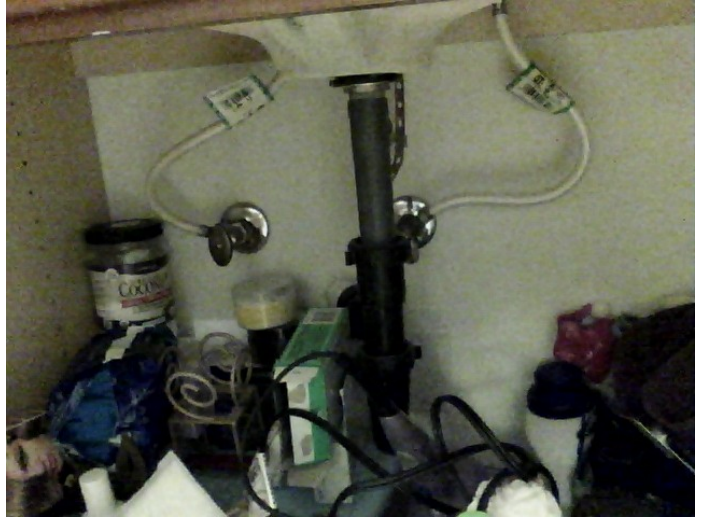
Location: Under Bath Sink Blue Bedroom

Hot water source. No anomalies.

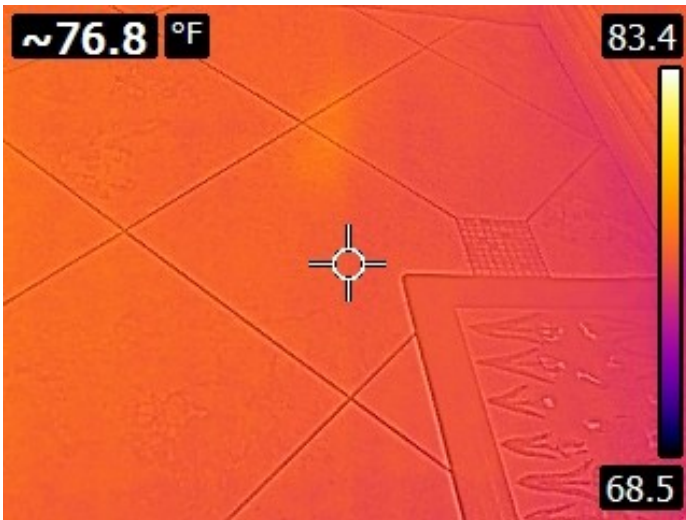
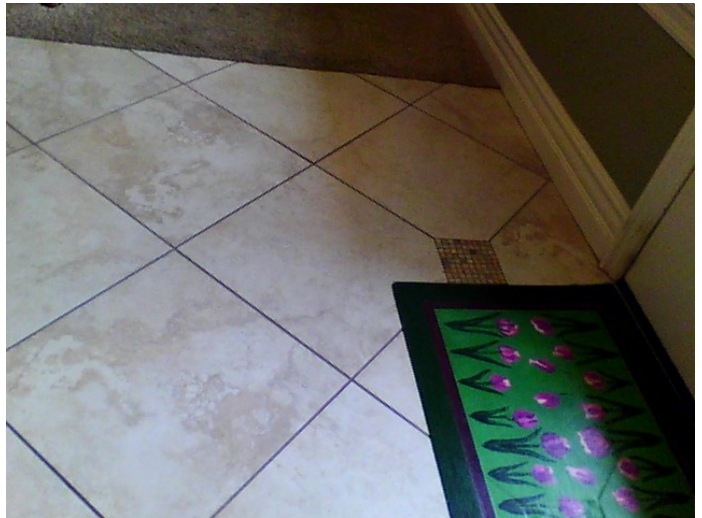
Location: Entry

No anomalies.

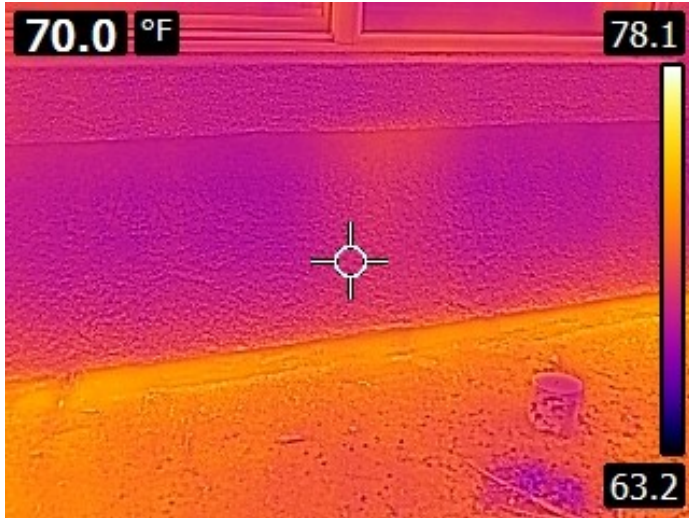
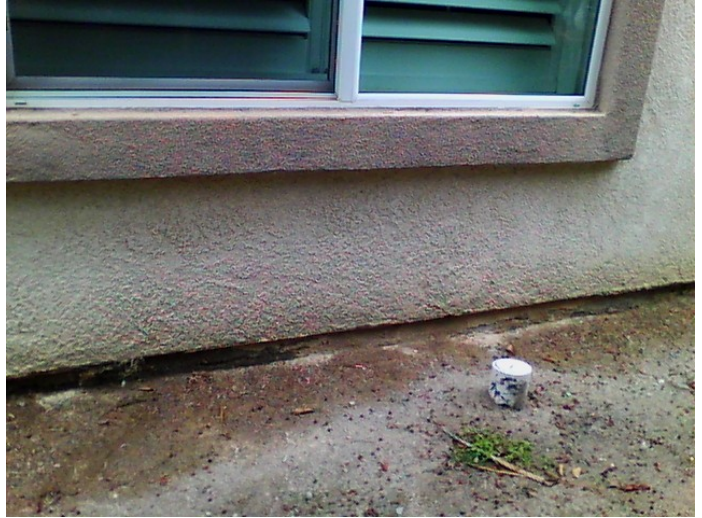
Location: Exterior

Moisture is wicking up into stucco

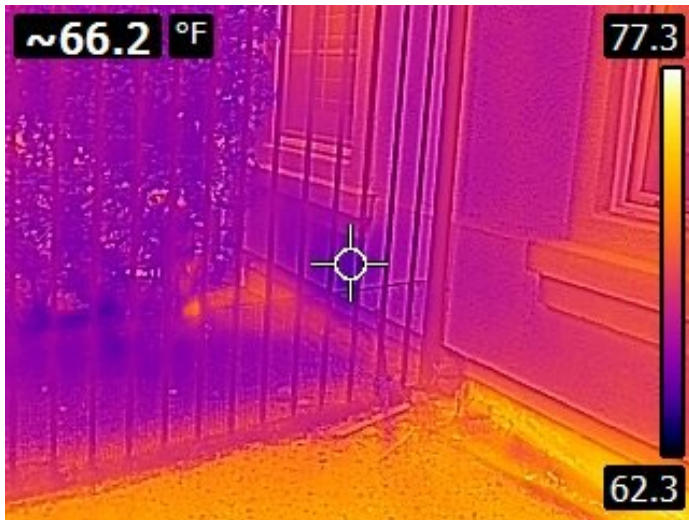
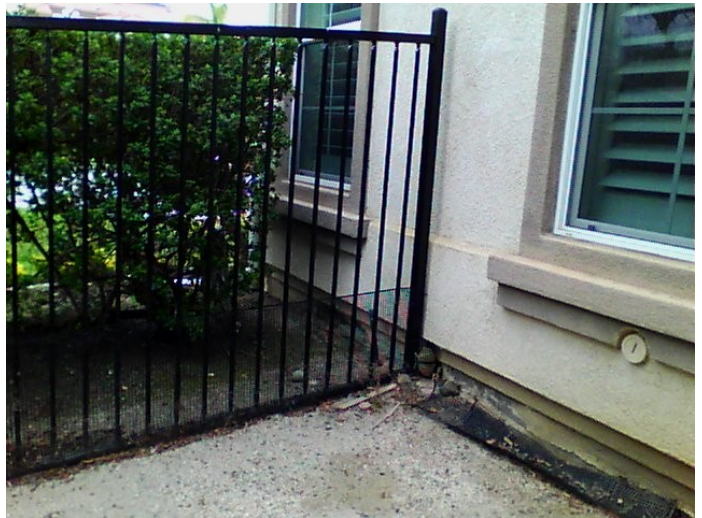
Location: Exterior

Moisture is wicking up into stucco
