The Uniform Building Inspection Report

Commercial Office Building:
2228 Kettner Blvd., San Diego

Prepared Exclusively for:
Blokhaus Development

Inspection Date:
9/24/12, 8:30 AM

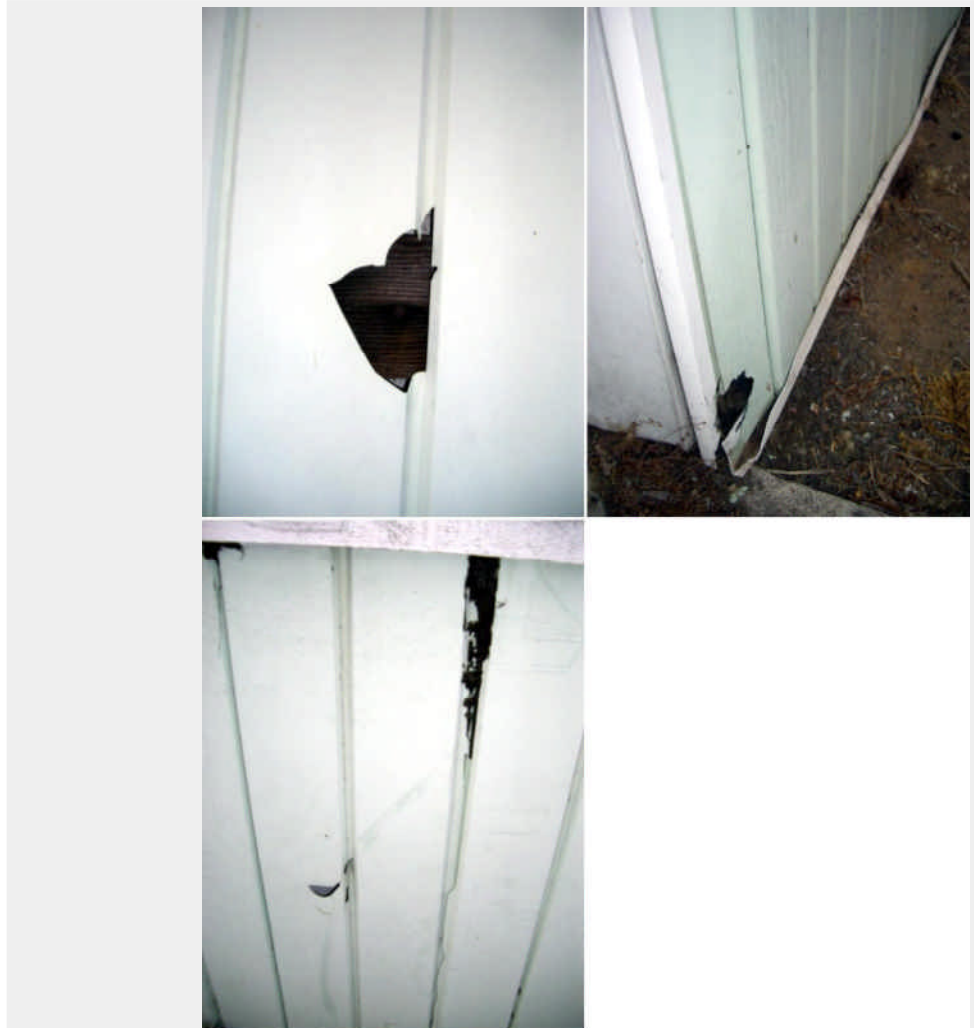
Concrete and vinyl siding.

Displacement cracks and damage noted - Recommend further evaluation by a structural engineer.

Major cracking is noted - Recommend further evaluation by a structural engineer.

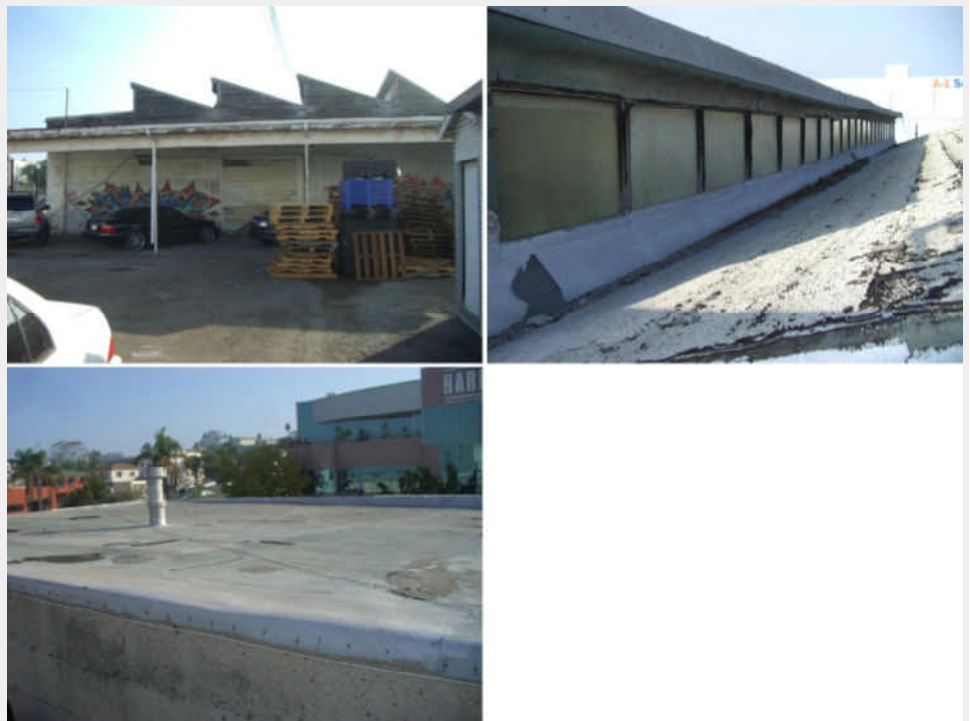
Combination of flat and shed.

Poor, A licensed roofing contractor should be called in to make further evaluation and repairs as needed.

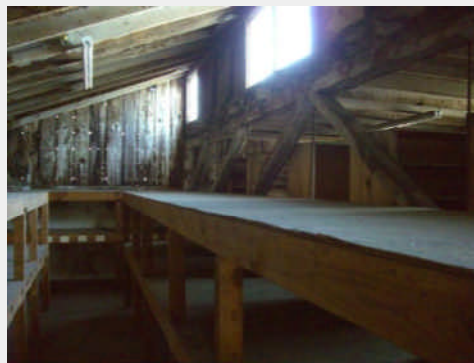
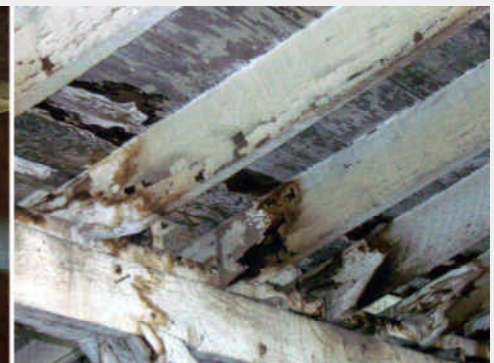
ROOF SUPPORT:

Roof Sheathing: 1 inch board, Poor overall condition.

I- beams with purlins spaced at 6 foot centers, 2x6 rafters at 24 inch centers.

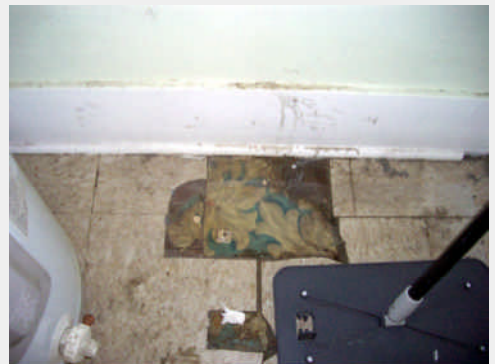
FLOORS:

Poor.
