Uniform Building Inspection Report

409 Ave. Victoria #A, San Clemente, Ca 92672

6/3/2016

Report # 1624

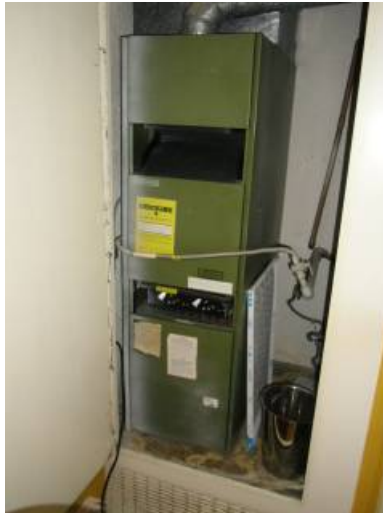
LOCATION OF PRIMARY UNIT: Forced Air Unit is located in a hall closet.

<i>AIR PLENUM:</i>	Appears serviceable.
<i>AIR FILTERS:</i>	Suggest cleaning/changing filter.
<i>NORMAL CONTROLS:</i>	Appear serviceable.
<i>GENERAL SUGGESTIONS:</i>	Suggest cleaning/servicing blower motor, pilot light, vent system and burners. Recommend consider replacement due to age and lack of efficiency.

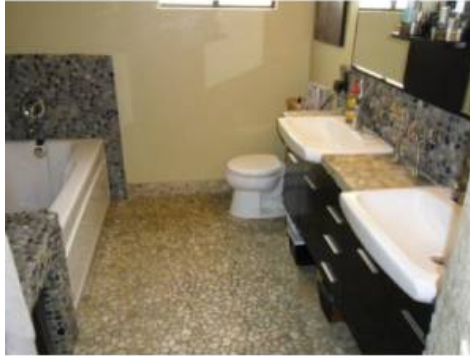
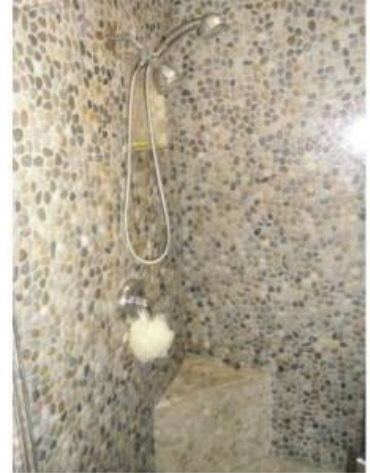
Master bedroom.

Left sink is slow to drain - Recommend calling a licensed plumber for further evaluation and necessary repair.

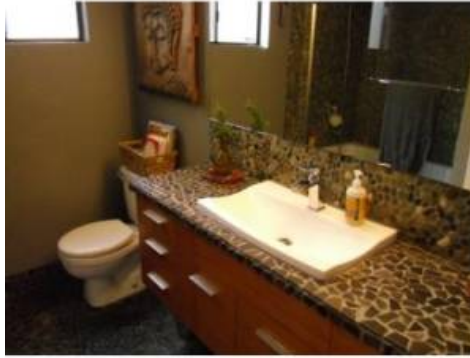
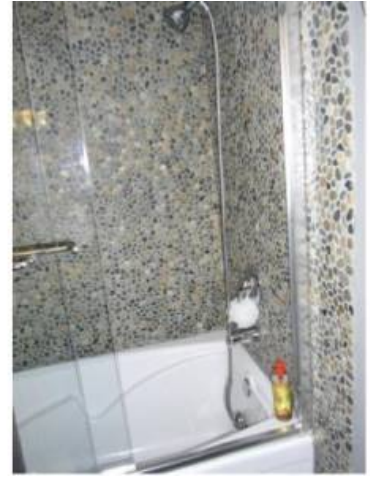
2nd floor.

Appears serviceable, The following problems were noted at the drain: Drainage is a bit slower than normal.
