# The Uniform Building Inspection Report

**Historic Bed & Breakfast:**  
406 Maple St., San Diego, Ca.

**Prepared Exclusively for:**  
Blokhaus Development

**Report Number:**  
040512-b000644

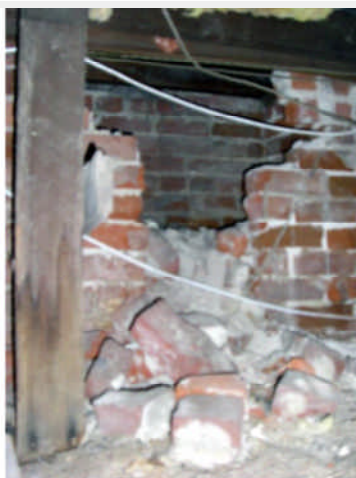
Deterioration noted to foundation walls is major. A Structural Engineer should be called to make further evaluation and recommendations as needed.

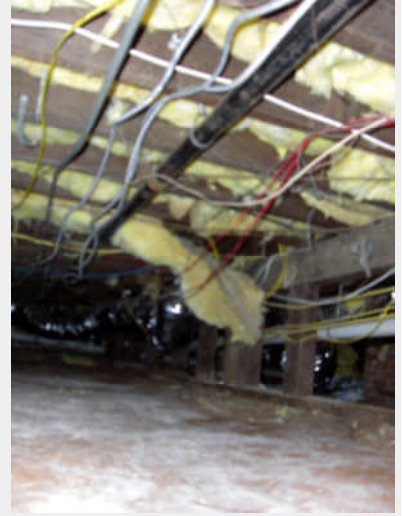
**COLUMNS/SUPPORTS:**

Column/pier is out of plumb or weak, water stains noted.

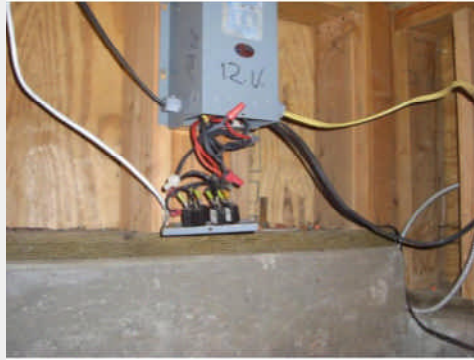
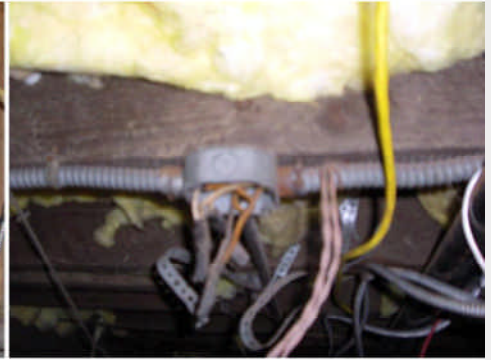
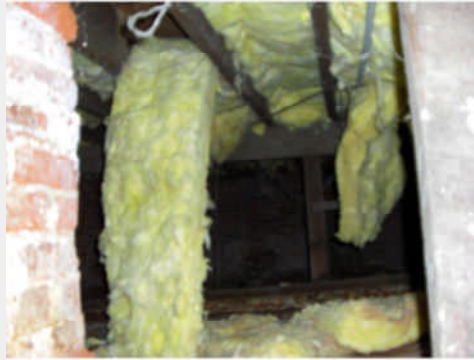
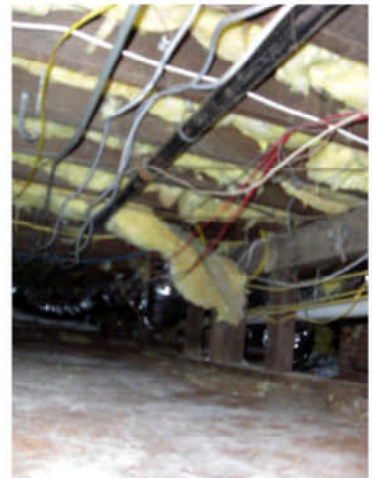
**OTHER  
OBSERVATIONS:**

Open j-box and exposed wires hanging out, and insulation falling down.

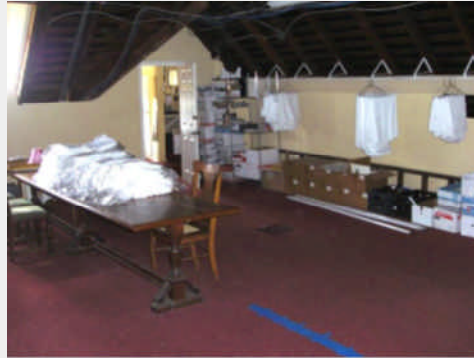
No insulation is provided.

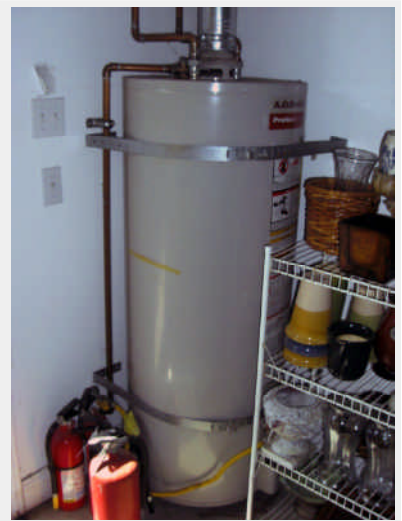
**Additional Comments & Photos:**

Drain line is not draining properly and flooding the basement floor, causing the water heater to rust - Repairs needed.

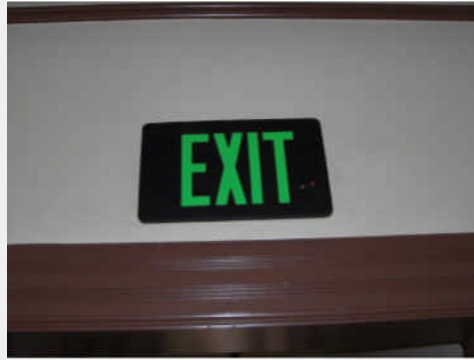
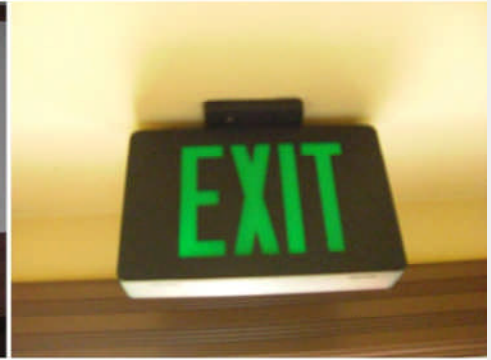
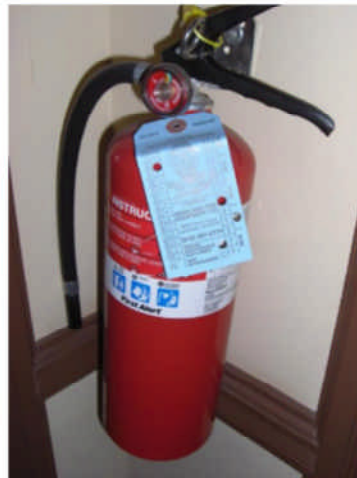
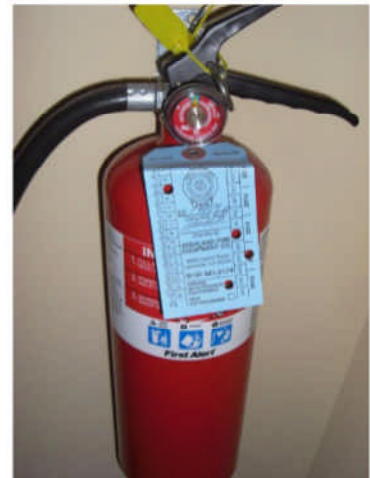
**Additional photos:**

Fire Suppression system & emergency light are noted, but not tested. Missing smoke detectors are noted in Gothic room and in hallway.

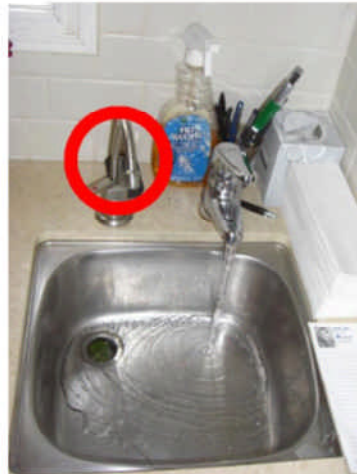
Stainless Steel, **ACTIVE LEAK** noted. Faucet is serviceable, Third faucet is inoperative.

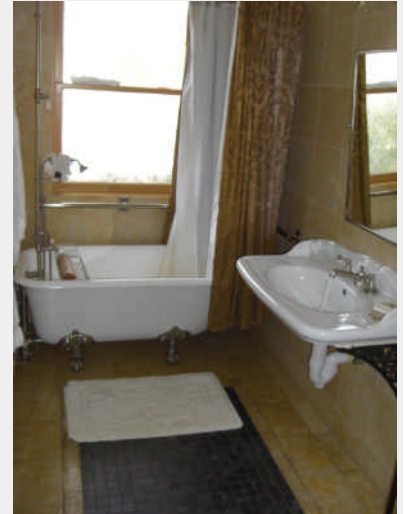
Library.

Sink leaks - **ACTIVE LEAK!**

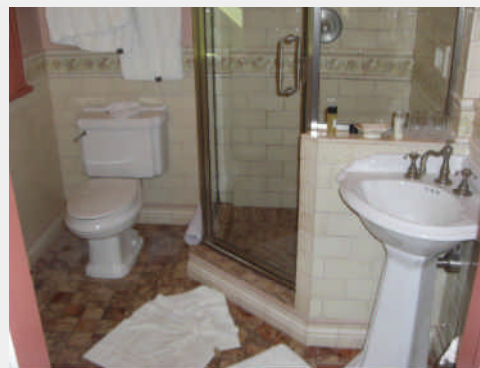
Garden.

Drain appear serviceable, The following problems were noted at the drain: Missing mechanical stopper.

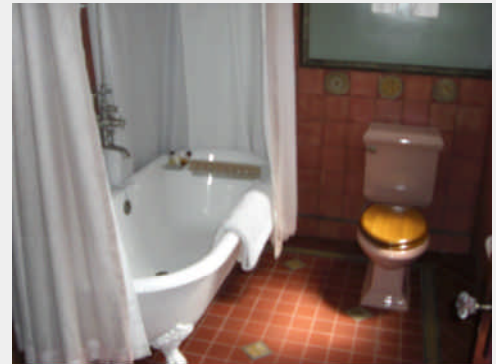
**BATH LOCATION:** Renaissance.

**CONDITION OF SINK:** Appears serviceable, Drain appear serviceable, Counters/cabinets appear serviceable.

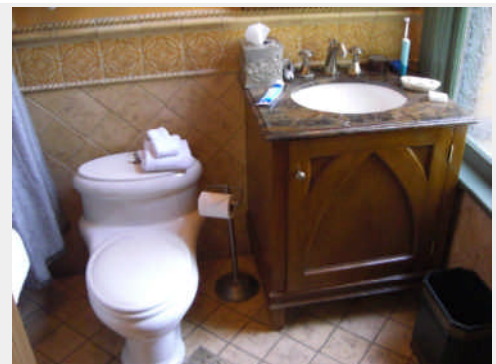
**BATH LOCATION:** Gothic.

Faucet leaks. Drain appear serviceable, Counters/cabinets appear serviceable.

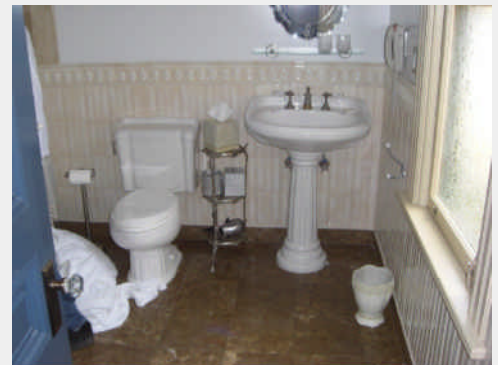
Balboa.

Appears serviceable, Drain appear serviceable.

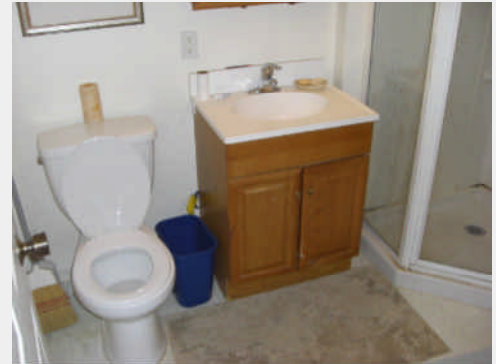
Manager's.

Appears serviceable, Drain appear serviceable. Counters/cabinets appear serviceable.

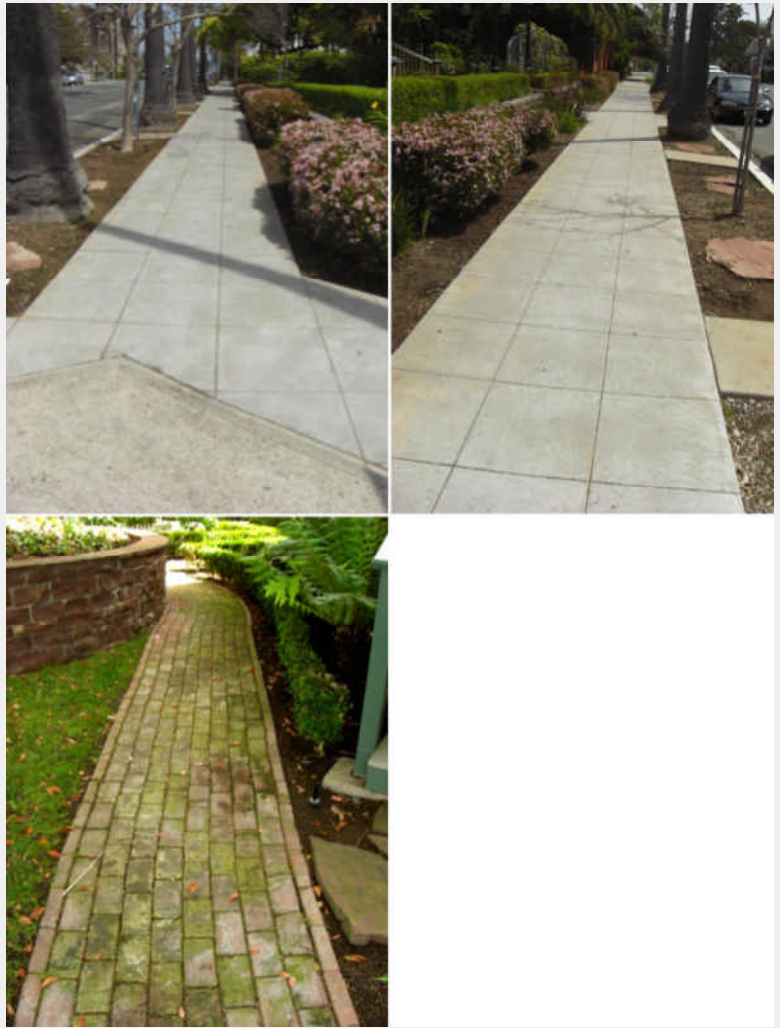
Appears serviceable.

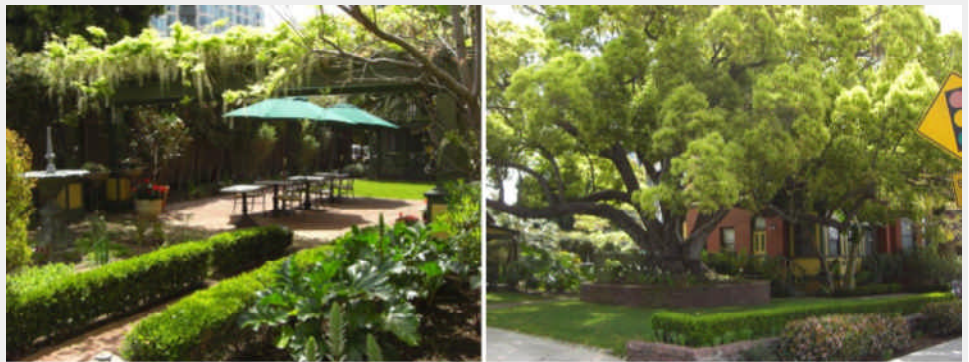
Maintained.

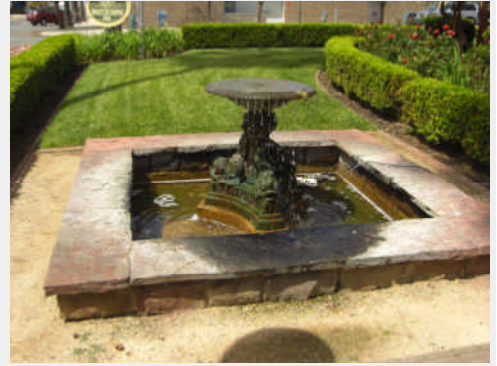
Operative.
