Uniform Building Inspection Report

2055 Dublin Dr., San Diego, Ca 92154

Prepared for: Corporate Communications
Report #1601

Thursday, January 14, 2016

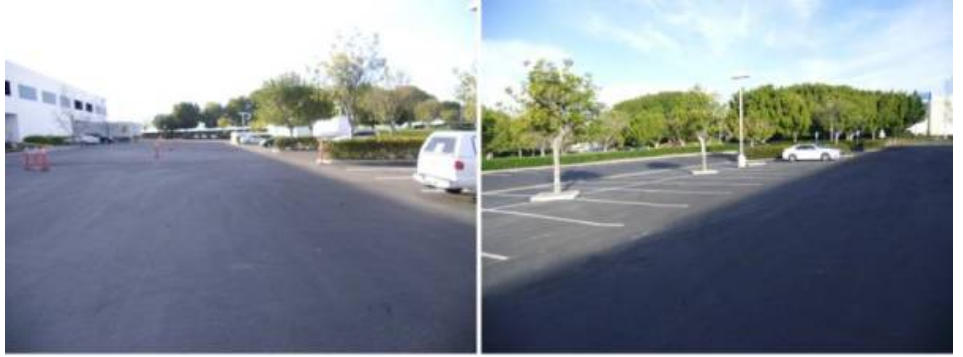
Surfacing Material:

Asphalt.

Condition:

Good.

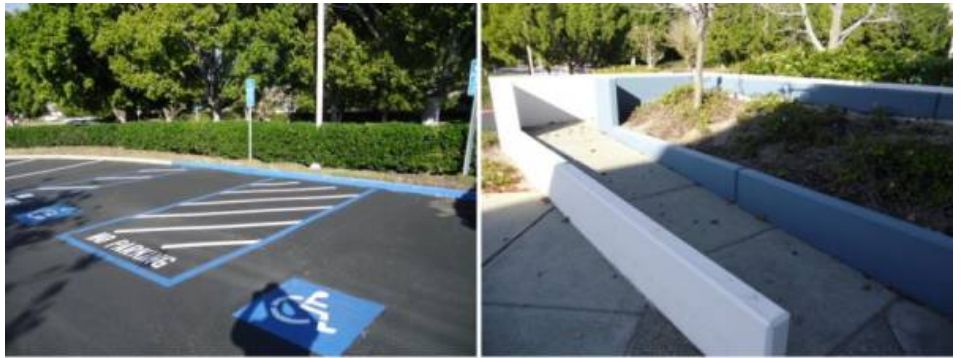
Handicap Parking & Ramp:

Marked and accessible.

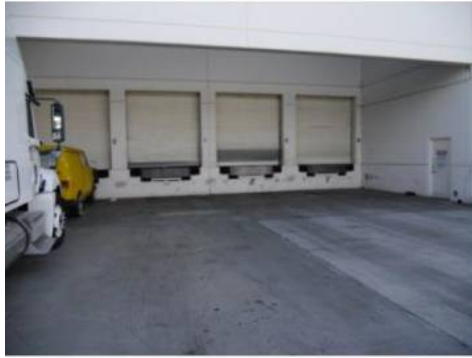
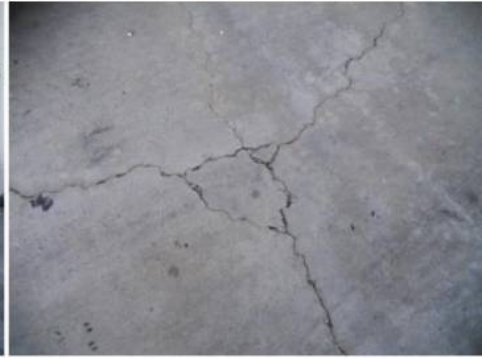
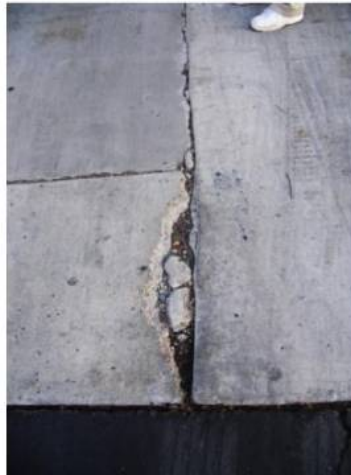
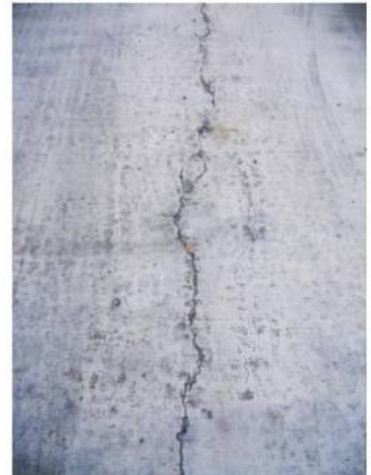
TRUCK DOCK:

Fair condition.

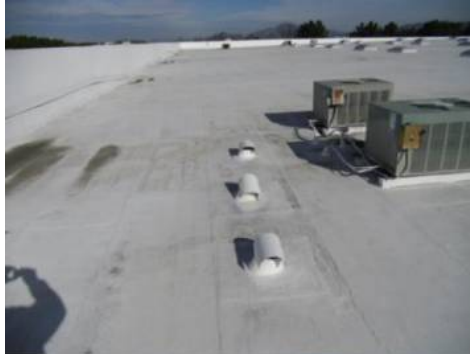
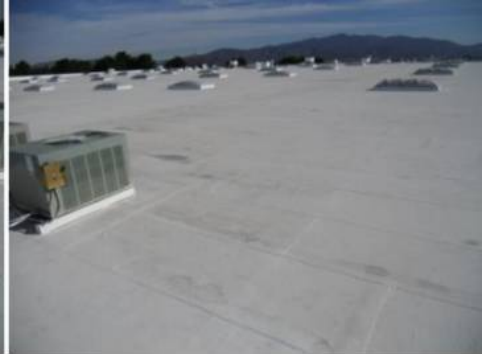
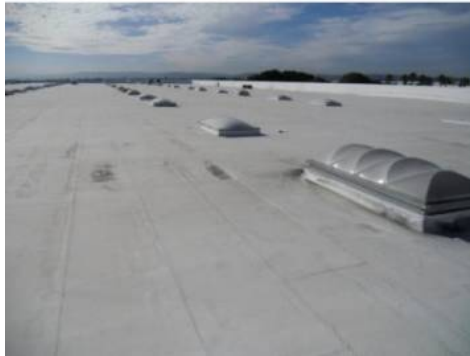
ROOF TYPE & CONDITION:

Shallow sloped flat roof.

Single ply roofing material. Roofing material has previously been coated with solar white roof paint.

Good, with ponding noted.

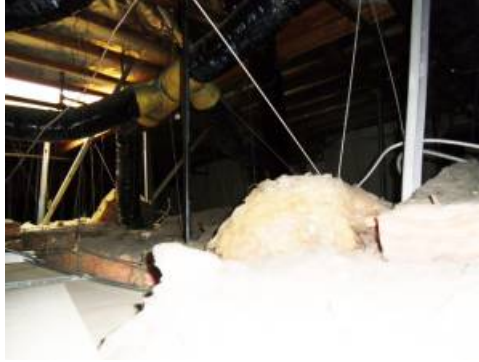
Viewing at the underside of the roof was done by lifting ceiling panels in various areas. Not every area under the roof could be observed.

Upstairs water stains noted on ceiling tiles. The cause is uninsulated air handlers just above the water stains - Repairs needed. **(See photos under INTERIOR - Ceilings)**

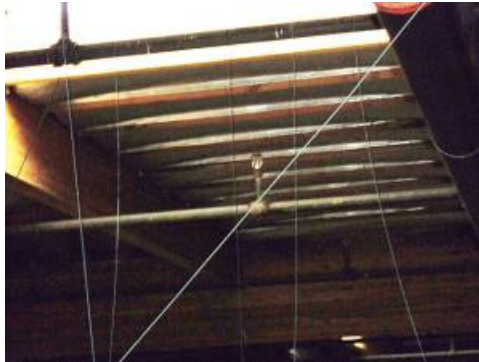
ROOF SUPPORT:

Glue Lam beams with purlins, 2x8s at 24 inch centers.

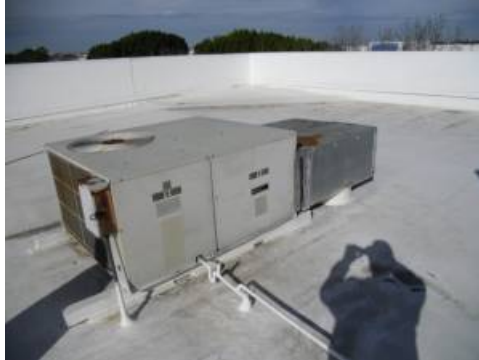
Package System Heat Pump.

Fair, due to age of equipment.

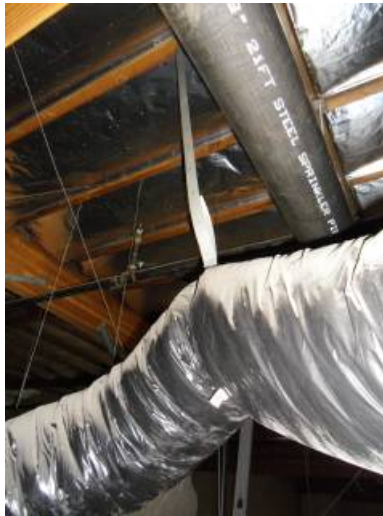
Ductwork and Air Flow:

Flex round. Fair overall condition. Air flow is good throughout.

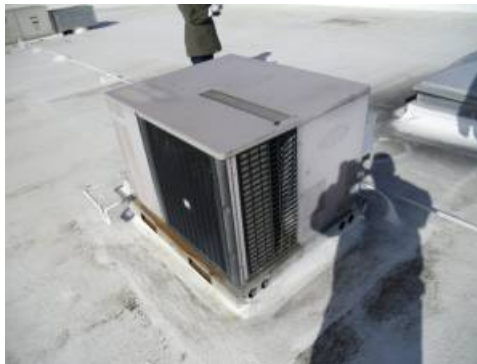
Package System Heat Pump.

Fair, due to age of equipment.

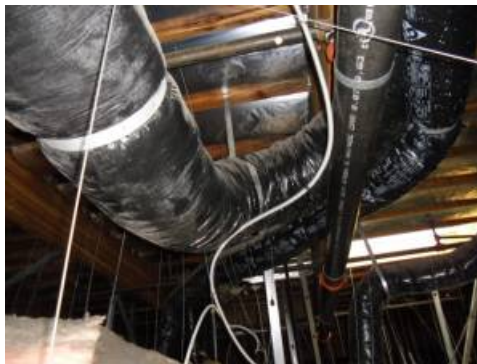
Ductwork and Air Flow:

Flex round. Fair overall condition. Air flow is good throughout.

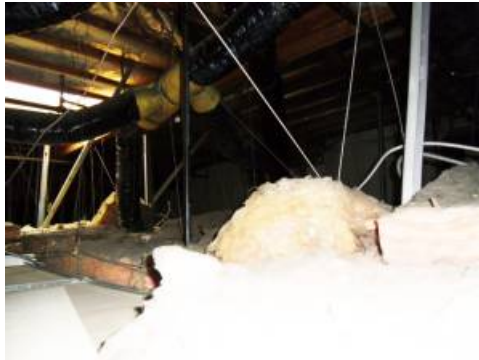
Return and Filter

Flex round. Fair overall condition. Air flow is good throughout.

Fair. Filters need cleaning or changing in the near future.

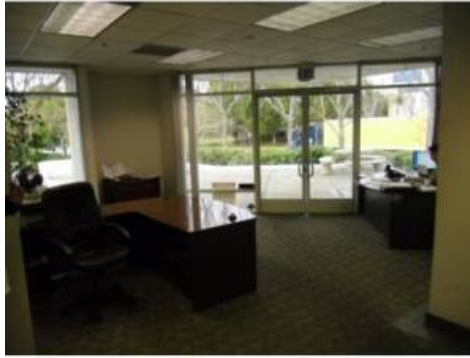
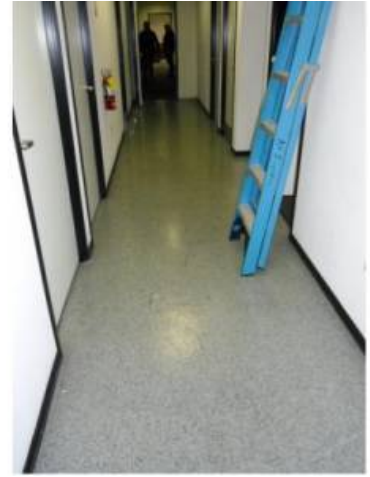
Carpeting throughout is only fair - normal wear and tear. Tile is Fair.

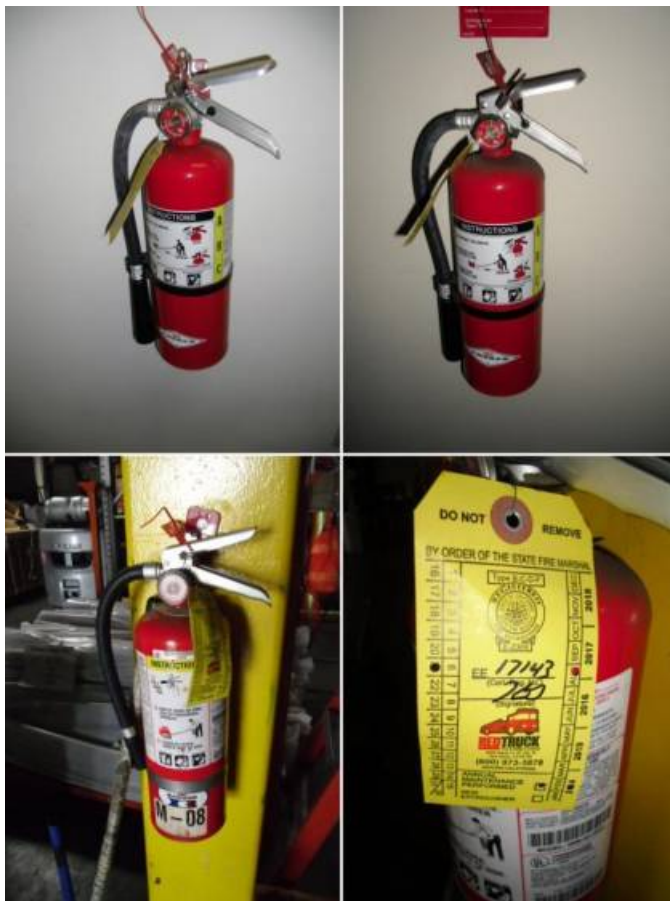
FIRE EXTINGUISHERS;

Present and charged.

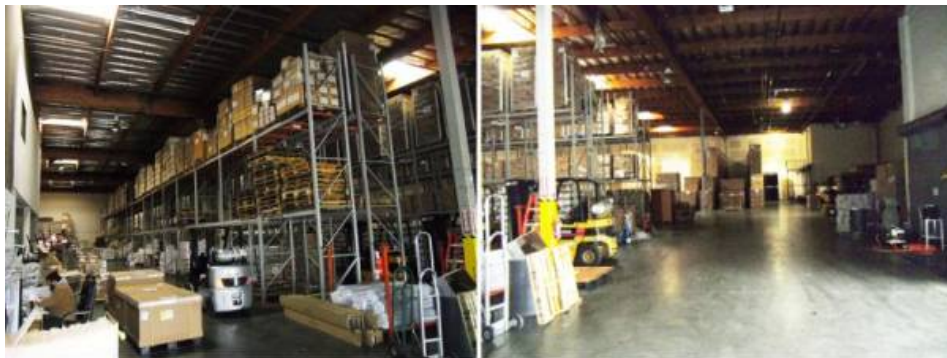
WAREHOUSE;

Fair overall.

Insulation coming down - Repairs needed.
