Uniform Building Inspection Report

27184 Ortega Hiway, San Juan Capistrano, CA 92675

Report #1710

RE: 27184 Ortega Hiway
San Juan Capistrano CA 92675

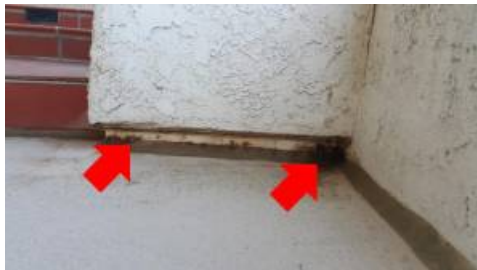
Weep Screed:

Rust is noted at the 2nd level.

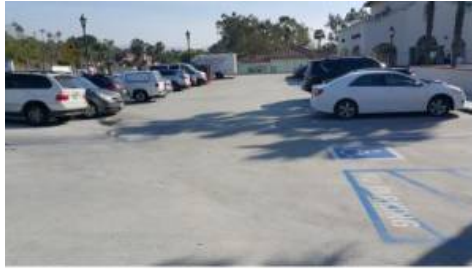
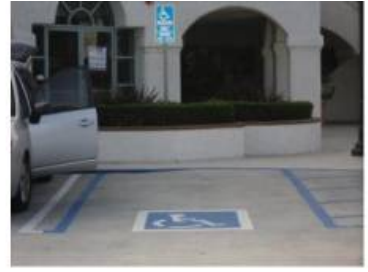
Other Paved Areas:

Sub terrain garage has major cracks. efflorescence and ACTIVE water leaks with moldy odors noted. Cinder block walls leak and need water proofing.

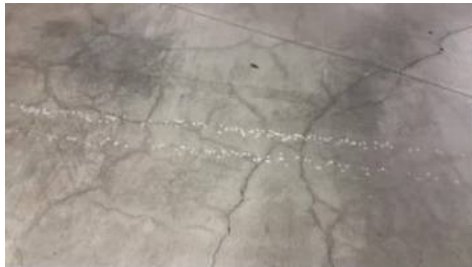
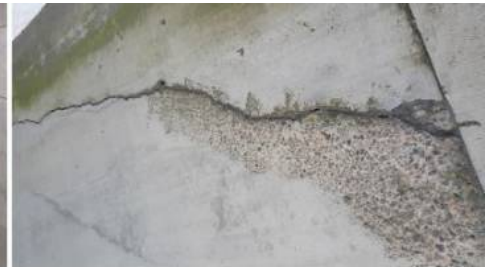
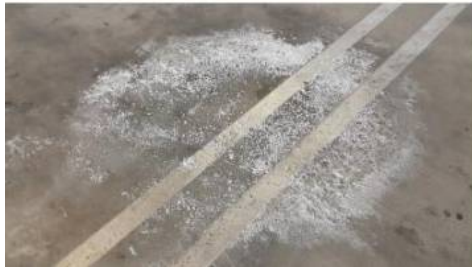
Additional Garage Photos:

Water damage and ACTIVE LEAKS noted.

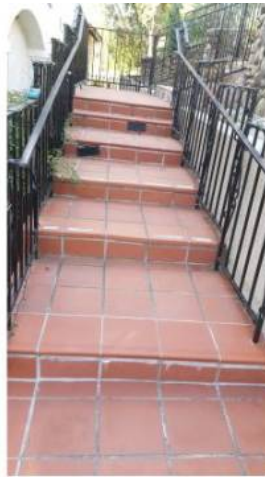
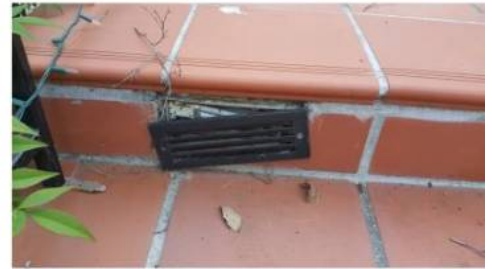
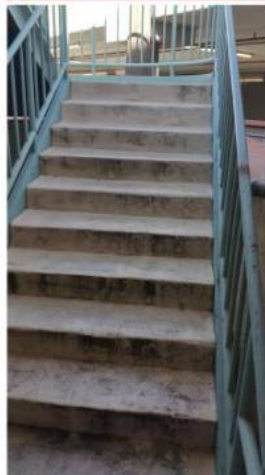
Stairs:

Good condition, except for a loose light grill and damage tile need to be repaired.

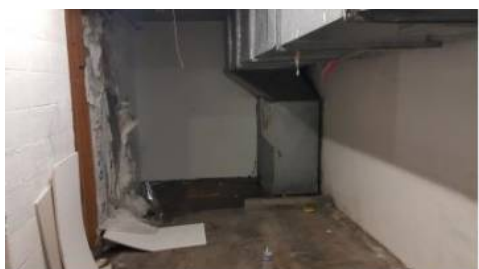
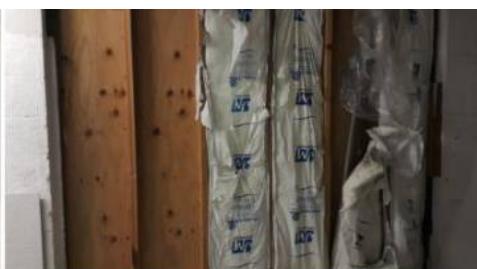
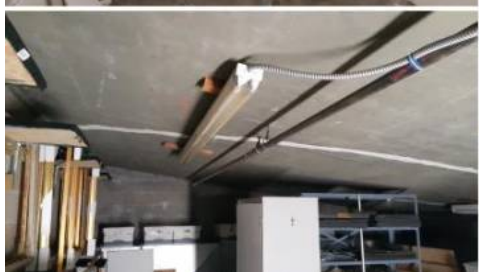
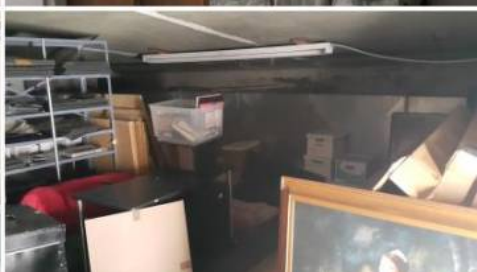
STORAGE AREAS:

Water intrusion and mold are noted - Repairs and remediation needed.

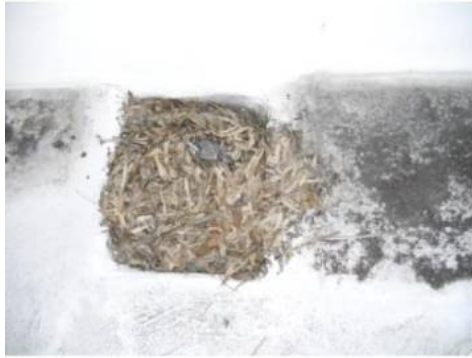
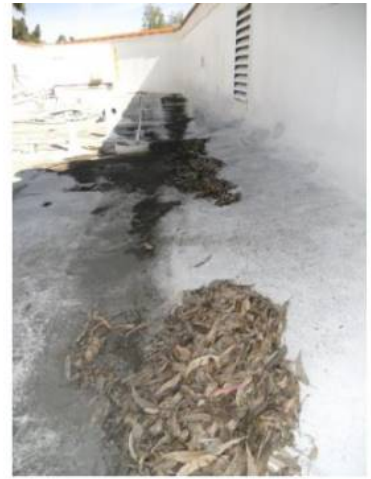
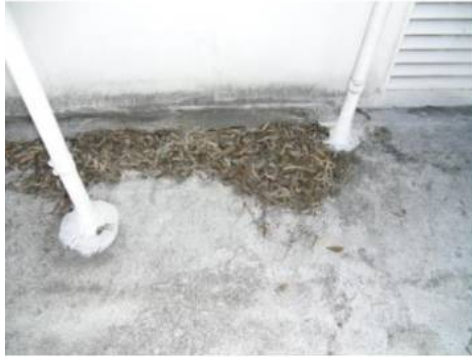
Drains:

Debris needs to be cleaned off the roof and out of the drains.

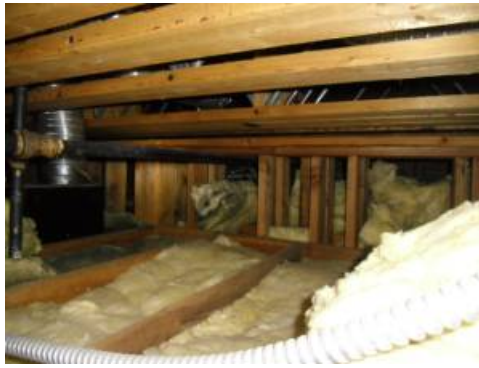
Side-Wall Insulation

3.5 inch Fiberglass batts, some are out of place.

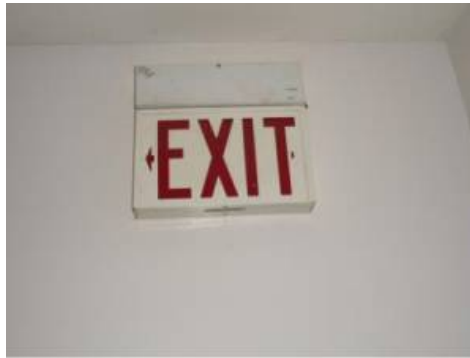
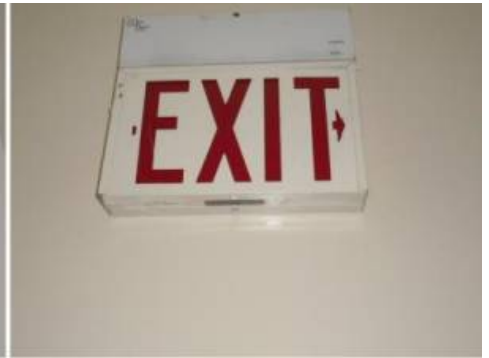
Emergency lighting was not operative unless it is tied into the alarm system.

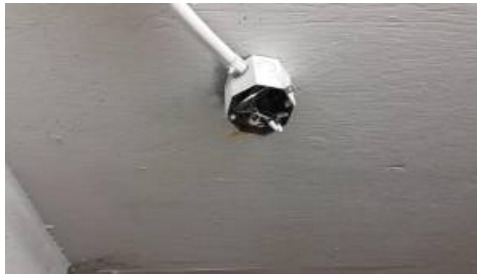
Areas of Concern: One exterior electrical junction box is open and not weather tight, and one garage junction box has no cover - **SAFETY HAZARDS!**

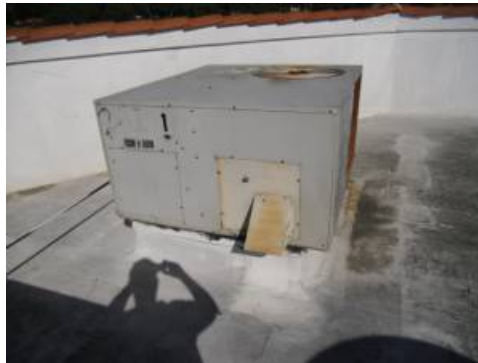
Unit 1

Fair- Primarily due to the age of the unit.

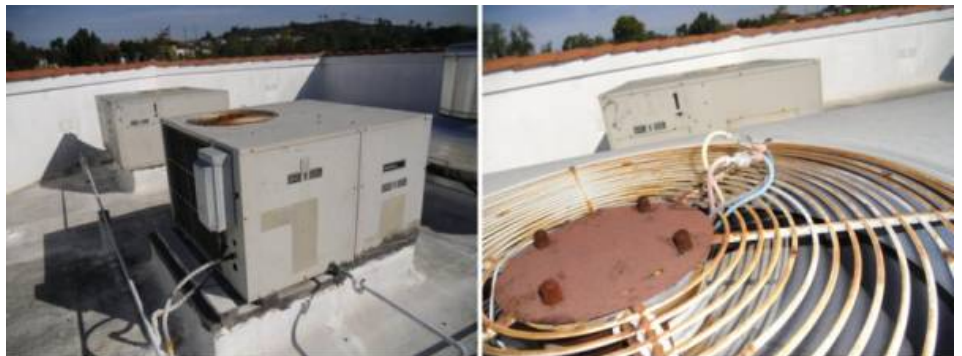
Unit 2

Fair- Primarily due to the age of the unit. Wires sticking out of the top.

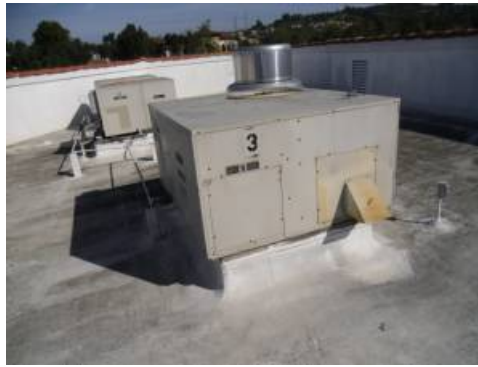
Unit 3

Fair- Primarily due to the age of the unit.

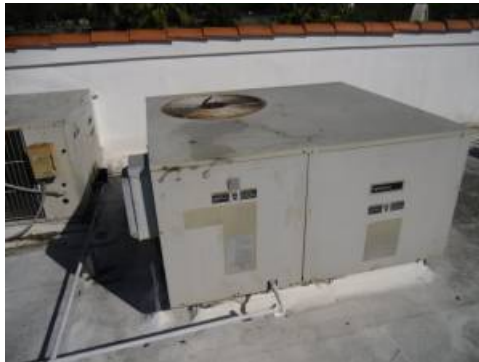
Unit 13

Fair- Primarily due to the age of the unit.

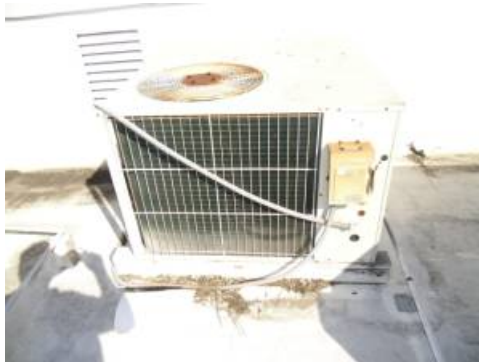
Unit 14

Fair- Primarily due to the age of the unit.

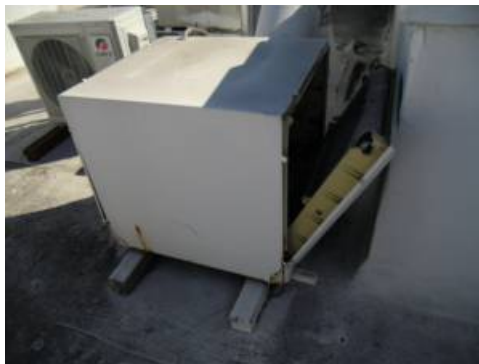
Unit 22

Poor.

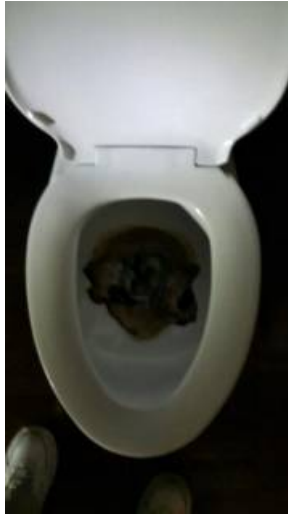
TOILETS:

Poor.

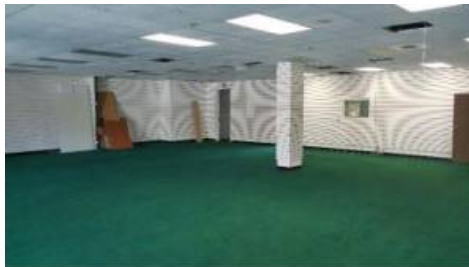
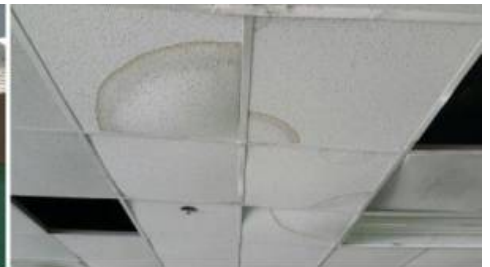
INTERIOR SPACES:

106.
Water leaks noted at ceiling.

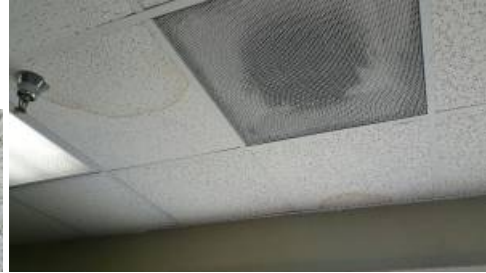
Previous water leaks noted.

Water stains noted.

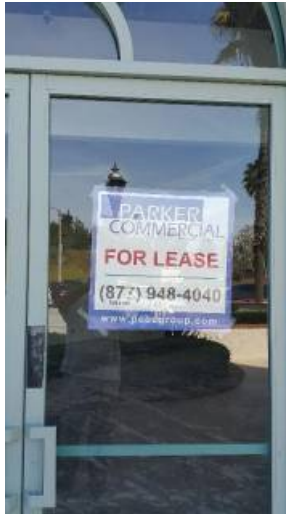
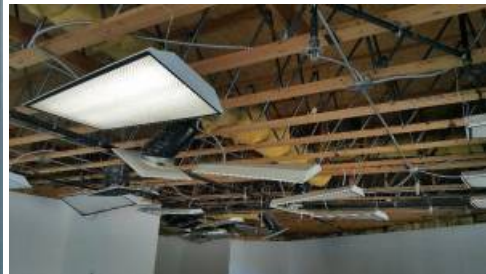
Unit 7

<i>INTERIOR SPACES:</i>	110. Vacant unit needs tenant improvement.
	No ceiling installed.

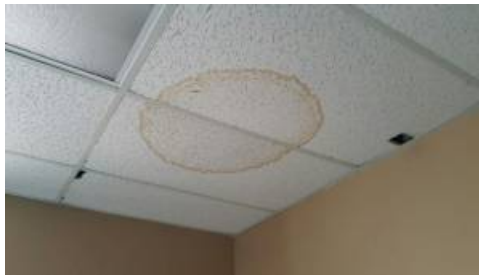
Tenant improvements?

Water stains on ceiling noted.
