# Uniform Building Inspection Report

4065 Strandberg St., Corona, CA 92881

6/13/2016

Report # 1625

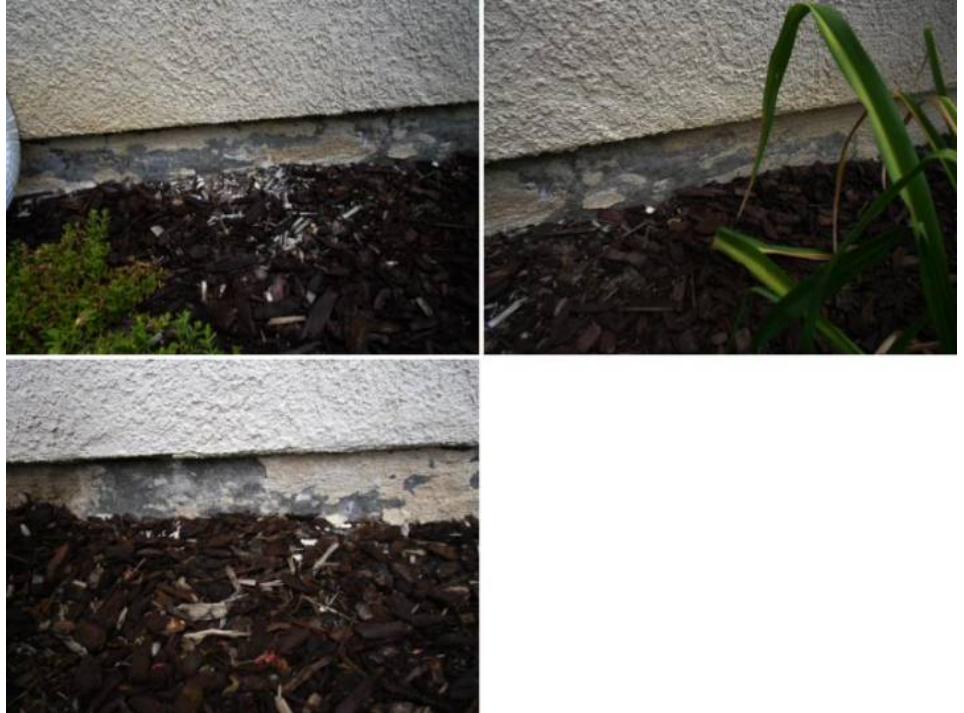
Cracks noted, stucco color coat is blistered and/or peeling away, rusted weep screed noted, cracked foundation noted, damage/rotted from moisture, A qualified contractor should be called to make further evaluation and repairs as needed.

Crack in foundation noted

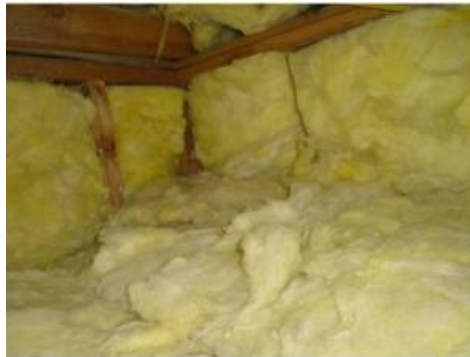
Fiberglass batts, Some insulation is installed unevenly.

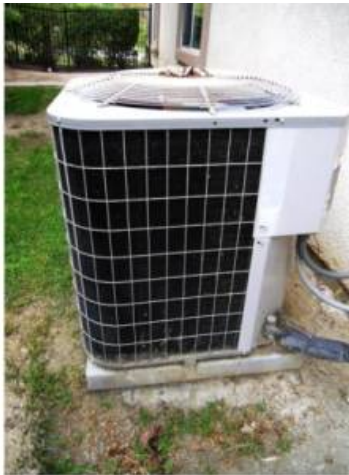
<b>POWER SOURCE:</b>	220 Volt.
<b>COMPRESSOR AGE IN YEARS:</b>	approx 13 years.
<b>SYSTEM CONDITION:</b>	Appears serviceable.
<b>CONDENSATE LINE:</b>	Condensate line installed.
<b>NORMAL CONTROLS:</b>	Appear serviceable.
<b>SECONDARY AIR CONDITIONING SYSTEM CONDITION:</b>	Appears serviceable, except insulation line needs replacement.

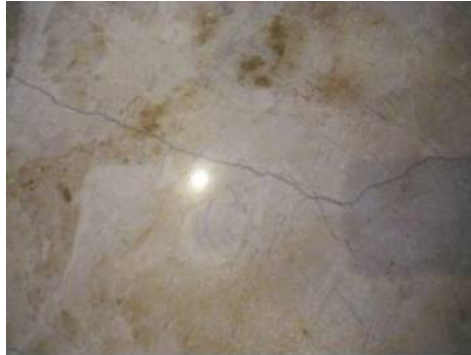
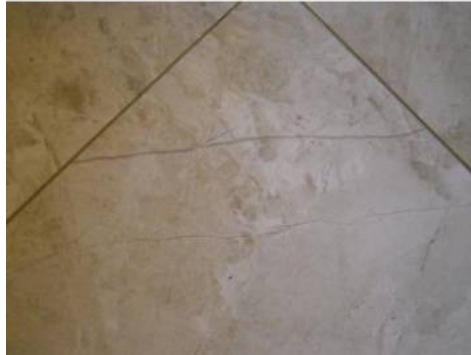
Carpet, Tile, General condition appears serviceable. Minor cracks noted in entry tiles.

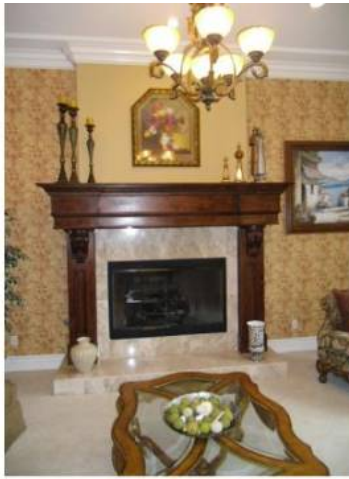
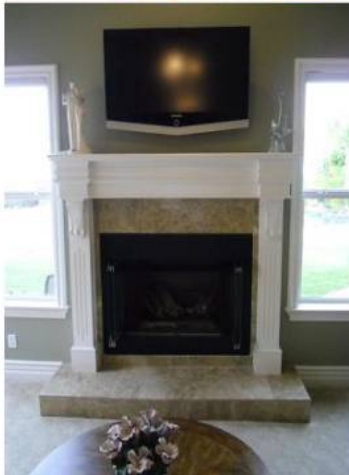
*LOCATION - TYPE - CONDITION:* Location #1: Living room. Location #2: Master bedroom. Prefabricated metal, Dampers are operational. Soot is noted, Recommend further evaluation by a licensed chimney sweep.

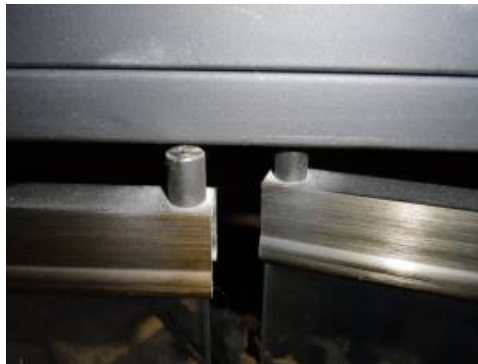
*Additional Photo:*

Living room screen needs adjustment.

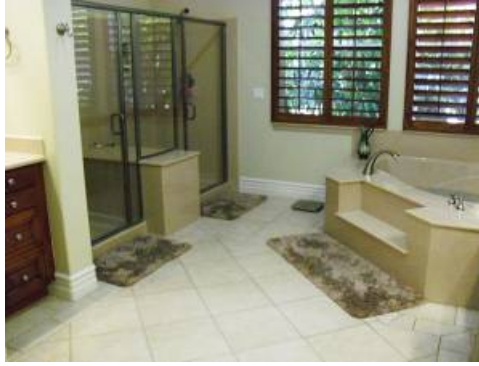
Master bedroom.

Previous leak noted under left side sink and broken mechanical stopper. Right side sink hot water side valve corrosion noted. Recommend further evaluation and necessary repair by a licensed plumber.

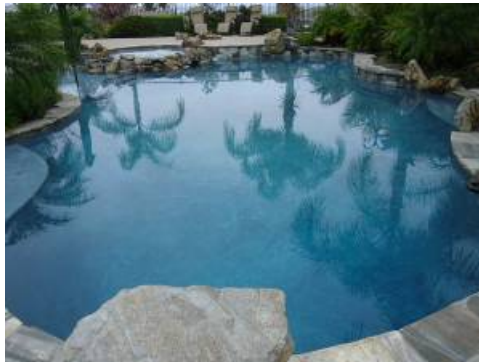
Concrete/Plaster.

Appearance is marginal, The following was seen: Stains noted - A qualified pool contractor should be called to make further evaluation and recommendations for repair or replacement.

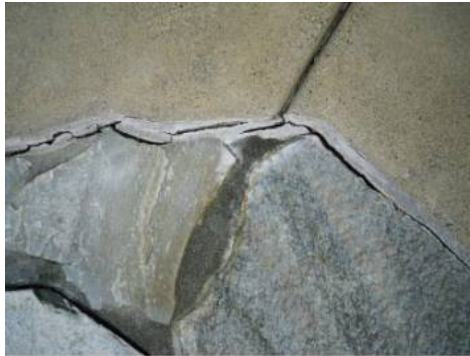
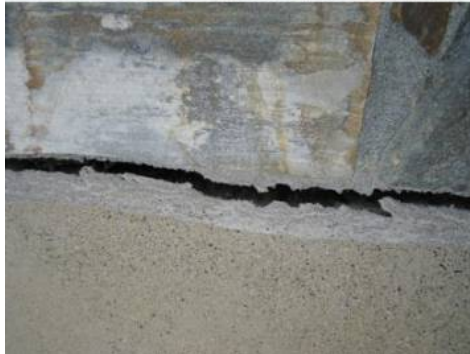
Scored concrete/Keystone, A few minor settlement cracks are noted. Repairs needed to prevent further damage - Recommend further evaluation and necessary repairs by a licensed pool contractor.

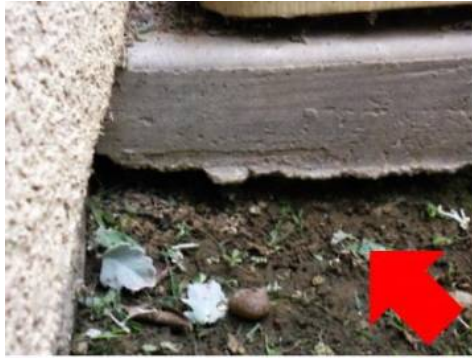
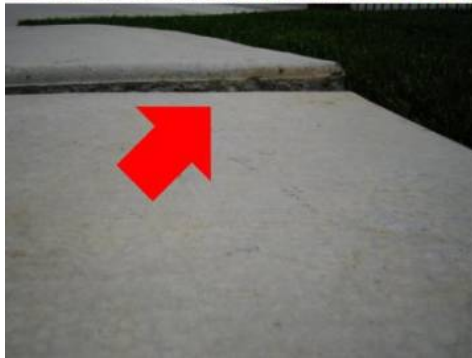
Left side of house sidewalk is undermined, Repair needed. Surface raised/settled, **TRIP HAZARD!**

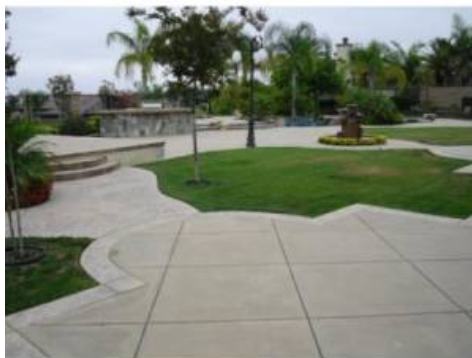
Maintained, Trees planted close to structure. Removal may be needed.

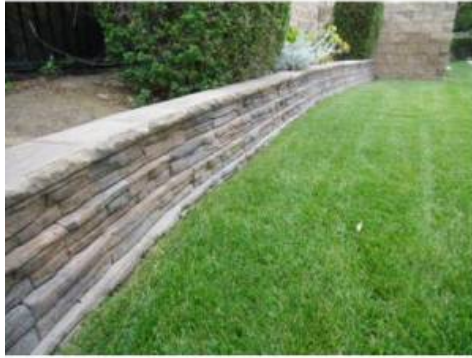
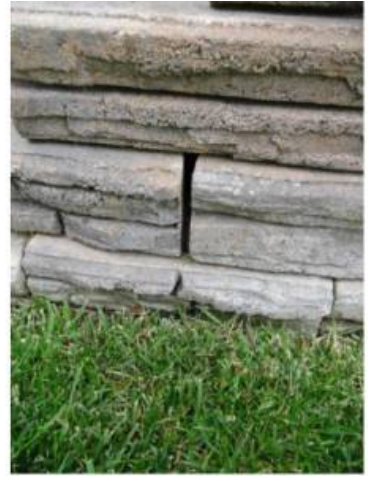
Appears serviceable, Displacement/Cracks typical. Re-direct the sprinklers away from the foundation and walls.

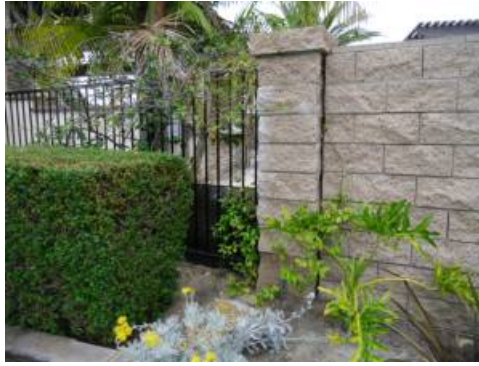
Wrot iron fences are rusted.
